PRODUCT CAMPAIGN BULLETIN

APPLICABILITY: 2003-2005 Subaru Legacy and Outback
 2003-2005 Subaru Baja
 2004-2005 Subaru Impreza**
 (including WRX and STI)

NUMBER: WQP-51R
DATE: January 2015
NHTSA ID: 14V-763
REVISED: October 5, 2017

SUBJECT: Regional Front Passenger Air Bag Inflator Replacement

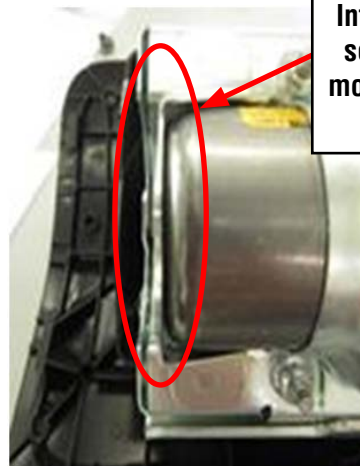
Inflator properly seated against mounting bracket (NO GAP)

STEP 9- Install the new inflator into the mounting bracket so the yellow taped end aligns with the removed stopper plate. Make sure the “D-shaped” portion of the inflator harness connector boss aligns with the “D-shaped” portion of the hole in the end of the mounting bracket as shown below. When properly installed, the end of the inflator will be seated tight against the mounting bracket. Do not peel the white harness connection dust cover at this time.
