**HYUNDAI**NEW THINKING.  
NEW POSSIBILITIES.**Technical Service Bulletin**

**14-01-056**

**SONATA (LFA) 1.6T****SUBJECT:** SONATA 1.6T LEFT FRONT DRIVESHAFT INSPECTION AND REPAIR (RECALL CAMPAIGN 126)**\* IMPORTANT****\*\*\* Dealer Stock and Retail Vehicles \*\*\***

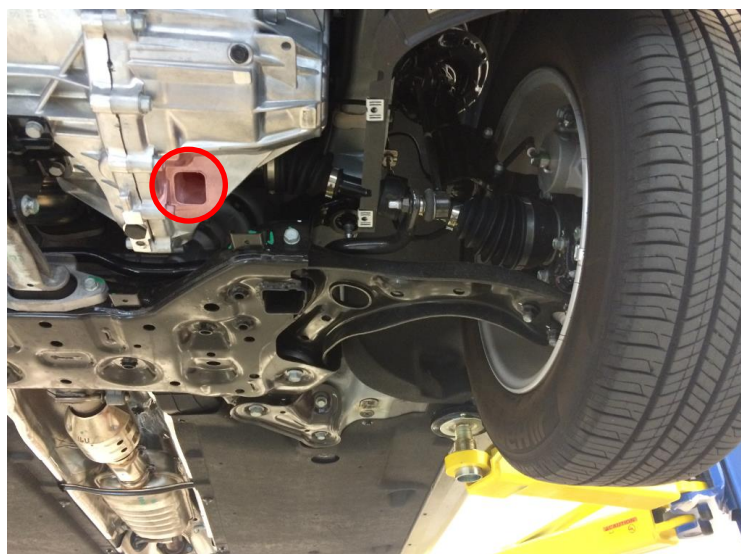
3. Locate the access hole where LH side driveshaft end can be visually inspected.

The access hole is located on bottom of transmission near the LH driveshaft install spline.
