IMPORTANT SAFETY RECALL

Airstream Interstate Motorhome

NHTSA Recall Number 15V-658

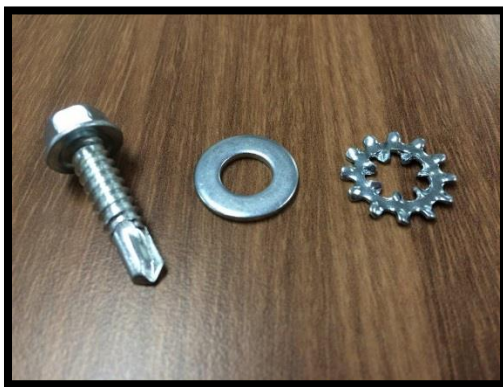
Process: The white wire connected to the stud under the jack knife seat was connected in the wrong location and will need to be removed from this location and attached to the bolt location on the wall just beside the stud.

SERVICE ACTION: The repair is to detach the 8 gauge interior wire harness ground wire from the battery/inverter ground block and reattach it to a sidewall rib and retighten all electrical connections as outlined in the attached repair procedure.

- Battery Drill
- Phillip's Head Bit
- 1/4" driver bit
- 1- 1/4" #14 thread-cutting screw (part # 345084)
- 1- Lock Tooth Washer, 1/4" (part # 350158-01)
- 1- Flat Washer, 1/4" (part # 300111-25)
