Safety Recall - USA ONLY

Code: 24BK

Subject: Certain 2012 MY Touareg Hybrid

Fuel Injection System Leak March 17, 2015

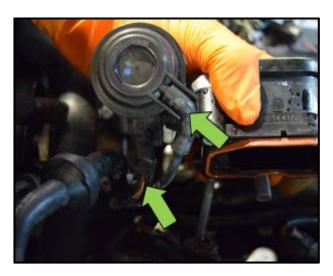
- Lift gently upward on the lower intake manifold/fuel rail assembly to unseat the fuel rail from the fuel injectors.
- During removal of the intake manifold/fuel rail assembly, disconnect the intake manifold runner position sensor and vacuum line <arrows>.
- Repeat the previous steps to remove the intake manifold/fuel rail assembly from the opposite side of the engine.

Some of the fuel injectors may come out with the fuel rail. Any injectors that are removed from the cylinder head MUST have replacement seals installed on them prior to reassembly (see Appendix B).

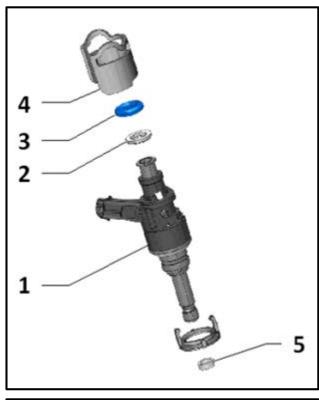
Appendix B – Replacing the Fuel Injector Seals

Follow this procedure ONLY on injectors that came out of the cylinder head during removal of the fuel rail.

- Remove the support ring <4>, the o-ring <3>, and the spacer ring <2> from the fuel injector.
- Carefully cut and remove the combustion chamber sealing ring <5>.
- Use a clean cloth to remove any excess combustion residue from the sealing ring groove on the fuel injector.
