Dealer Service Instructions for:

Safety Recall R36 / NHTSA 15V-459

Steering Wheel Wiring

2012 – 2014	(DS) RAM 1500 Pickup
2012 – 2014	(DJ) RAM 2500 Pickup
2012 – 2014	(D2) RAM 3500 Pickup
2012 – 2014	(DD) RAM 3500 Cab Chassis
2012 – 2014	(DP) RAM 4500/5500 Cab Chassis

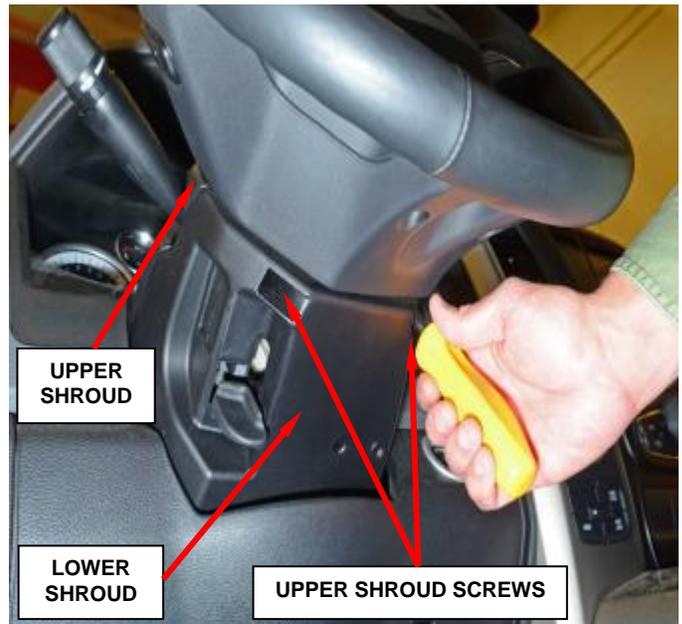
Figure 1 – Upper Shroud Screw Locations

1. Disconnect and isolate the negative battery cable. Wait two minutes for the system capacitor to discharge before further service.
2. Remove the two upper shroud screws from the steering column and remove the upper shroud (Figure 1).
3. Release the steering column tilt lever and lower the column to its most downward position for easiest driver airbag removal access.
4. There are three driver airbag (DAB) retainer access holes on the instrument panel side of the hub of the steering wheel, located at the two o'clock, six o'clock and ten o'clock positions. The steering wheel must be rotated to bring each of these access holes up to the twelve o'clock position of the steering column one at a time for removal access.

24. Reinstall the upper shroud onto the steering column (Figure 1).

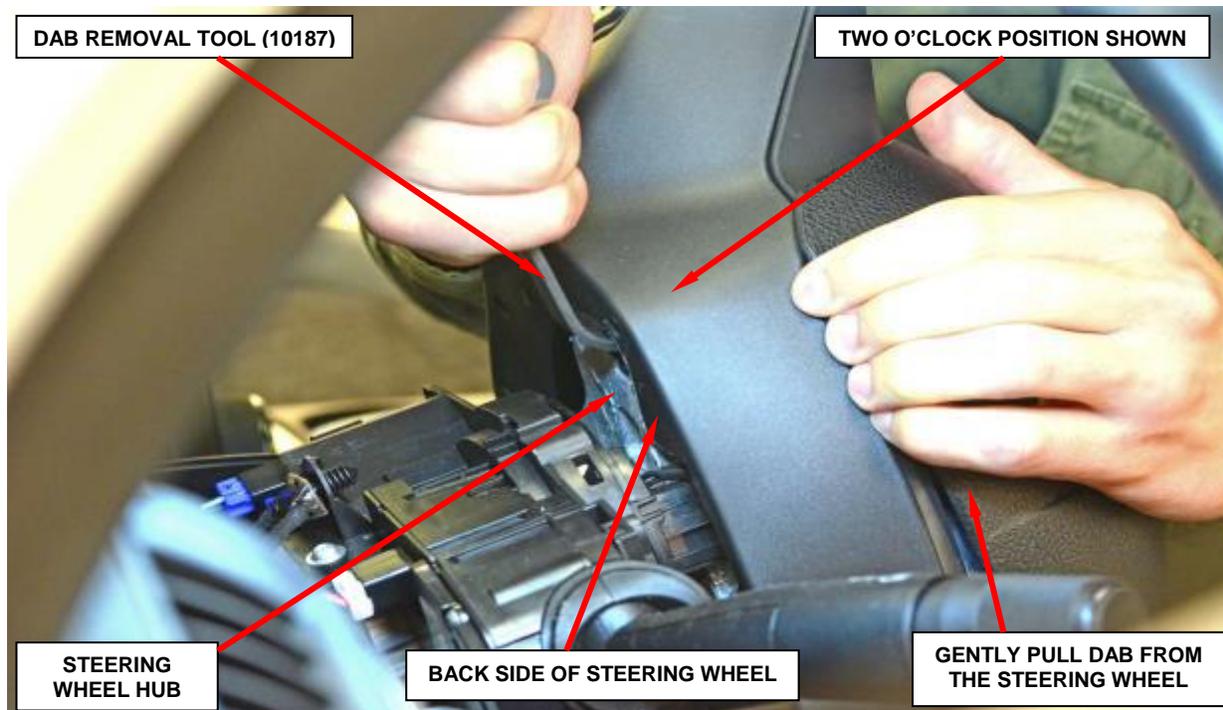
**Figure 2 – DAB Removal Tool (10187)**

5. Insert the short blade (Tip A) of the DAB Removal Tool (Special Tool Number 10187) or the blade of an equivalent prying tool into either of the upper (two o'clock or ten o'clock) access holes of the steering wheel hub rear trim cover, being certain to place the blade of the tool on the inboard (steering wheel hub) side of the airbag snap retainer wire loop (Figure 2).

6. Push the handle of the tool downward for the blade to pry the snap retainer wire loop upward far enough to disengage the loop from the hook of the steering wheel armature. At the same time, gently pull the DAB away from the steering wheel to prevent the retainer from snapping back into place over the hook once it is disengaged (Figure 2).

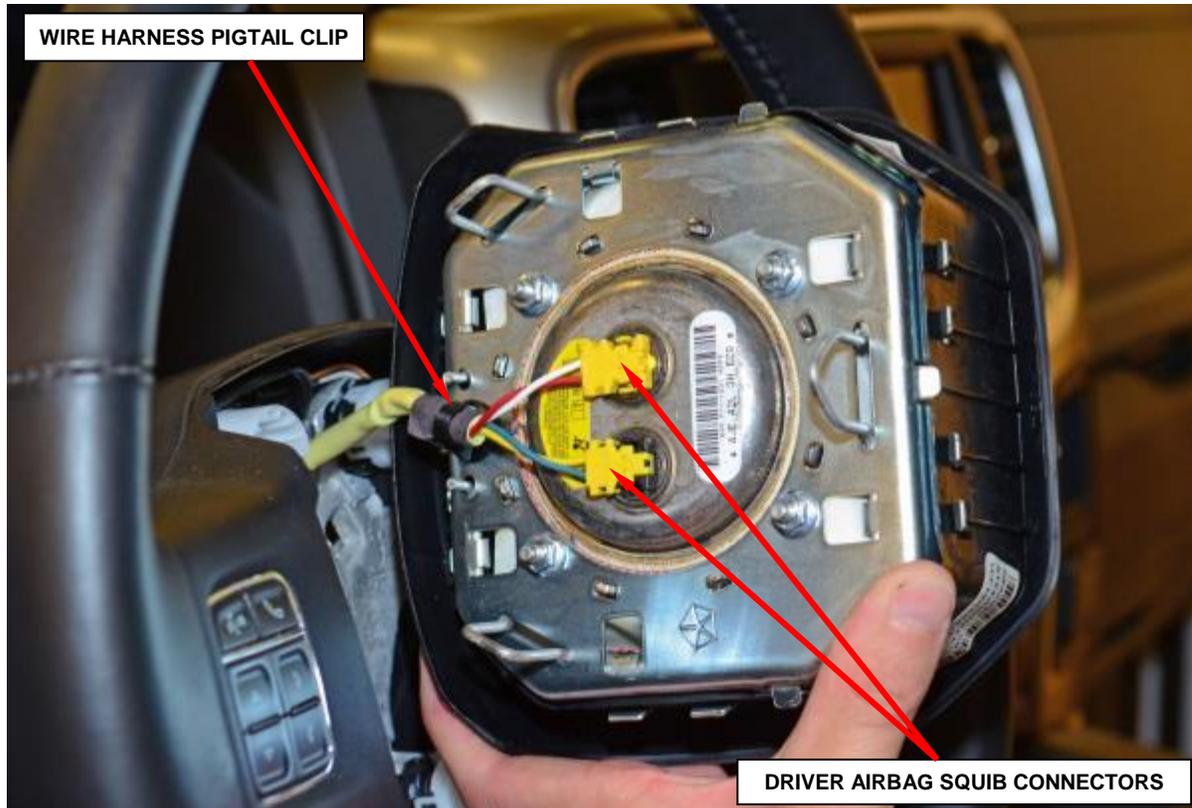
Figure 3 – Driver Airbag Squib Connectors

9. Disconnect the two driver airbag squib connectors. Depress the latches on each side of the connector insulator and pull the insulators straight out from the driver airbag inflator to disconnect them from the connector receptacles (Figure 3).

10. Disengage the wire harness pigtail clip from the housing and remove the driver airbag (Figure 3).

20. Engage the wire harness pigtail clip to the housing (Figure 3).
21. Carefully position the driver airbag into the hub cavity of the steering wheel and connect the two driver airbag squib connectors to the airbag inflator connector receptacles by pressing straight in on the connector. Be certain to engage each keyed and color-coded connector to the matching connector receptacle. Be certain that each connector is fully engaged in its receptacle by listening carefully for a distinct, audible click as the connector latches snap into place (Figure 3).

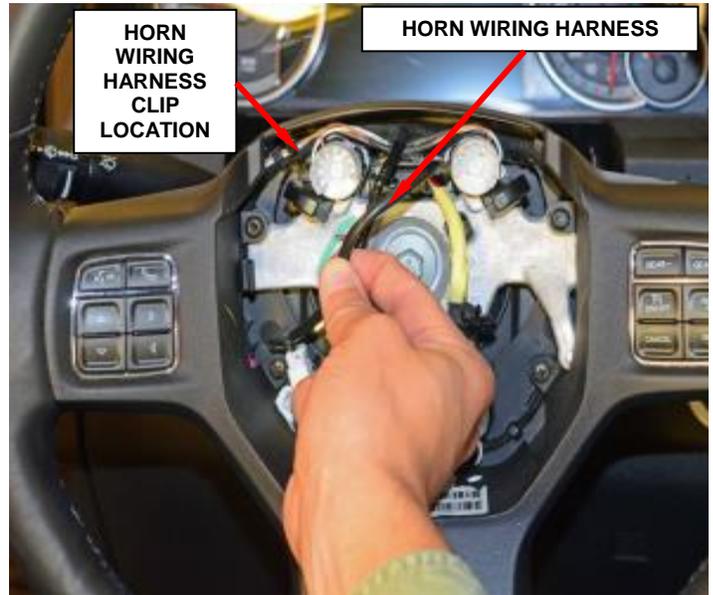
Figure 5 – Horn Wiring Harness

13. Unclip the horn wiring harness and move it down to gain access to the steering wheel harness (Figure 5).

17. Position the horn wiring back into the clip (Figure 5).
18. Connect the steering wheel wire harness six way connector (Figure 4).
19. Install the two rubber caps to the two posts on the back side of the driver airbag module (Figure 8).

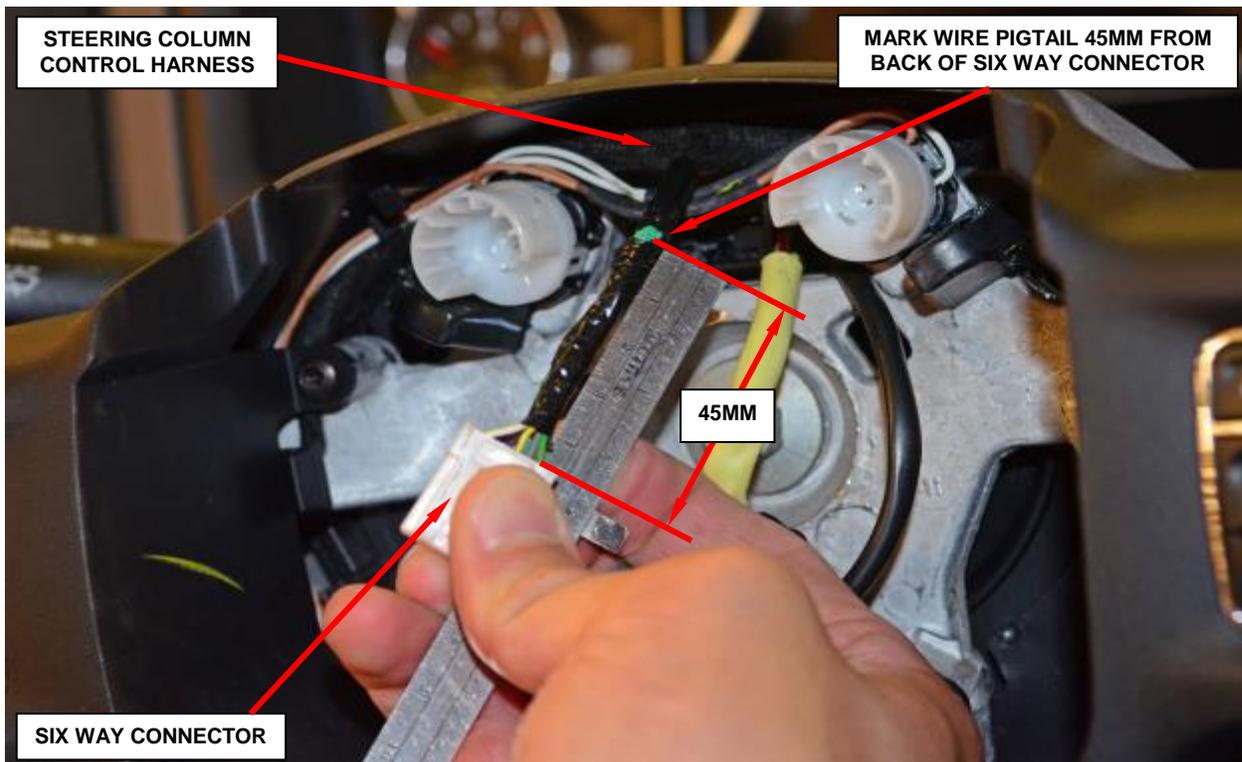
Figure 6 – Mark Wire Harness for Reference

14. Measure 45mm from the back of the six way connector and mark the wire pigtail for reference in step 15 (Figure 6).
