RECALL CAMPAIGN BULLETIN

Reference: NTB15-074 Date: August 17, 2015

VOLUNTARY SAFETY RECALL CAMPAIGN 2015 ARMADA FRONT SEAT BELT BUCKLE

CAMPAIGN ID #: PC385 APPLIED VEHICLES: 2015 Armada (TA60)

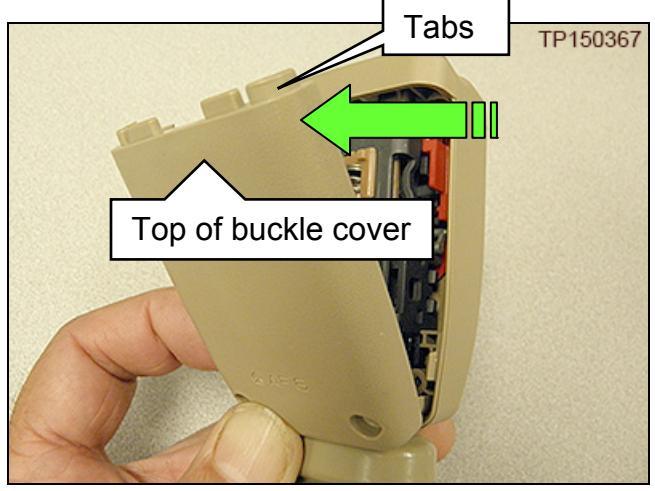
- c. With the bottom of the buckle cover held against the buckle, pivot the top of the buckle cover away from the buckle.
- Only pivot the buckle cover far enough away to inspect the seat belt buckle latch mechanism.
