October 2015

Dealer Service Instructions for:

## **Safety Recall R43 / NHTSA 15V-517 Battery Wire Harness**

#### **2014 (DS) RAM Trucks (1500 series)**

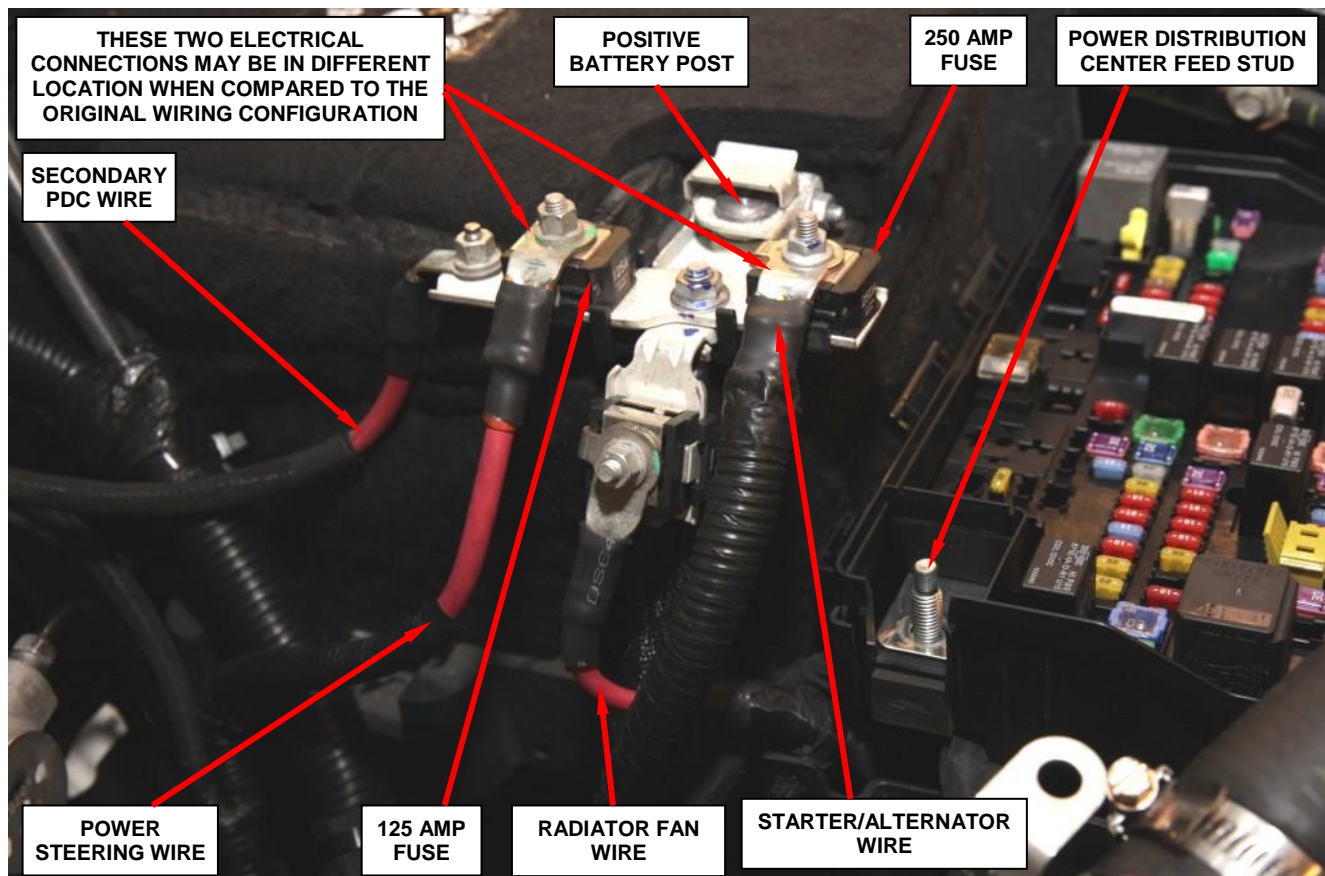
**Figure 11 – Battery Positive Electrical Connections**

**CAUTION: Some of the B+ terminal positions for the battery feed wires have moved to different locations on the positive battery post terminal.**

53. Connect the wire harness three-pin electrical connector (Figure 5).
54. Connect the Power Distribution Center (PDC) electrical connector to the bottom of the PDC top panel (Figure 4).
55. Snap the PDC top panel into the PDC housing.
56. Connect the PDC battery B+ feed wire to the PDC feed stud (Figure 11). Tighten the retaining nut to 106 in. lbs. (12 N·m).
57. Install the PDC cover.
58. Connect the positive battery terminal to the positive battery post. Tighten the battery terminal nut to 48 in. lbs. (5.4 N·m).
59. Connect the battery feed wires at the positive battery post terminal studs (Figure 11). Tighten the nuts to 80 in. lbs. (9 N·m).
