SAFETY RECALL BULLETIN

SUBJECT: RIGHT PARKING BRAKE CABLE INTERFERENCE WITH FUEL TANK – SAFETY RECALL CAMPAIGN			No: SR-15-009
			DATE: October, 2015
			MODEL: 2014-15 Lancer RAE and Lancer Evolution
CIRCULATE TO:	<input checked="" type="checkbox"/> GENERAL MANAGER	<input checked="" type="checkbox"/> PARTS MANAGER	<input checked="" type="checkbox"/> TECHNICIAN
<input checked="" type="checkbox"/> SERVICE ADVISOR	<input checked="" type="checkbox"/> SERVICE MANAGER	<input checked="" type="checkbox"/> WARRANTY PROCESSOR	<input checked="" type="checkbox"/> SALES MANAGER

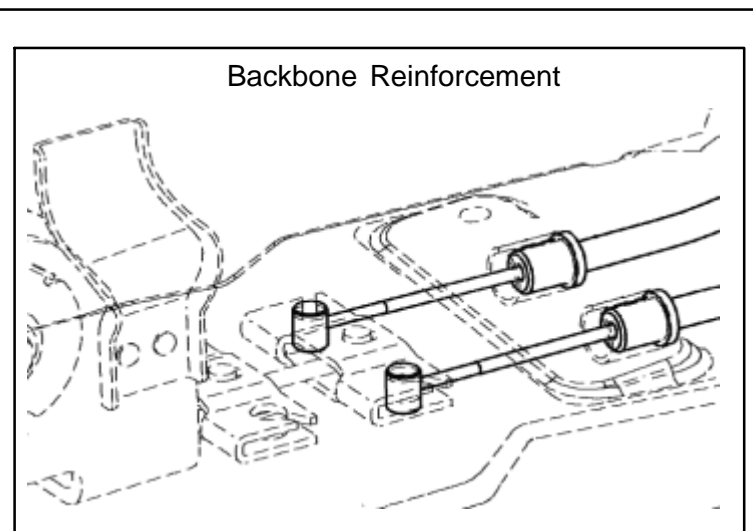
19. Lift the vehicle. Ensure there is sufficient gap between the fuel tank and right parking brake cable.

18. Connect the equalizer and the parking brake cable before installing it to the backbone reinforcement.
