# SAFETY RECALL BULLETIN

SUBJECT: <b>SRS WARNING LIGHT ILLUMINATES – SAFETY RECALL CAMPAIGN</b>			No: <b>SR-15-011</b>
			DATE: <b>October, 2015</b>
			MODEL: <b>2012 i-MiEV &amp; 2014 Mirage</b>
CIRCULATE TO:	<input checked="" type="checkbox"/> GENERAL MANAGER	<input checked="" type="checkbox"/> PARTS MANAGER	<input checked="" type="checkbox"/> TECHNICIAN
<input checked="" type="checkbox"/> SERVICE ADVISOR	<input checked="" type="checkbox"/> SERVICE MANAGER	<input checked="" type="checkbox"/> WARRANTY PROCESSOR	<input checked="" type="checkbox"/> SALES MANAGER

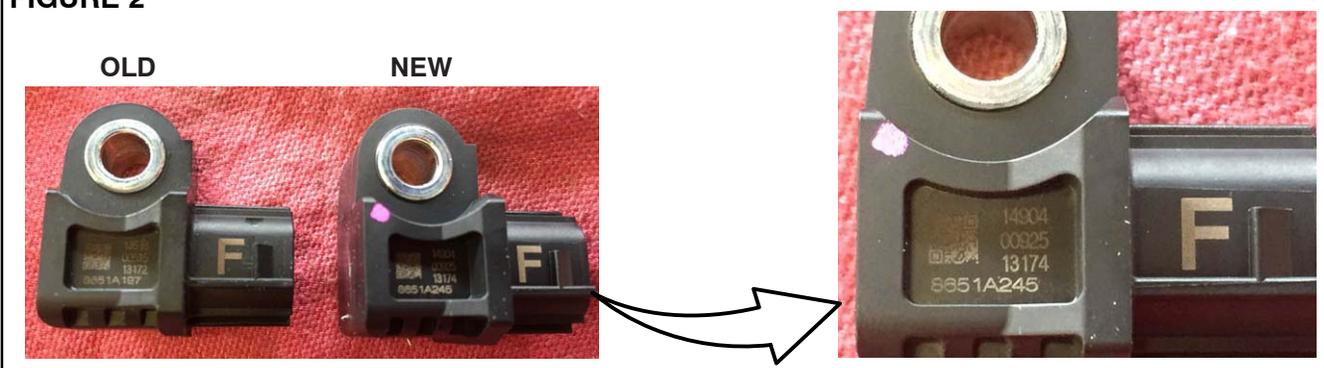
**FIGURE 2**

Make sure the old impact sensors and new impact sensors are kept separate.  
The new sensors may be identified by the individual sensor part number (8651A245).

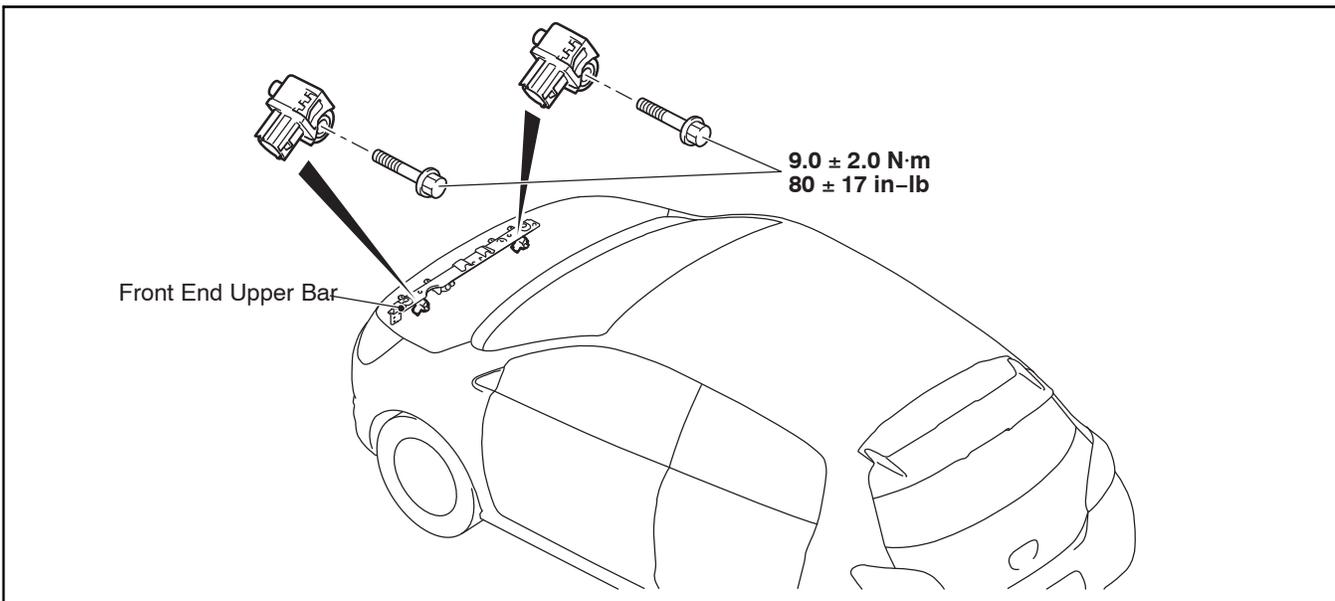
The SRS may not operate properly if an impact sensor is not installed correctly, increasing the risk of personal injury. Refer to Figure 1 at the beginning of this bulletin for proper alignment.

5. Remove the front impact sensor fitting bolts.
6. Remove the front impact sensors.
7. Connect the new front impact sensor connectors. [Refer to FIGURE 3 at the beginning of this bulletin.]
8. Install the new front impact sensors with the fitting bolts.

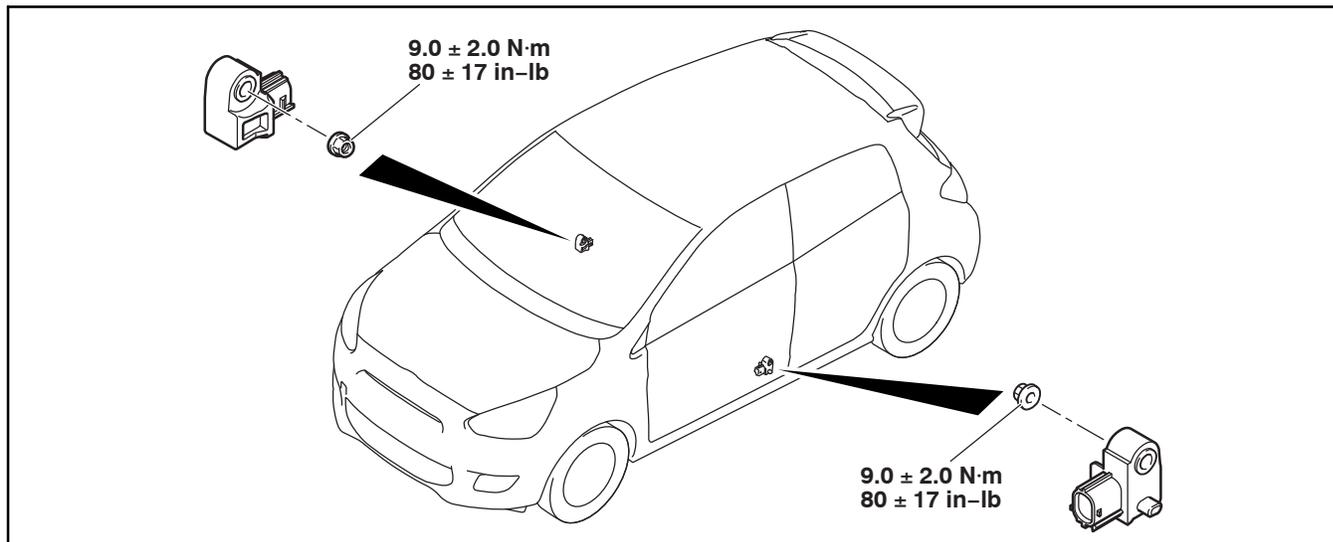
The SRS may not operate properly if an impact sensor is not installed correctly, increasing the risk of personal injury. Refer to Figure 1 at the beginning of this bulletin for proper alignment.

7. Unlock and remove the connector from the side impact sensor. [Refer to FIGURE 3 at the beginning of this bulletin.]
8. Remove the side impact sensor.
9. Connect the connector to the new side impact sensor. [Refer to FIGURE 3 at the beginning of this bulletin.]
10. Install the new side impact sensor with the fitting nut.

11. Repeat the same procedure on the opposite side (steps 1 – 10) to replace both side impact sensors. Replacement is required on **BOTH** sides.

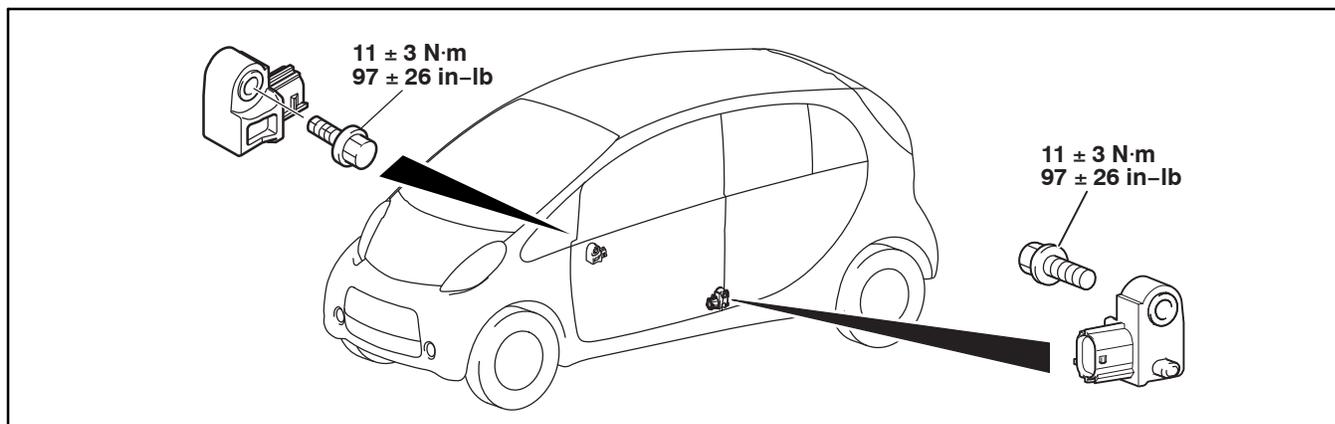
The SRS may not operate properly if an impact sensor is not installed correctly, increasing the risk of personal injury. Refer to Figure 1 at the beginning of this bulletin for proper alignment.

**NOTE:** Side impact sensor replacement is required on **BOTH** sides.

4. Unlock and remove the connector from the side impact sensor. **[Refer to FIGURE 3 at the beginning of this bulletin.]**
5. Remove the side impact sensor.
6. Connect the connector to the new side impact sensor. **[Refer to FIGURE 3 at the beginning of this bulletin.]**
7. Install the new side impact sensor with the fitting bolt.

8. Repeat the same procedure on the opposite side (steps 1 – 7) to replace both side impact sensors.
