HYUNDAI
Technical Service Bulletin

GROUP RECALL	NUMBER 25-01-008H
DATE FEBRUARY 2025	MODEL(S) SONATA (YF) ELANTRA (MD)

SUBJECT: FRONT COIL SPRING URETHANE TUBE INSTALLATION
 (RECALL 133)

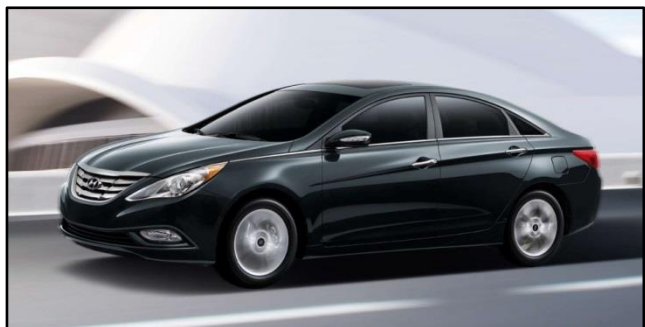
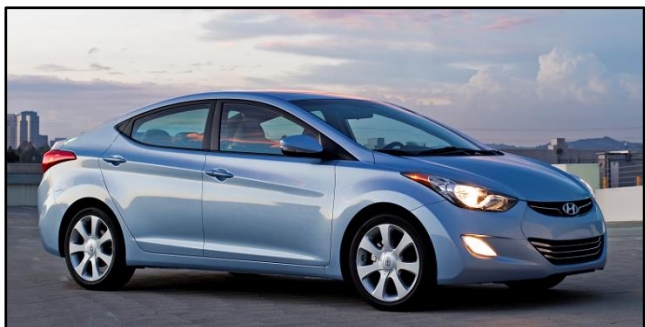
Description: On certain 2011 Sonata (YF) and Elantra (MD) vehicles, corrosion can build up at the front coil springs, resulting in possible fracture near the base. A fractured spring can make contact with the tire, potentially resulting in a tire puncture and increasing the risk of a crash. This bulletin describes the procedure to install urethane tubes over the front coil springs to prevent a tire puncture.
