This Service Information bulletin supersedes SI 32 02 15 **dated March 2016**.

SUBJECT**Recall 15V-660: Electro-Hydraulic Power Assist Steering (EHPAS) System****MODEL**

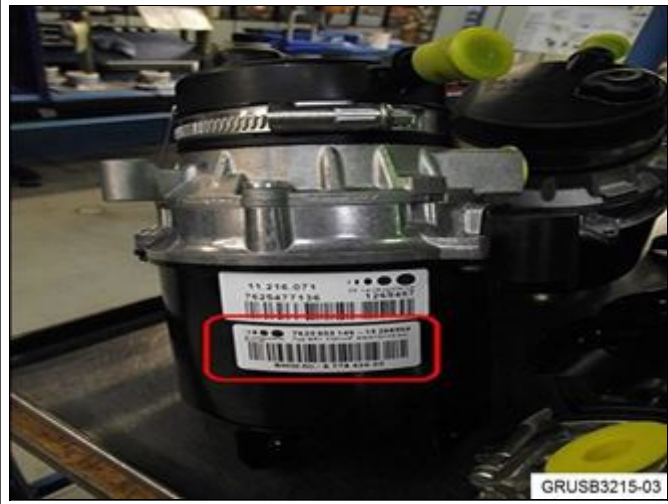
- Identify the part number on the label attached to the power steering pump

There are 3 different types of labels that can be found on the power steering pump
