# RECALL CAMPAIGN BULLETIN

NTB15-091

## VOLUNTARY SAFETY RECALL CAMPAIGN OCCUPANT CLASSIFICATION SYSTEM REPROGRAMMING

**APPLIED VEHICLES:** 2013 – 2014 Altima Sedan (L33)  
2013 – 2015 Pathfinder (R52)  
2013 – 2015 Sentra (B17)

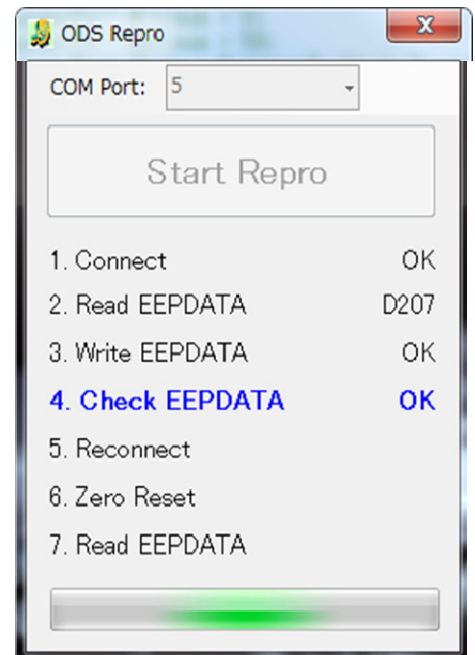
Figure 5

- Items 1 through 4 will likely complete quickly.
- If the OCS reprogramming stops (displays NG) at item 1,2,3 or 4, refer to Figures 10 through 13 on pages 8 and 9.

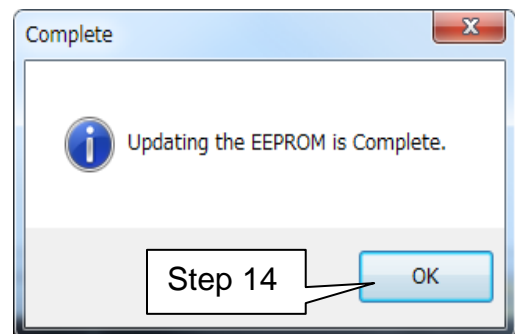
Figure 8

13 When this screen displays (Figure 8), OCS reprogramming is complete.

14. Select **OK**.
