Recall Bulletin

PRODUCT SAFETY RECALL

SUBJECT: Power Window Master Switch Failure

MODELS: 2009-2010 Pontiac Vibe

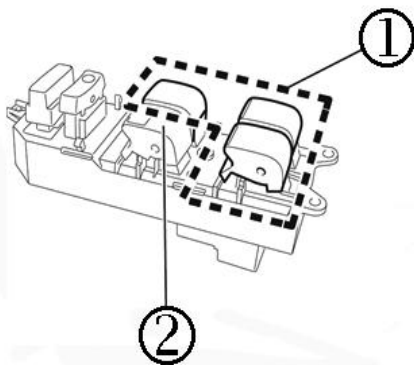
3021144

2. Check all switches (1) that do not have AUTO function (2) for the catching condition.

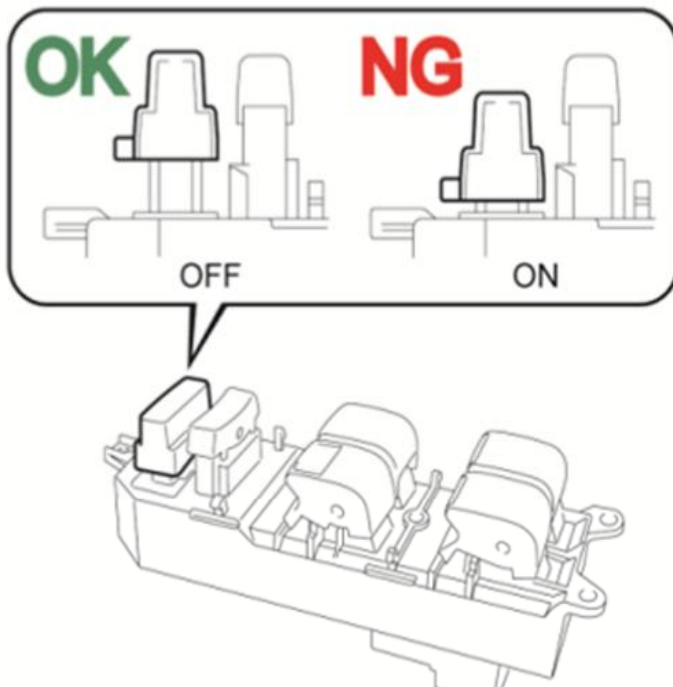
3021150

- Removing the lock button while it is turned ON may damage the switch.
- To prevent damage, Do Not use tools.

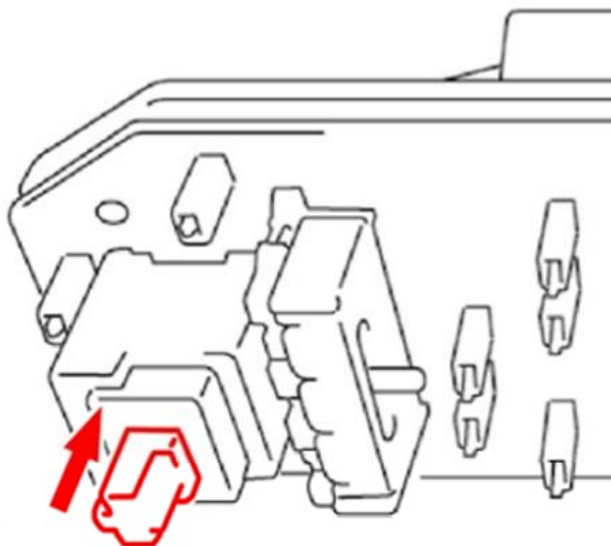
3021155

- If the AUTO switches are not aligned correctly, the readings may be inaccurate
- The switches MUST be in this position when checking the resistance. This is the OFF position. If the switch is in any other position, the readings will be incorrect.
- ALL switches that ARE NOT AUTO MUST be checked.

5. Align each switch pin with the “V” mark on all switches that do not have AUTO function.
6. Align the switch pin with the center line on all AUTO function switches.

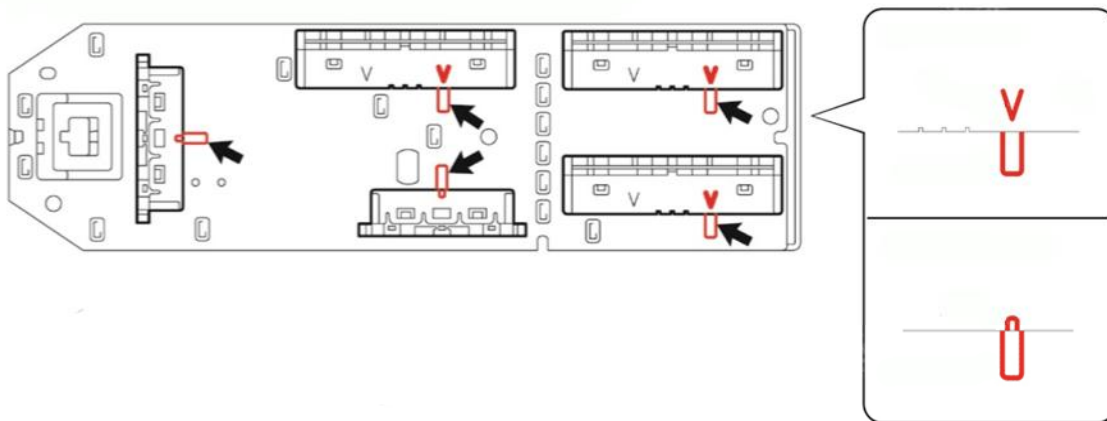
3021208

Important: If the switch pins are not aligned, the switches will not operate correctly after reassembly.

2. Position the switches. Align all switch pins with the marks as shown in the illustration below.
