SAFETY RECALL BULLETIN

SUBJECT:			No: SR-16-001
SRS CONNECTOR CORROSION – SAFETY RECALL CAMPAIGN			DATE: February, 2016
			MODEL: 2014-15 Mirage
CIRCULATE TO:	<input checked="" type="checkbox"/> GENERAL MANAGER	<input checked="" type="checkbox"/> PARTS MANAGER	<input checked="" type="checkbox"/> TECHNICIAN
<input checked="" type="checkbox"/> SERVICE ADVISOR	<input checked="" type="checkbox"/> SERVICE MANAGER	<input checked="" type="checkbox"/> WARRANTY PROCESSOR	<input checked="" type="checkbox"/> SALES MANAGER

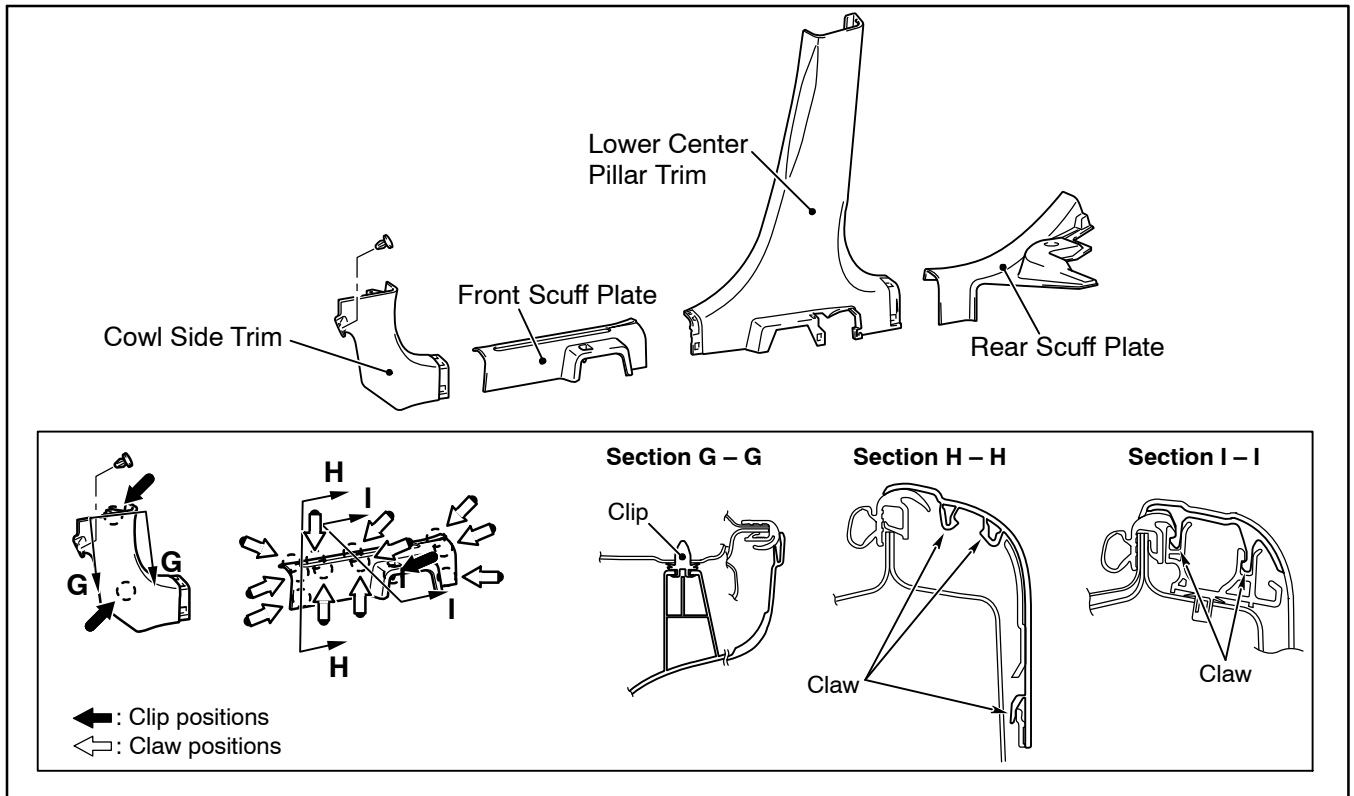
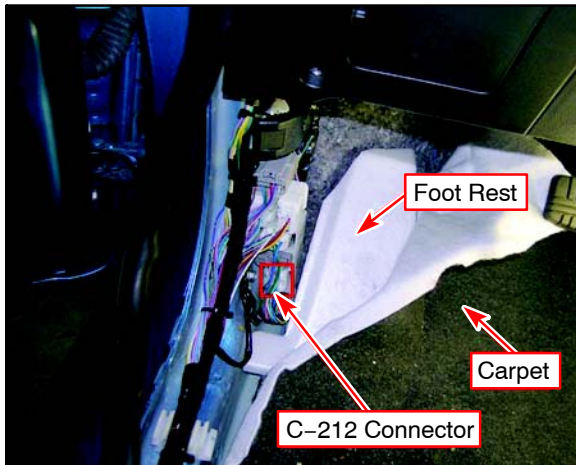
- c. Pull up and fold carpet over in order to access the connector block with C-212 Connector and footrest.
- d. Remove the footrest.
