# Service Bulletin No. 429

| SUBJECT | MERITOR DRIVE AXLE HANGER BRACKET WELD | | | | | |

Ref. MCI NHTSA Recall No.:15V-837

### Bracket Weld Inspection

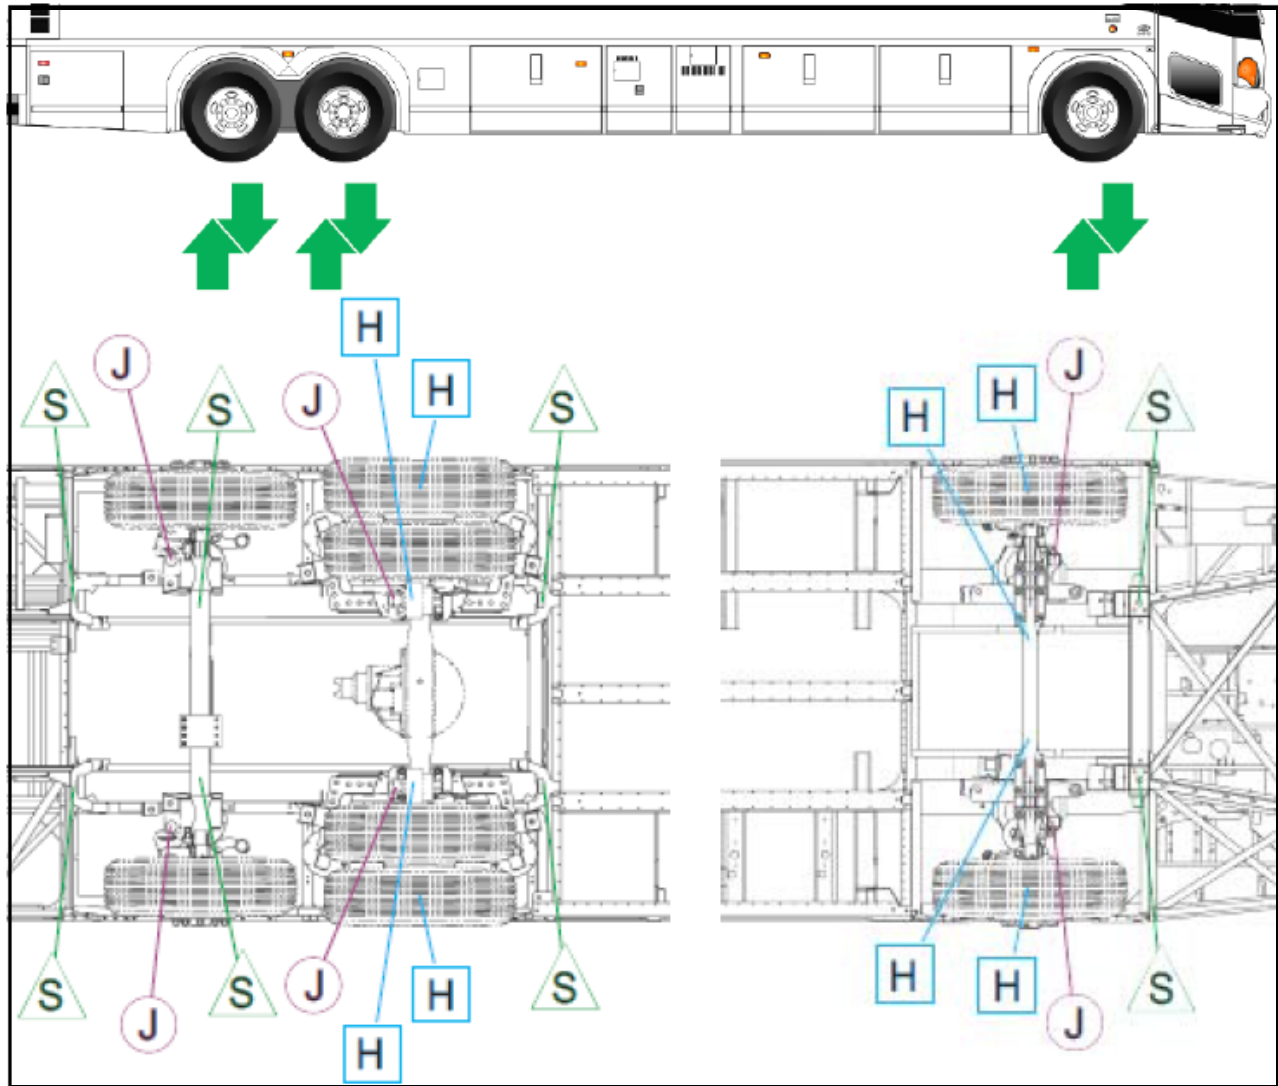
**Figure 1.**

5. Lift the coach to desired work height. Position safety stands underneath the coach in only the specified locations shown in Sections 3F and 3G in the MCI D Series Maintenance Manual ( as shown in Figure 1 ).

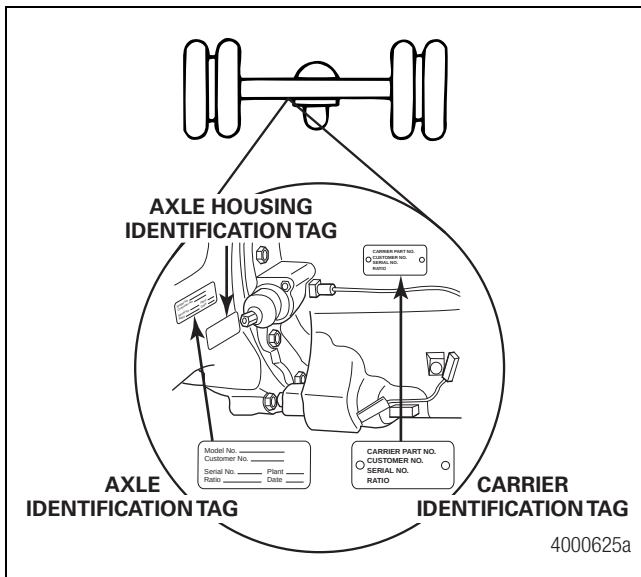
**Figure 1**

- Reference to Meritor's Program number C15AJ
- Complete 17-digit vehicle identification number (VIN)
- Vehicle owner's name, address and telephone number
- Axle model and serial number. Figure 1.
- Vehicle in-service date
- Vehicle mileage
- Repair facility's name, address and telephone number
- Repair facility's hourly rate, if applicable
