Dealer Service Instructions for:

Safety Recall R71 / NHTSA 15V-879

Sun Visor Wiring

2011 – 2012 (WD) Dodge Durango

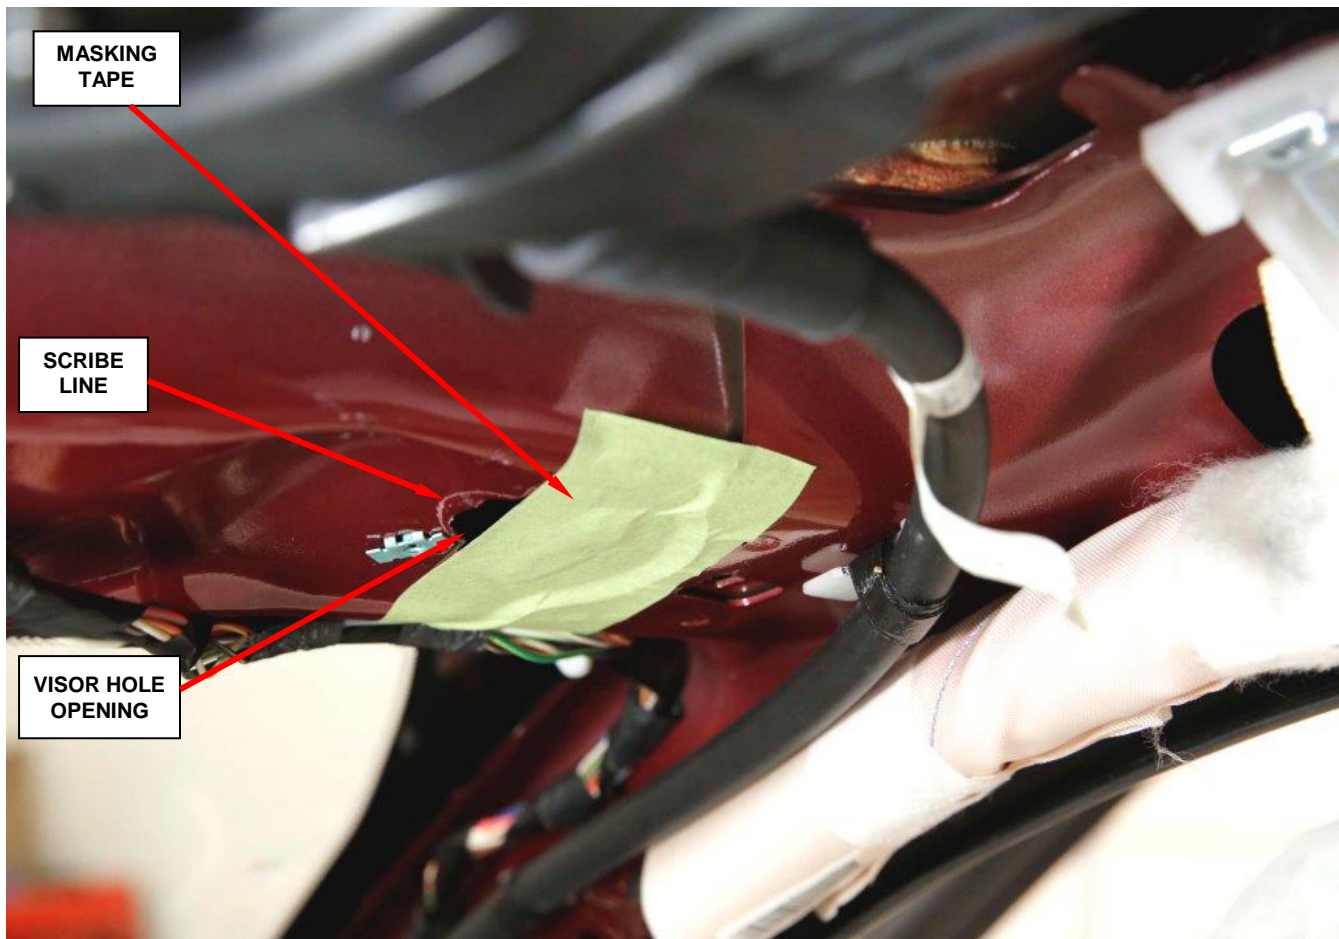
Figure 14 – Apply Masking Tape to Cover Majority of the Visor Hole Opening (right side shown)

NOTE: Covering the visor hole opening with masking tape will greatly decrease the potential for metal shaving being thrown about the interior of the vehicle during the grinding process.

35. Apply masking tape (or equivalent) over the right and left visor hole opening in the sheet metal panel as shown in Figure 14.

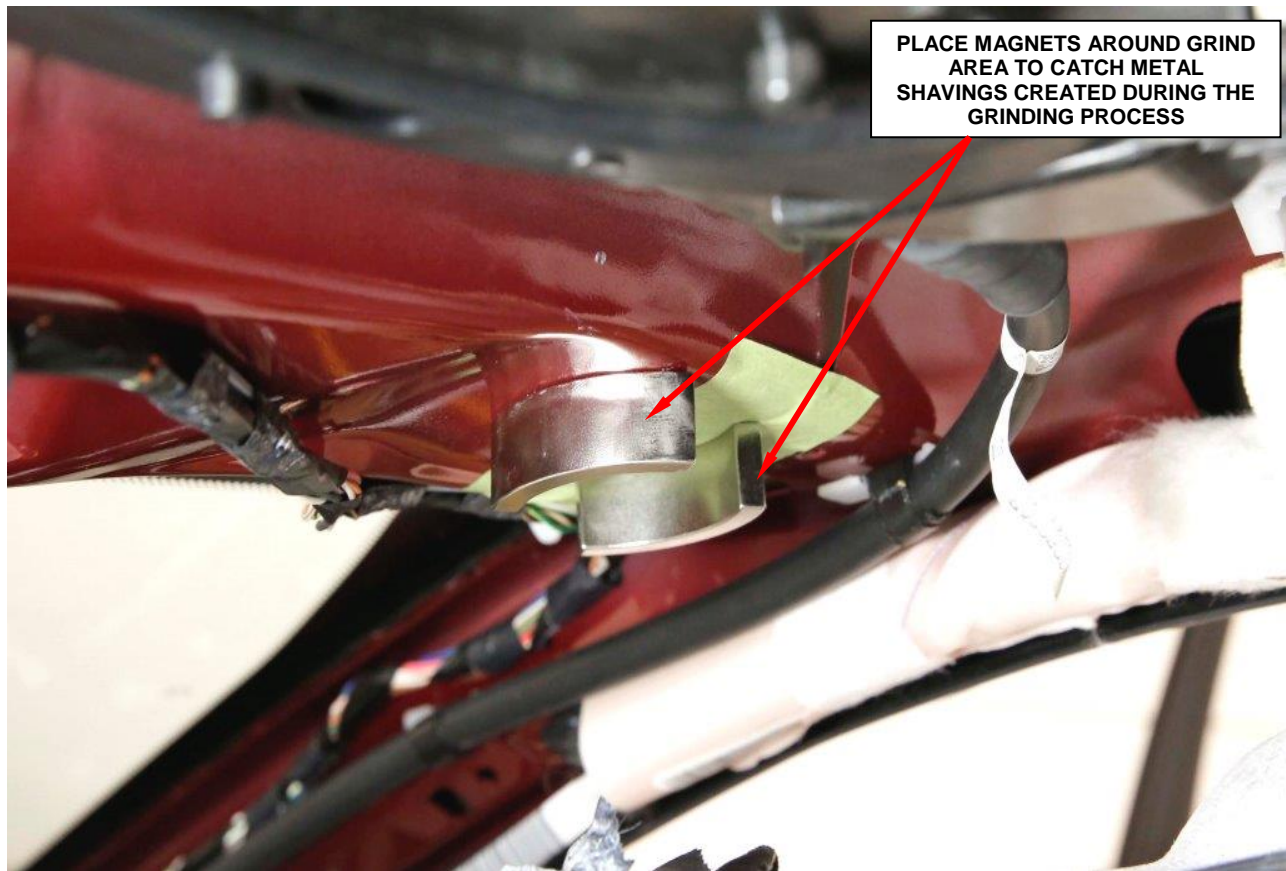
**Figure 15 – Install Magnets to Catch Metal Shavings
(right side shown)**

CAUTION: Failure to use magnets to catch the metal shavings will allow the shavings to fall throughout the interior of the vehicle and on the top of the headliner.

36. Place a fender cover or equivalent over the defroster vents on the instrument panel to prevent any metal shavings from entering the defroster vents.
37. Install the two supplied magnets around the left visor hole to catch any metal shavings created from the grinding process (Figure 15).
