TO: All Mazda Dealership General Managers, Service Managers, and Parts Managers

DATE: July 2016

SUBJECT: Passenger Air Bag Inflator Replacement - Safety Recall 9416E

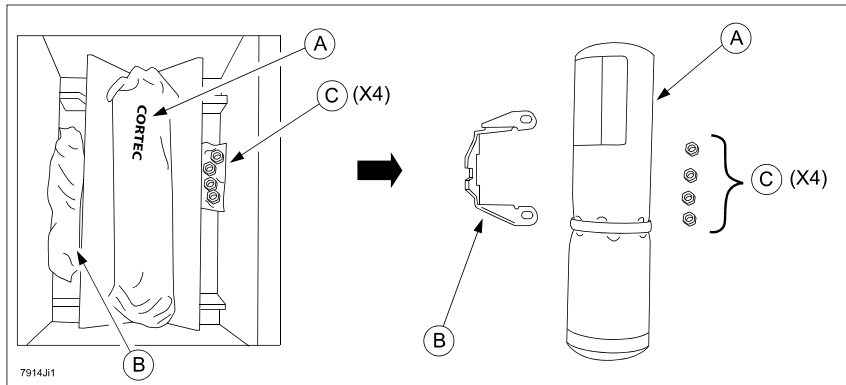
Parts Information: The service parts are available in one box [Inflator (A), Stopper Plate (B), and 4 Nuts (C)].

1. Remove the inflator from the passenger-side air bag module (A), then replace it with a modified one (B) identified with a white stripe (C).

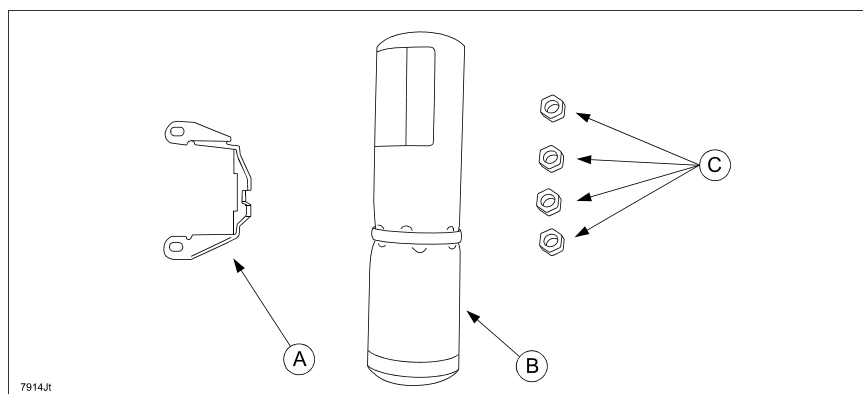
Parts Information: The service parts are available in one box [Stopper plate (A), Inflator (B), and 4 Nuts (C)].

1. Remove the inflator from the passenger-side air bag module (A), then replace it with a modified one (B) identified with a white stripe (C).

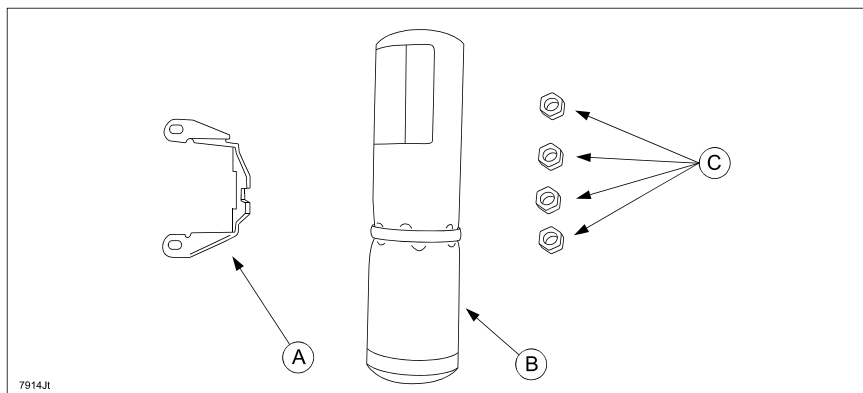
Parts information: The service parts are available in one box [Stopper plate (A), Inflator (B), and 4 Nuts (C)]

1. Remove the inflator from the passenger-side air bag module (A), then replace it with a modified one (B) identified with a white stripe (C).
