## **IMPORTANT SAFETY RECALL**

### **NHTSA Recall Campaign # 16V555**

## Service Bulletin

### 503067 Rev. A

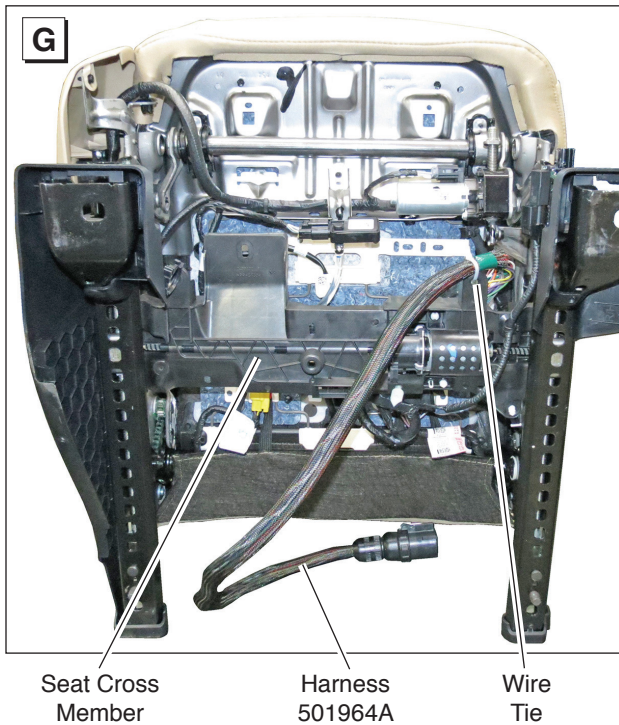
8. At 34 pin connector, inspect harness 501964A for damage. See Photo H.

If any wires are damaged, harness 501964A must be replaced with 16V555KS.

6. Remove wire tie securing harness 501964A to seat cross member. See Photo G.

Note: If damaged, discontinue use of seat until harness is replaced.
