SAFETY RECALL

ABS Actuator

Voluntary Safety Recall Campaign

Reference: PC482

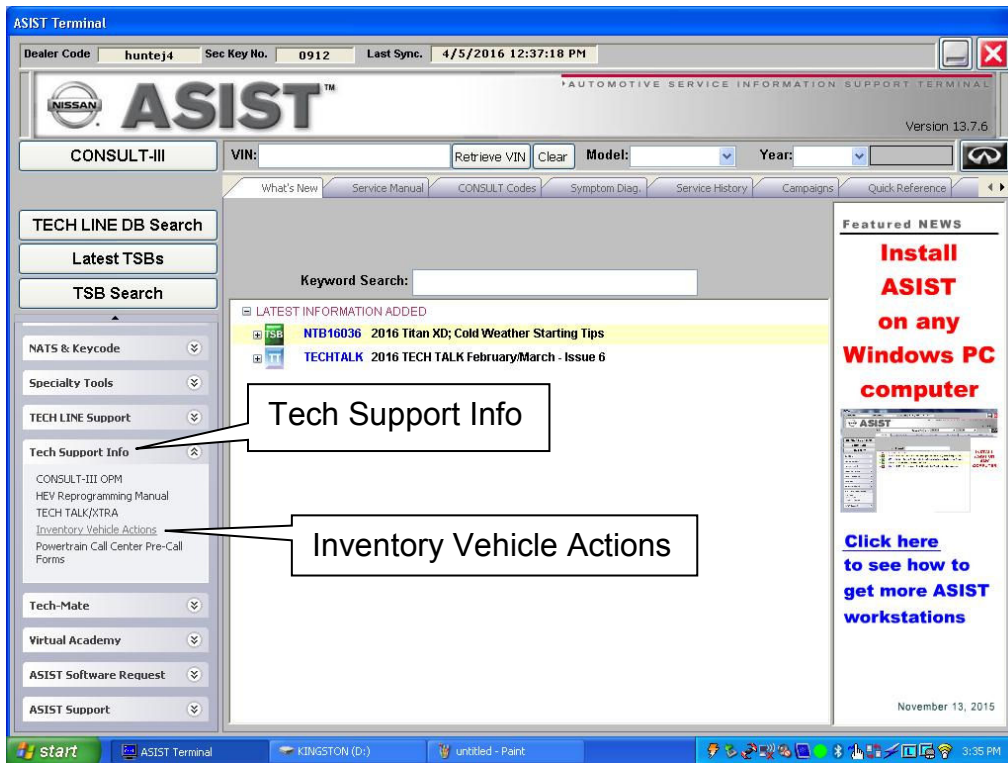
Figure 3

- Take the repair order (with serial number) to an ASIST work station.
- On the left side of the ASIST main menu, select **Tech Support Info**, then **Inventory Vehicle Actions**.

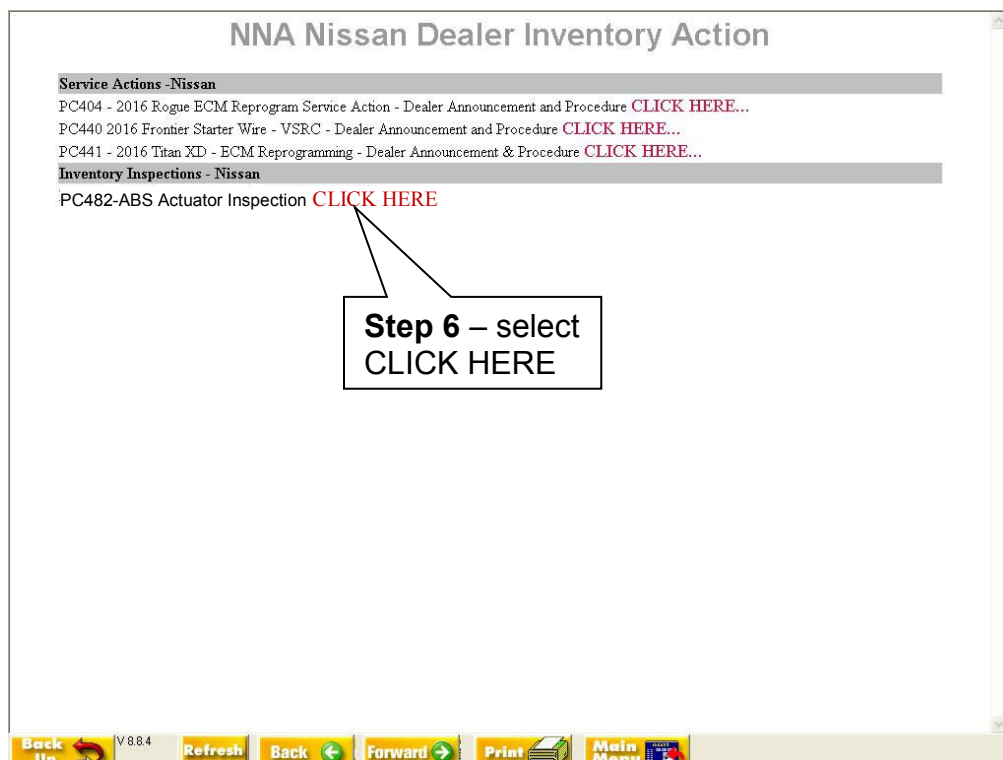
Figure 4

- Select **CLICK HERE** (PC482-ABS Actuator Inspection).
