February 2017
FL721A-E
NHTSA #16V-656
Transport Canada #16-441
REVISED NOTICE

Subject: CNG Fuel Tank and CPDM Mounting Location

Models Affected: Specific Freightliner Cascadia vehicles manufactured September 24, 2012, through May 27, 2015, built with CNG fuel tanks

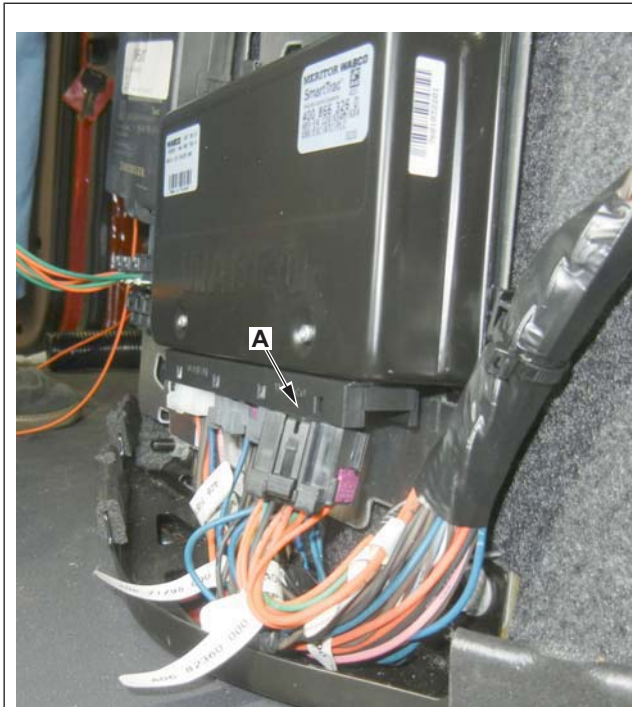
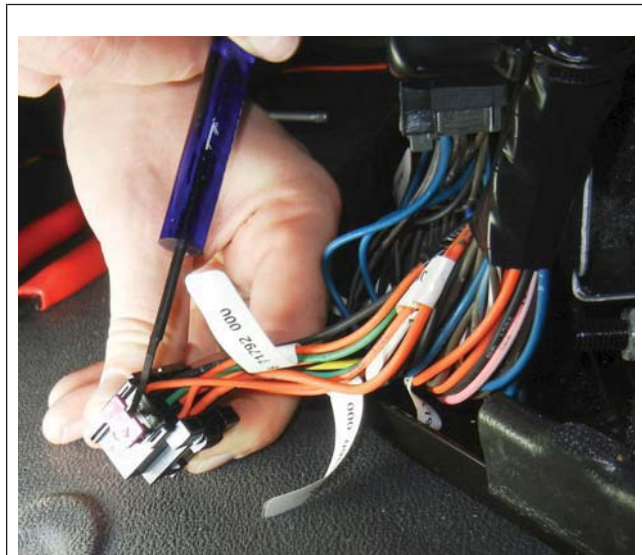
A. Connector A is located on the right-hand side of the ABS module.

27. Disconnect connector X1A from the ABS module and remove the terminal lock. See [Fig. 19](#) and [Fig. 20](#)

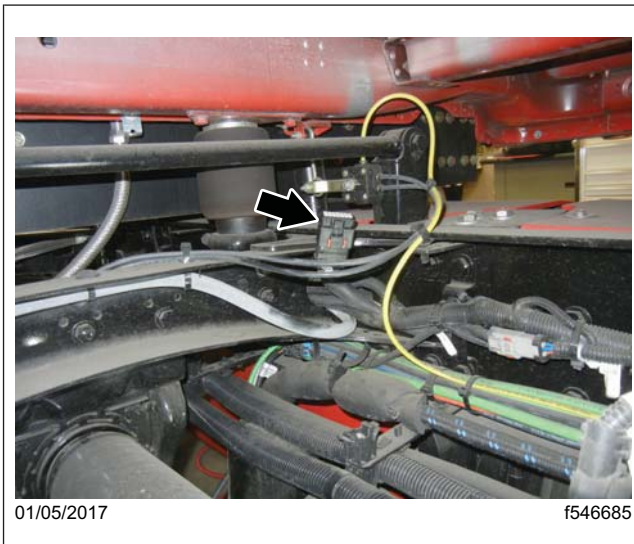
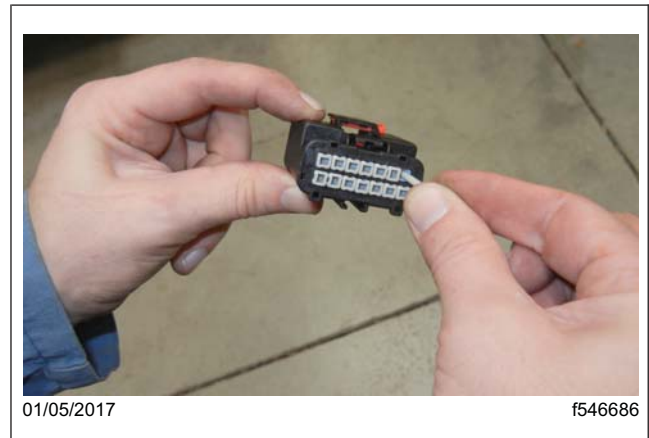
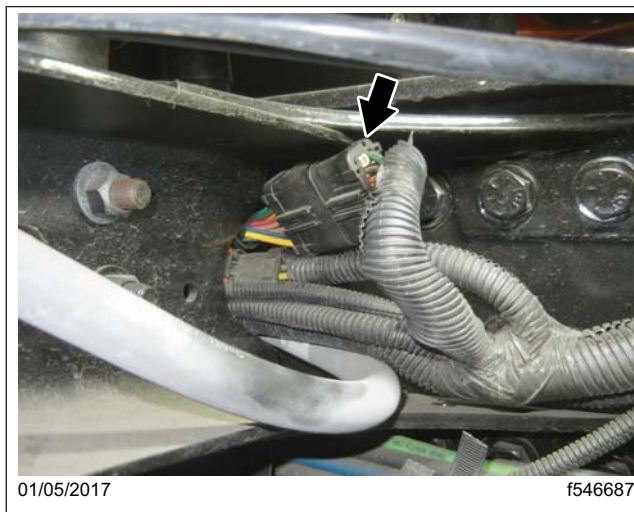
The chassis power distribution module (CPDM) is located at the back of the cab and beneath the compressed natural gas (CNG) fuel tank. Due to the location of the CPDM, it may be subject to higher than expected levels of water spray and contamination from the road, which may lead to localized melting or burning of the CPDM in close proximity to the CNG fuel tanks. This may increase the risk of a vehicle fire.

34. Outside the cab, disconnect the CPDM harness and cap it with part number 23-13153-011. Plug each cavity with a cavity plug (23 13218 300). See **Fig. 25**, **Fig. 26**, and **Fig. 27**.
