Technical Service Bulletin

Ref: TSB 01-009-15 Date 9/2/15 Page 1 of 7

Subject: Potential improper securement of central steering ball joints.

Applies To: Commander Chassis with Reyco Granning IFS.

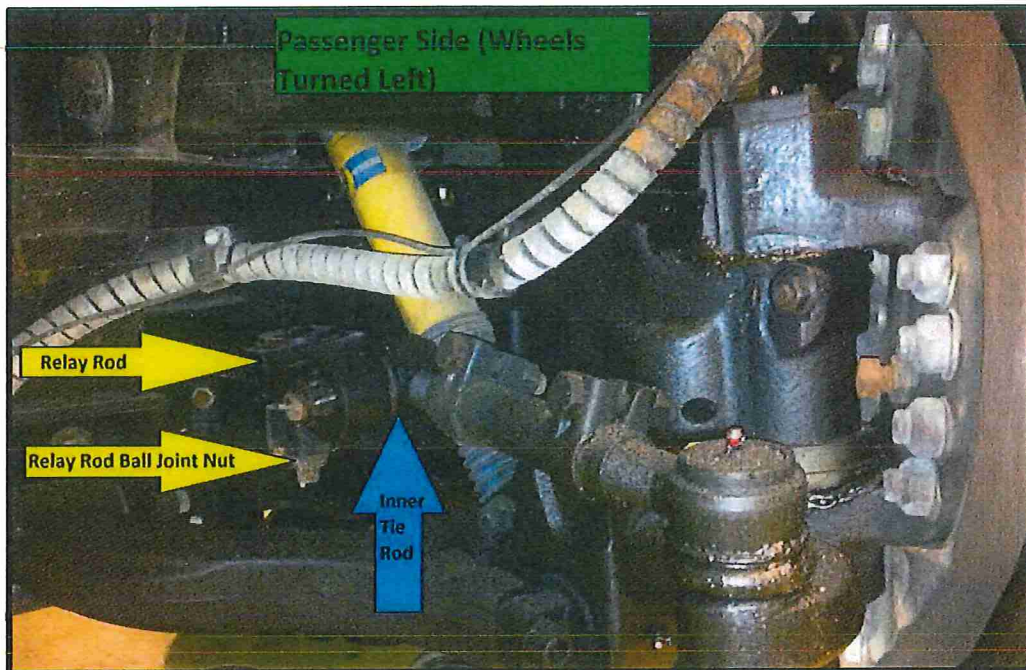
FIG. 4-1

1. If a ball joint is found loose contact Mark Bachman at 765-838-0361 ext. 6 to acquire loaner tools 708116-03, 708116-06. Credit card information will be required for security on tools.
2. Using industry standards means lift the front of the truck high enough to remove the front tires. Secure the truck and remove the front tires.
3. Turn the steering to full left lock to gain access to the relay rod from the passenger side. Starting on the passenger side remove the following from the relay rod. Refer to FIG. 4-1:
 - Inner tie rod joint
 - Relay rod ball joint from the pitman arm.
 - Pitman arm from steering gear (only needed on the passenger side).
