REPAIR DOCUMENT

Ag Hopper Trailer – Hopper Side Slope Panel to Lower Rail Connection – Recall Remedy

Repair Document #: **RD-00056**

US NHTSA Recall No. 16V050

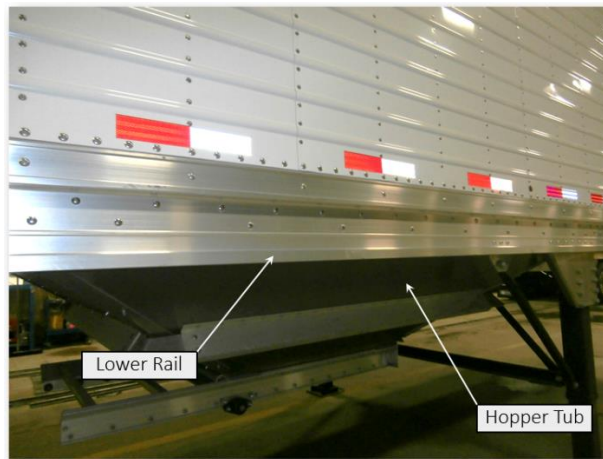
Inspection Procedure

- The inspection will consist of placing a template on the bottom of the lower rail of the trailer and against the side of the hopper tub.
- This inspection should be done on the roadside and curbside of both the front and rear hopper tubs. The inspection should cover at least 3 points along the length of each side.
- The template will check the distance the hopper tub is installed from the bottom of the lower rail.
- If the template hits the bottom of the lower rail prior to hitting the hopper tub then the tub is located in the proper position.
- If the template hits the hopper tub prior to hitting the bottom of the lower rail then the tub is not located in the desired position.
