## Recall Campaign 16V-071: Driver's Front Air Bag Module E82 E88 E90 E91 E92 E93

This Service Information bulletin supersedes SI B65 16 16 dated July 2017.

BMW is conducting a Voluntary Safety Recall involving the driver's front air bag module on certain BMW vehicles that are equipped with non-desiccated Takata PSDI-5 inflators. These vehicles, covering model years 2006-2015 **have not been part of earlier Takata air bag recalls.**

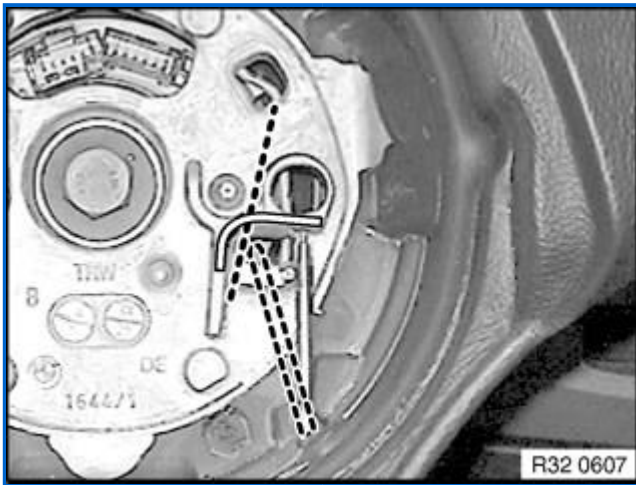
Insert Torx screwdriver (T20) roughly straight from below into opening on reverse side of steering wheel up to stop (approx. 5.5 cm). Swing Torx screwdriver (T20) with handle sideways until airbag unit is unlocked.

Repeat procedure on other side.

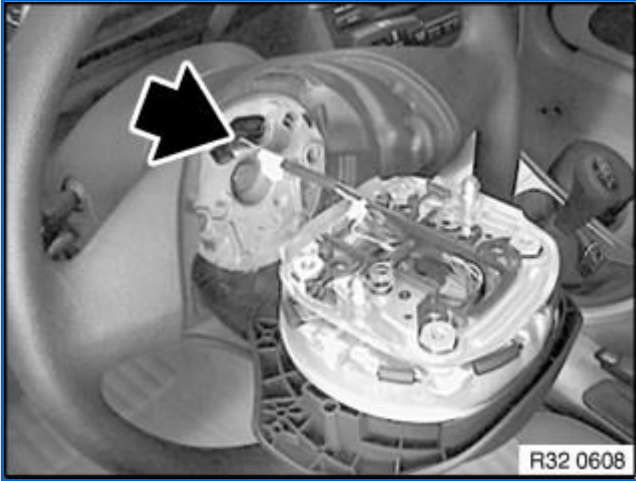
Tilt airbag unit towards rear.

Disconnect plug connection and remove airbag unit.

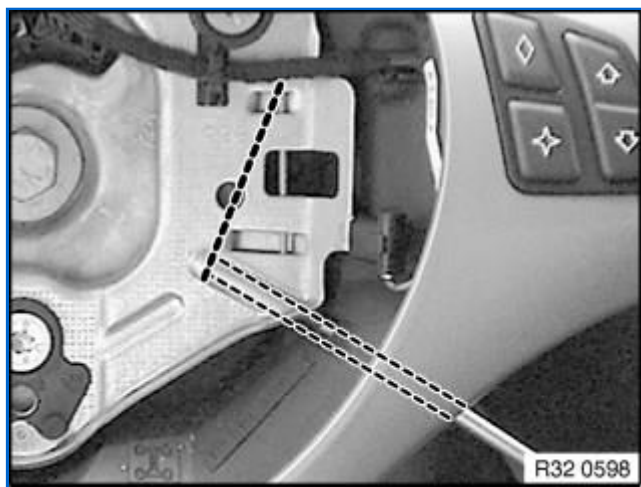
Insert Torx screwdriver (T25) at an angle into concealed opening on reverse side of steering wheel until a spring resistance is felt (approx. 1.5 cm).

Increase pressure on spring leg (concealed) using Torx screwdriver (T25) until airbag unit is unlocked.

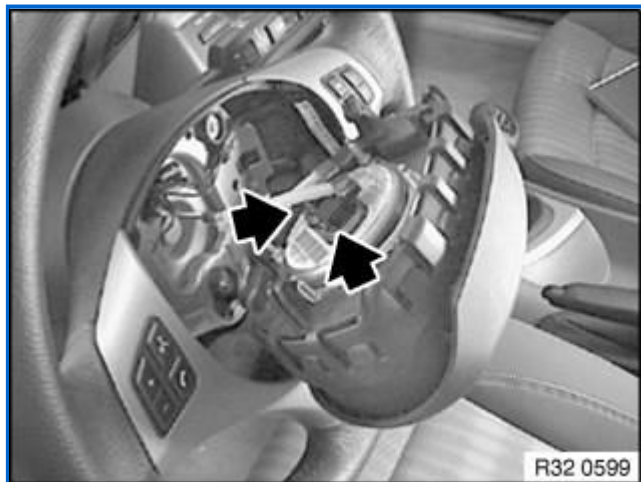
Tilt airbag unit forwards.

Disconnect plug connections and remove  
airbag
