RECALL CAMPAIGN 16V-071: DRIVERS FRONT AIR BAG MODULE E70(X5) E71(X6) E72(X5 HYBRID)

This Service Information bulletin replaces SI B65 14 16 dated **May 2017**

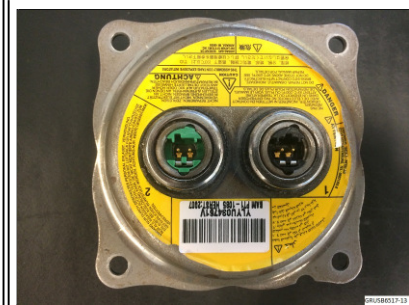
<p>UPDATE ! The Repair Kit gas generator p/n 32 30 6 884 813 is</p>
--	--

installed utilizing the existing wiring harness in the vehicle.

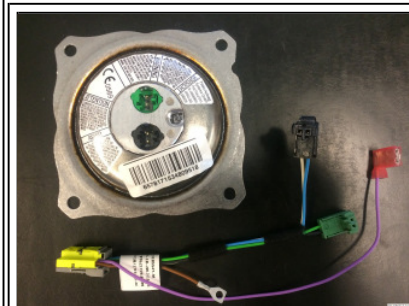
The new Repair Kit gas generator p/n 32 30 6 888 429 is installed utilizing a new jumper wiring harness that is installed between the generator and the steering wheel assembly.
