SIB 65 09 17

## RECALL CAMPAIGN 16V-071: DRIVERS FRONT AIR BAG MODULE E84 (X1)

This Service Information bulletin (Revision 4) replaces SI B65 09 17 **dated October 2017**.

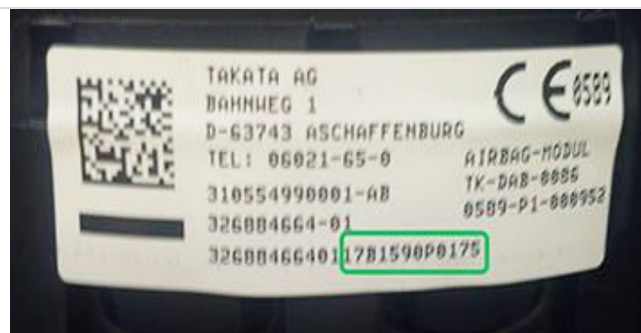
It is necessary to document which air bag goes into which vehicle. Therefore the technician is required to note on the repair order the serial number of the new air bag.

The serial number can be found on the label on the side of the airbag. This is the longest number usually on the bottom of the label.
