RECALL CAMPAIGN 16V-071: DRIVERS FRONT AIR BAG MODULE E70 E71 E72 E84

This Service Information bulletin replaces SI B65 14 16 **dated December 2016**.

BMW AG is conducting a Voluntary Safety Recall involving the driver's front air bag module on certain BMW vehicles that are equipped with non-desiccated Takata PSDI-5 inflators. These vehicles, covering model years 2007-2015 have not been part of earlier Takata-related air bag recalls.

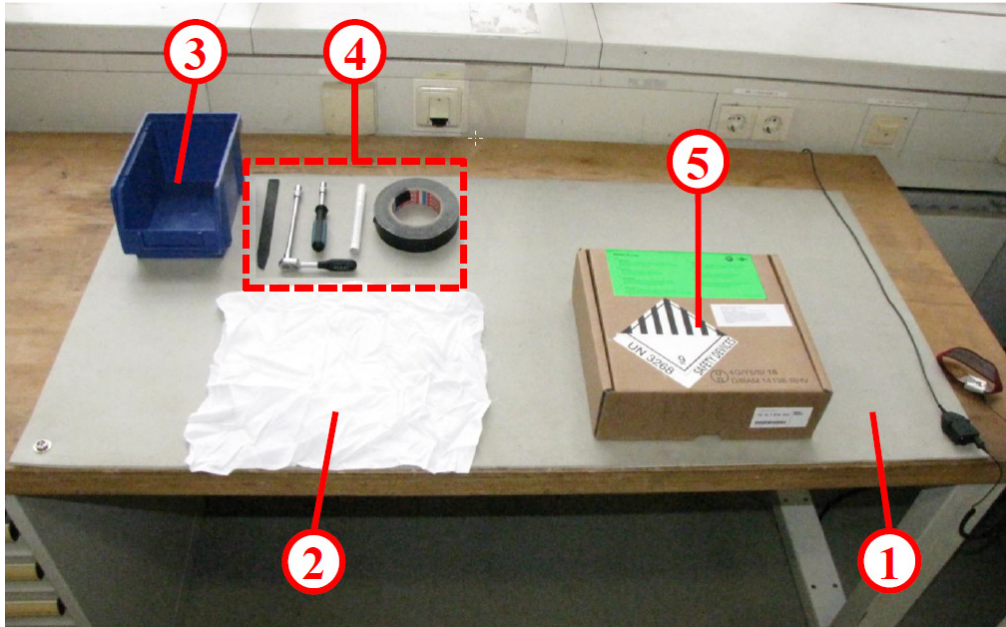
[1] The workbench should be prepared with the following items:

- Anti-Static mat (1) which must be grounded (See SWS 2 06 04 (128))
- A soft blanket or material (2) to prevent damaging the airbag cover
- A container (3) for disposal of the original Generator nuts
- A packaged new part (5)

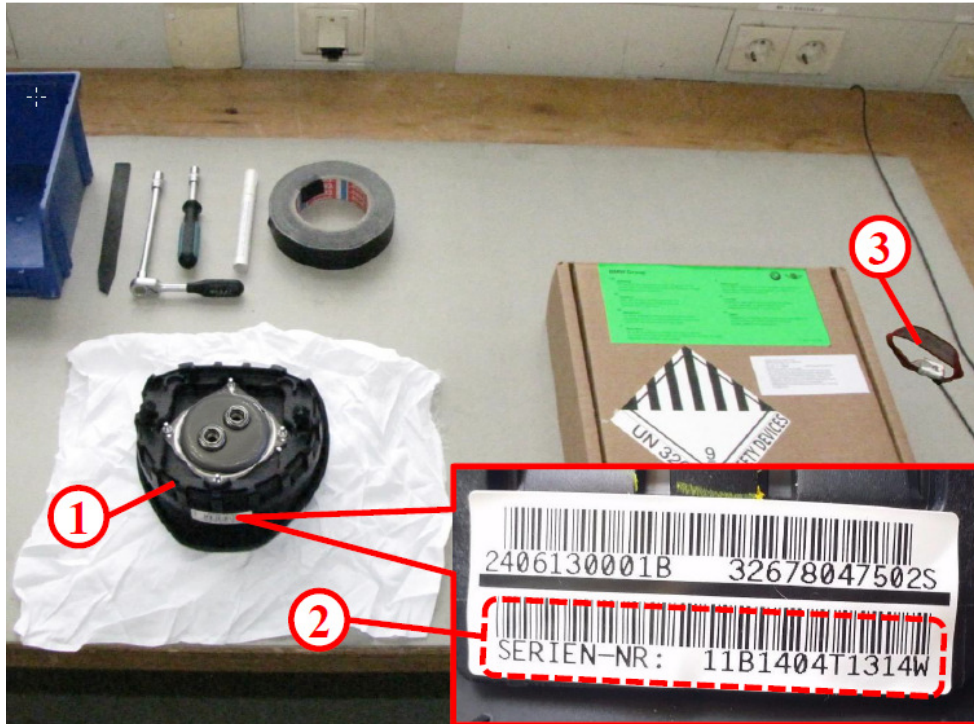
[2] Remove Air Bag from the vehicle

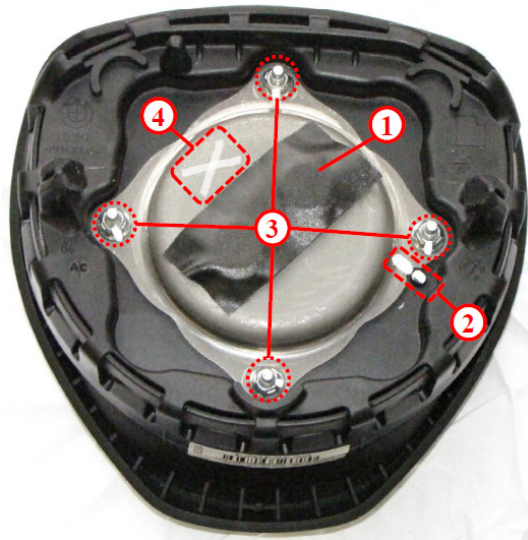
[6] Cover the connections on the old Generator with duct tape (1) so the contacts cannot be touched.

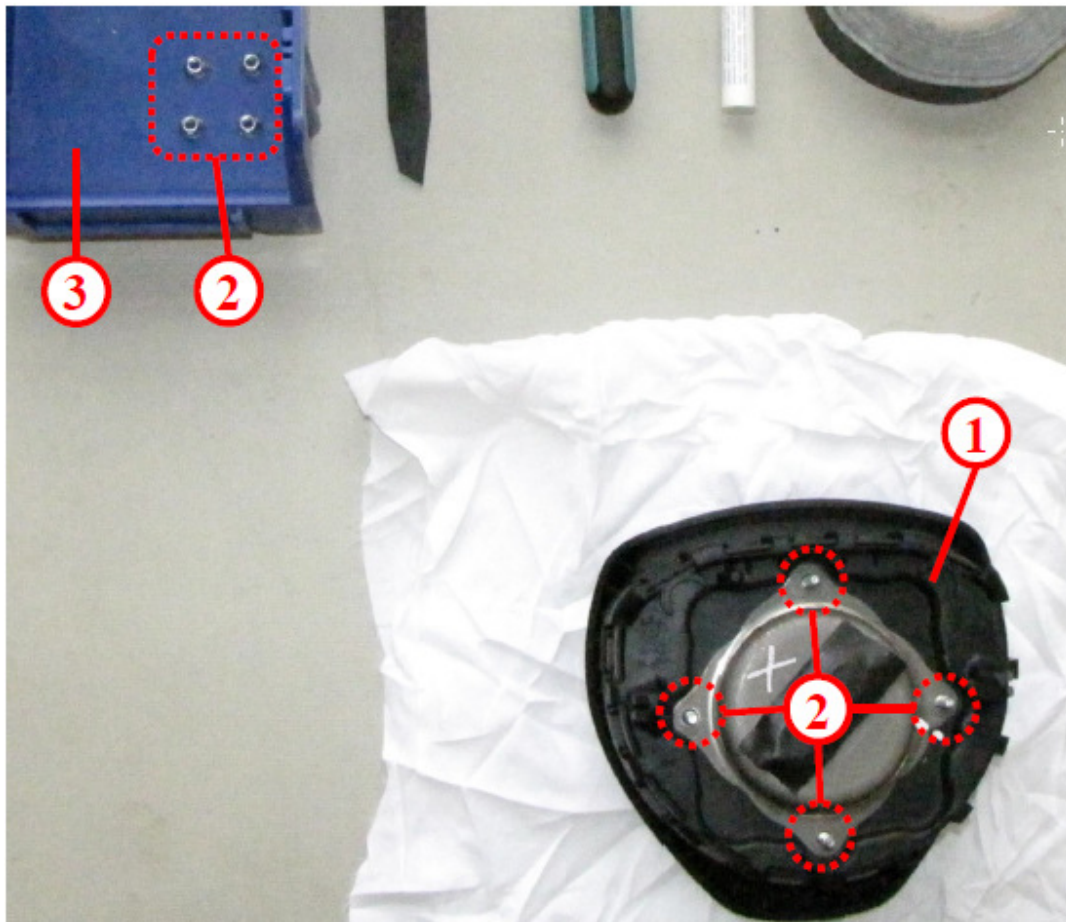
[8] 2nd Technician should hold airbag steady for 1st Technician

1st Technician should remove all four nuts (1) in any order and immediately place the used nuts into the provided container (2) for disposal. This is done to avoid mixing old parts and new parts.

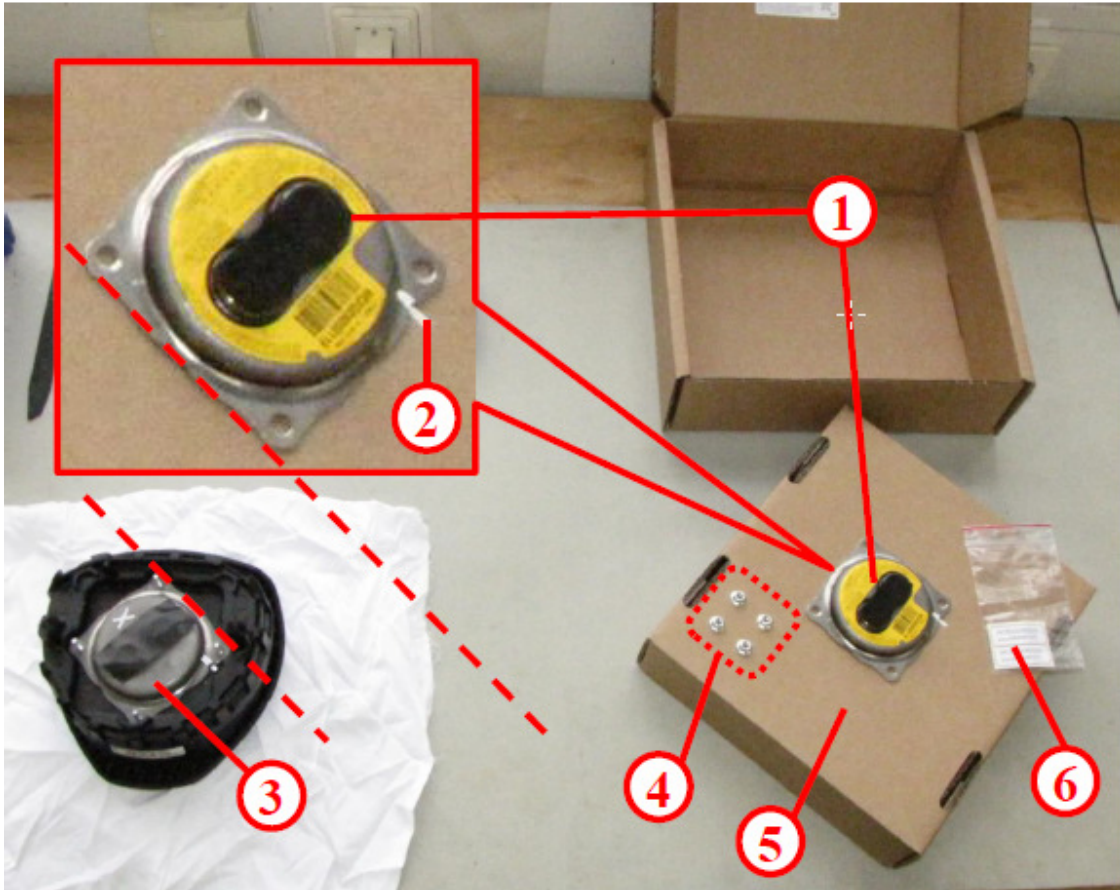
[9] Cover electrical contacts with duct tape. Remove the new Generator (1) from the packaging.

Position the new Generator in the same orientation (2) as the original. Dashed lines show how both are oriented in relation to the air bag assembly.

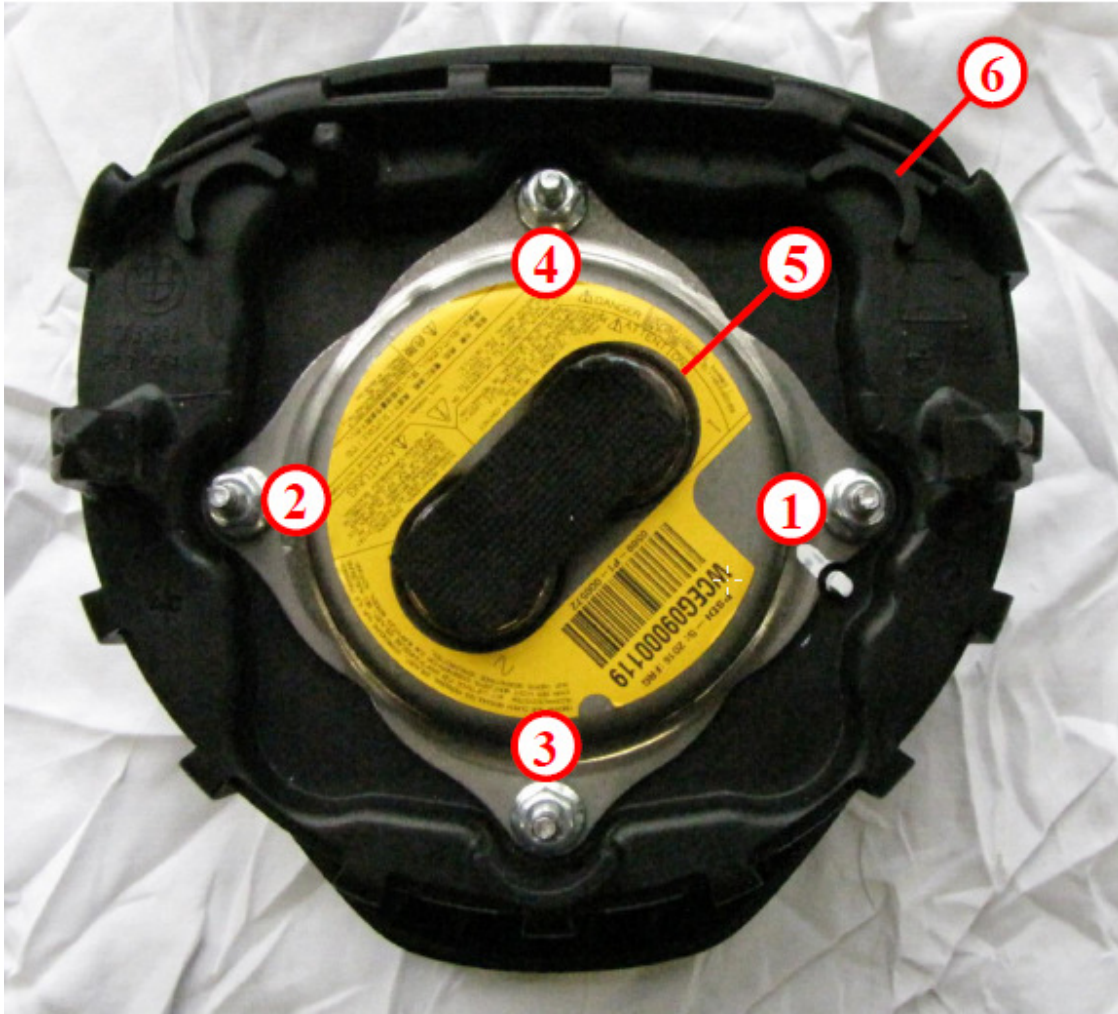
[16] 2nd Technician should hold airbag steady for 1st Technician

Install the four new nuts (1,2,3,4) onto the studs and lightly tighten the nuts in the sequence shown (1,2,3,4).

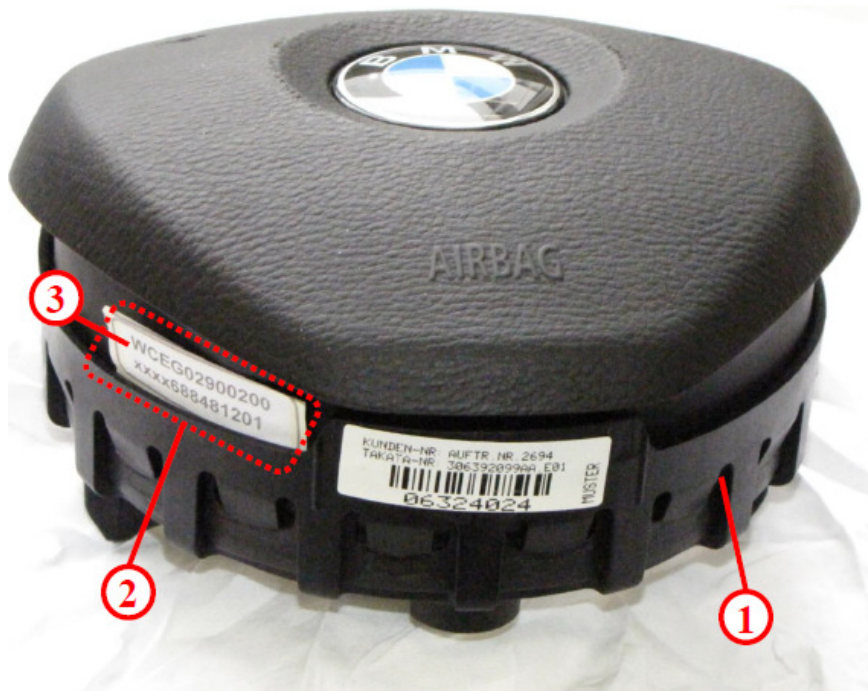
[18] Remove the 2 supplied stickers

Place the 1st airbag sticker onto the Air Bag in location (2) shown.

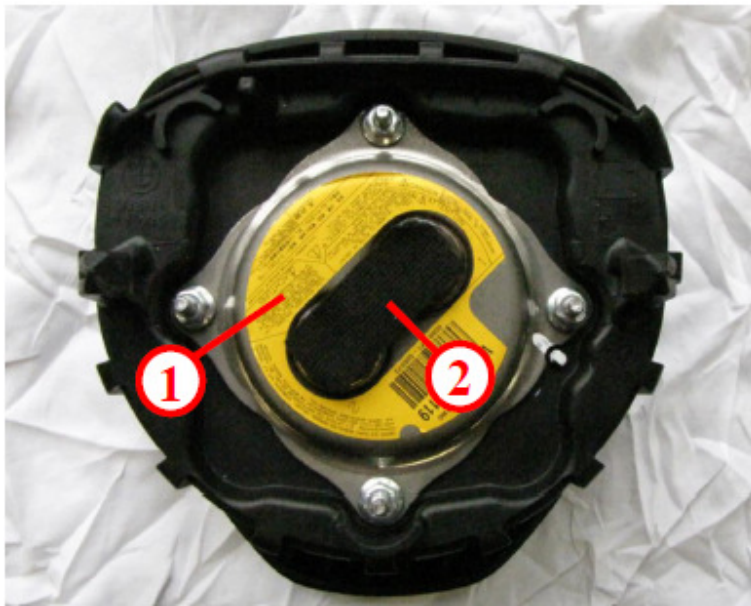
[19] Remove the tape from the new generator
