SI B65 14 16
Audio, Navigation, Monitors, Alarms, SRS

December 2016
Technical Service

RECALL CAMPAIGN 16V-071: DRIVERS FRONT AIR BAG MODULE E70 E71 E72 E84

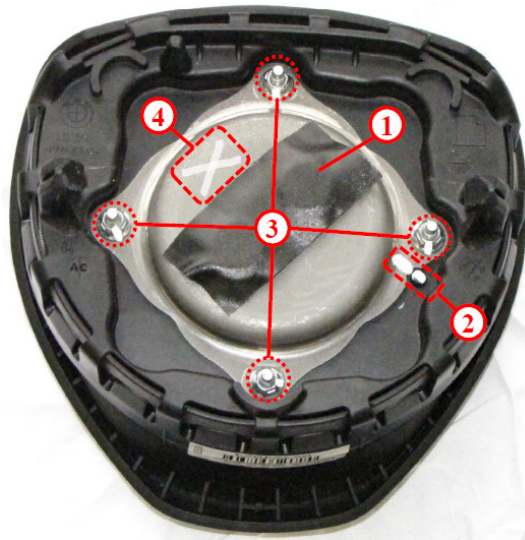
[6] Cover the connections on the old Generator with duct tape (1) so the contacts cannot be touched.

NOTE: – Picture above is an example and may not exactly match your Generator

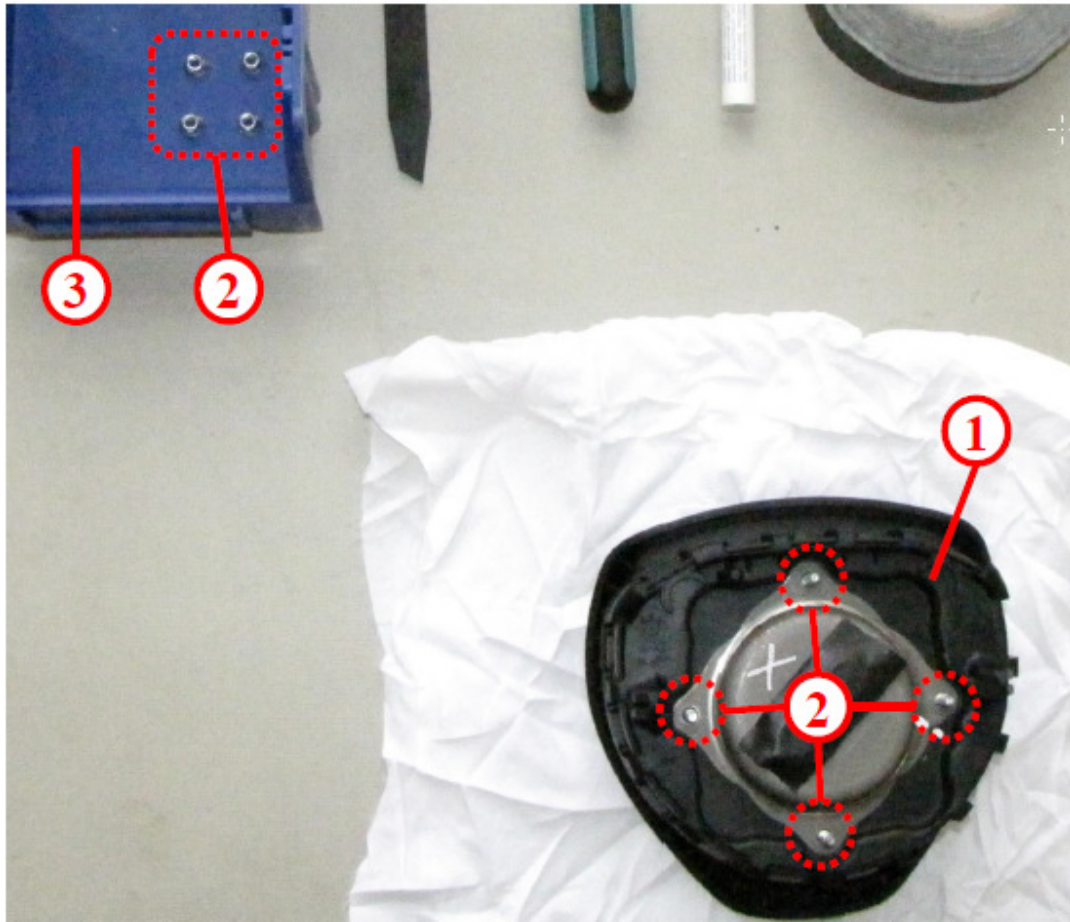
[8] 2nd Technician should hold airbag steady for 1st Technician

1st Technician should remove all four nuts (1) in any order and immediately place the used nuts into the provided container (2) for disposal. This is done to avoid mixing old parts and new parts.

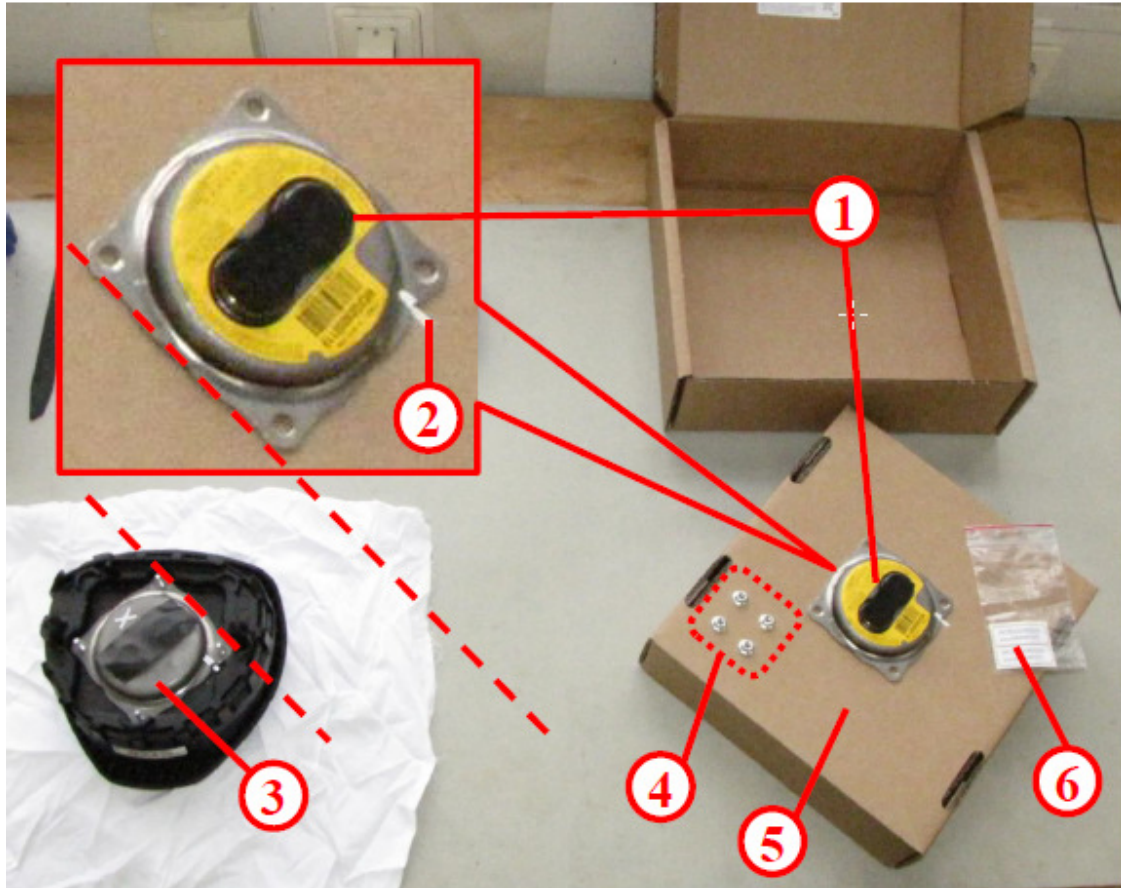
[9] Cover electrical contacts with duct tape. Remove the new Generator (1) from the packaging.

Position the new Generator in the same orientation (2) as the original. Dashed lines show how both are oriented in relation to the air bag assembly.

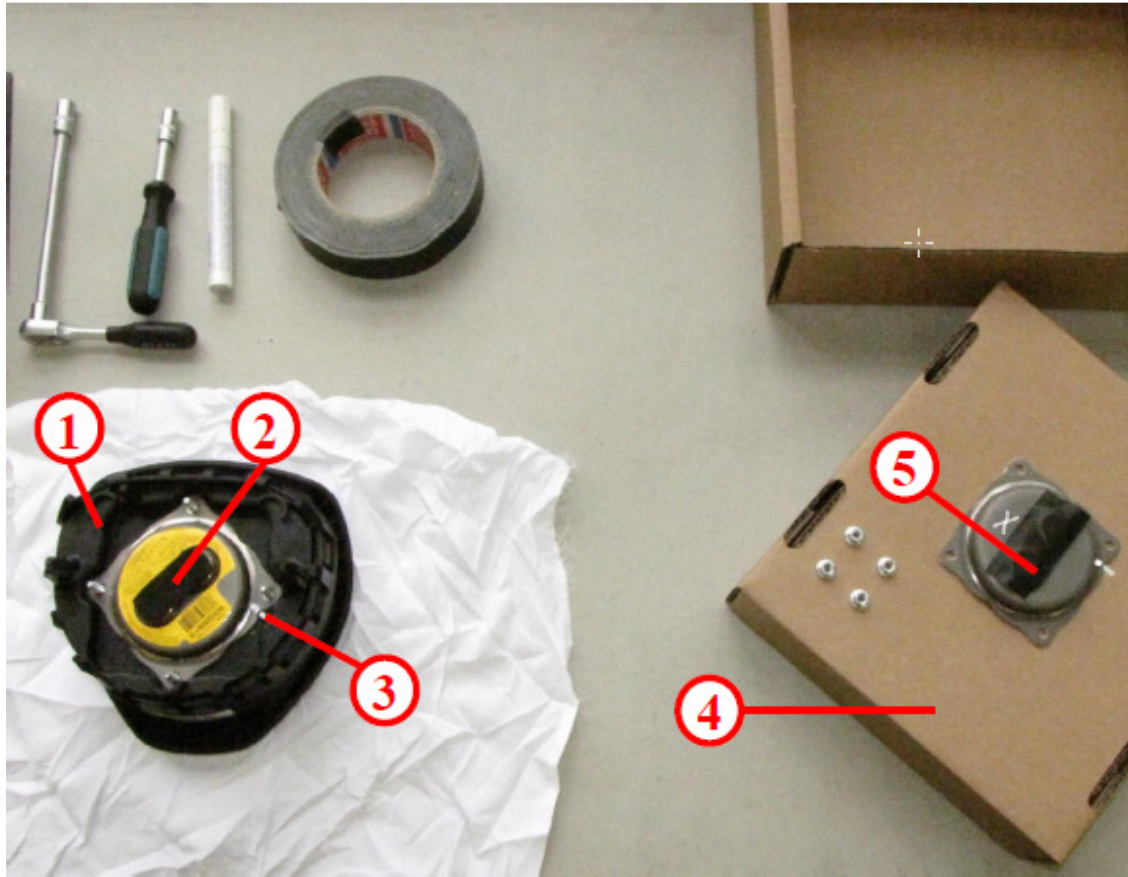
[14] Immediately after the visual inspection of the airbag cavity the new Generator (2) should be installed into the Air Bag (1).

Check the orientation of the new Generator and the Air Bag and make sure the marks line up (3).

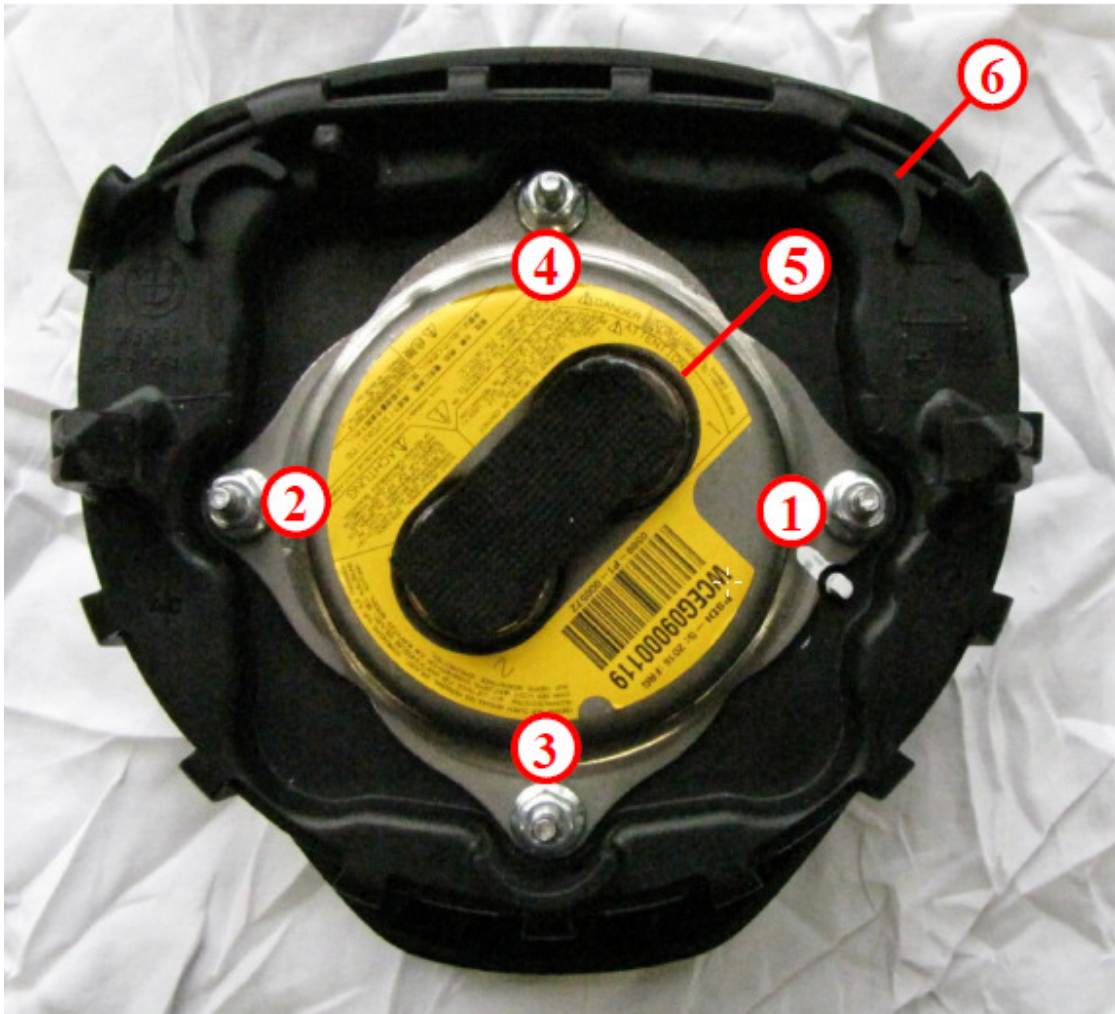
[16] 2nd Technician should hold airbag steady for 1st Technician

Install the four new nuts (1,2,3,4) onto the studs and lightly tighten the nuts in the sequence shown (1,2,3,4).

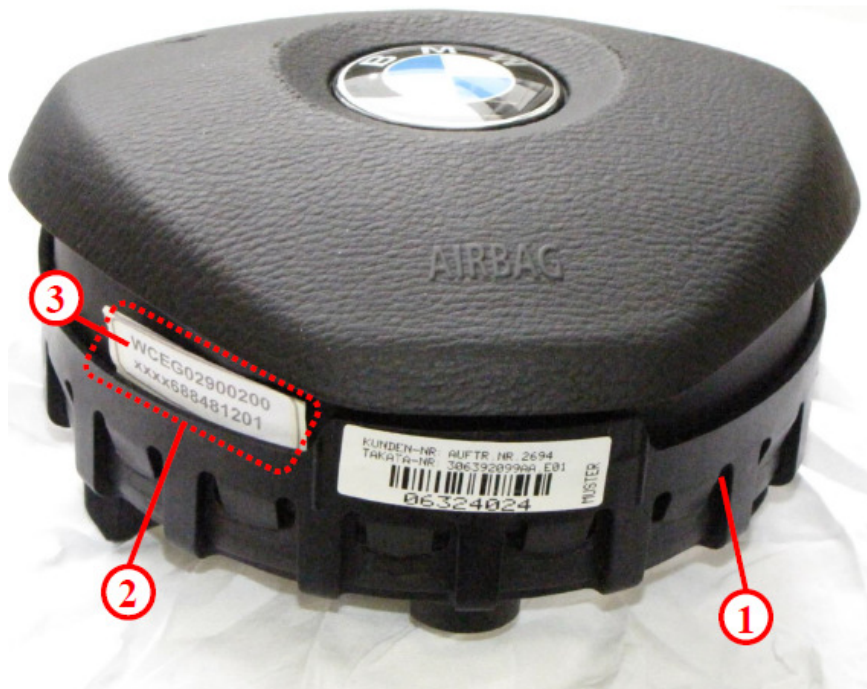
[18] Remove the 2 supplied stickers

Place the 1st airbag sticker onto the Air Bag in location (2) shown.

The 2nd serial number sticker of the new Generator must be placed on the Repair Order.

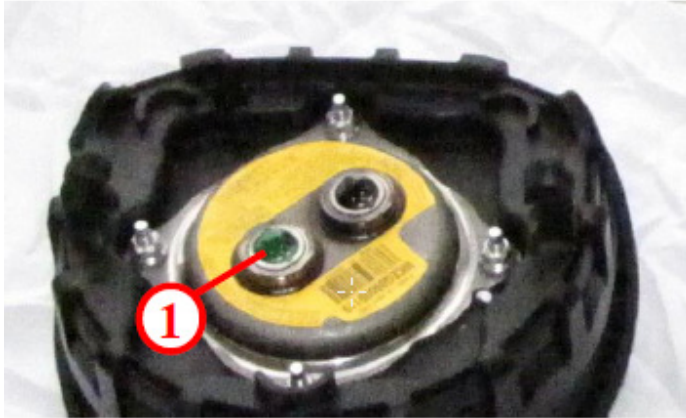
[20] 1st and 2nd Technician must ensure green connector is orientated as shown (1)
