Safety Recall **Code: 69M8**

REVISION	
Subject	TAKATA PSDI-5 Driver Fronta	I Airbag Inflator	
Release Date	April 7, 2017		
Revision Summary	Updated Priority Group 5 repa	ir availability.	
Affected Vehicles		2006-2007 MY Volkswagen Passat Sedan & Passat Wagon s equipped with a Takata PSDI-5 driver frontal airbag	
	Check Campaigns/Actions screen in E action. Elsa is the <u>only</u> valid campaig	Elsa on the day of repair to verify that a VIN qualifies for repair under this n inquiry & verification source.	
	 ✓ Campaign status must show "open." ✓ If Elsa shows other open action(s), inform your customer so that the work can also be completed at 		
		in the workshop for this campaign.	
Takata Recall Priority Groups and Repair Rollout	Third Amendment to the Coordin	ccording to the requirements mandated by the NHTSA in the nated Remedy Order. Transport Canada is following the same by this recall fall into the following priority groups established

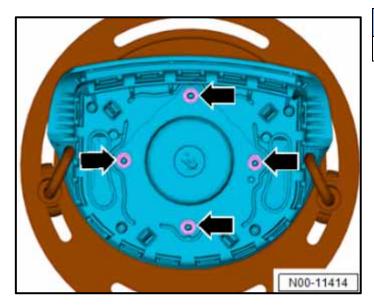
The nuts are self-locking and must be replaced

Install new nuts <arrows> and torque to 5 Nm ± 0.4 Nm.

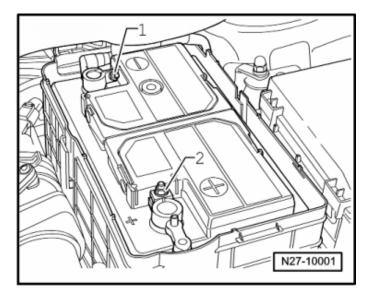
Ignition must be ON when connecting battery. If pyrotechnic components (e.g. airbag, belt tensioner) are not repaired correctly, they may deploy unintentionally after connecting battery. There must not be anyone inside the vehicle when connecting the battery.

- Connect the battery ground cable terminal by hand to the battery negative terminal.
- Torque the nut <1> to 6 Nm.
