APPLICABILITY: 2015-2016 MY Forester 2.0XT
2015-2016 MY WRX

NUMBER: WTA-62
DATE: 03/17/16

SUBJECT: Repair Procedure for Subaru Recall
Campaign Stop-Sale: WTA-62 Turbocharger
Air Intake Duct

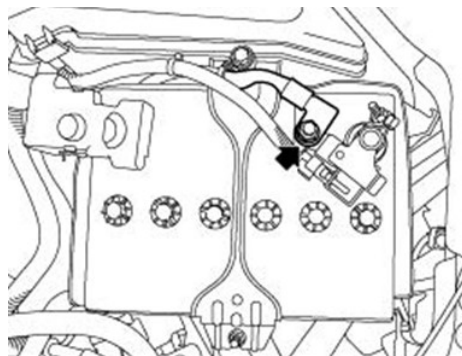
- Turn the ignition off and disconnect the battery from the battery sensor on the ground or **negative (-) terminal first**.

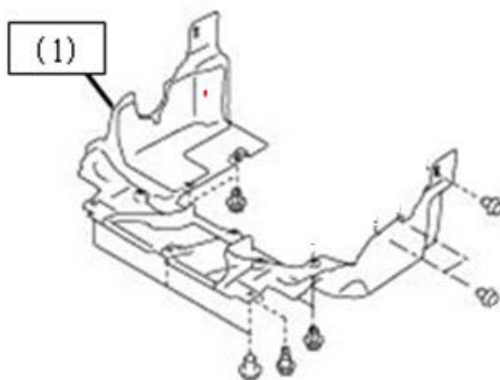
- Raise the vehicle and remove the bolts and clips securing the plastic under cover (1) following the procedure in the applicable Service Manual in order to gain access to the turbocharger air intake duct.

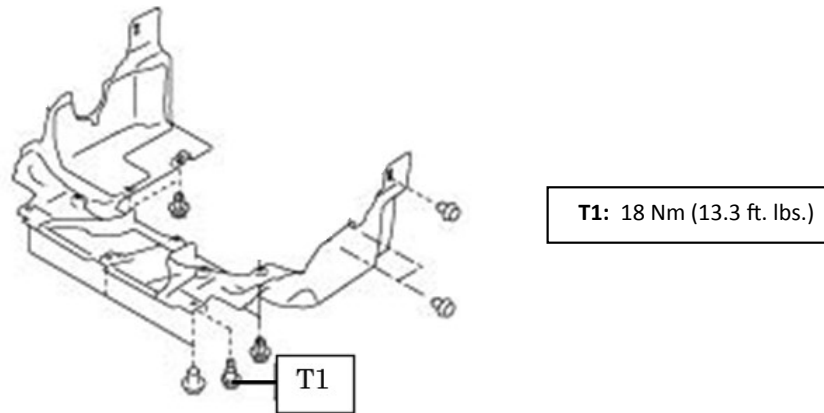
- Reinstall the undercover in reverse order of removal. Torque the bolts per the illustration below.

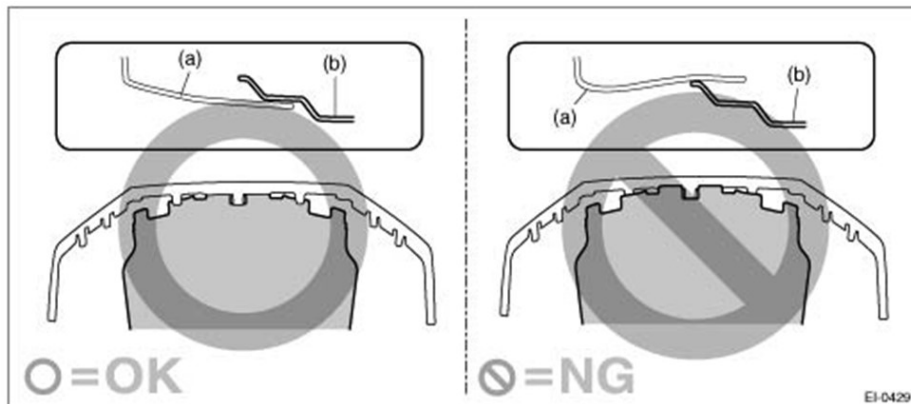
CAUTION: Make sure the front edge of the under cover (b) fits inside the the bumper cover (a) as shown in the illustrations below.

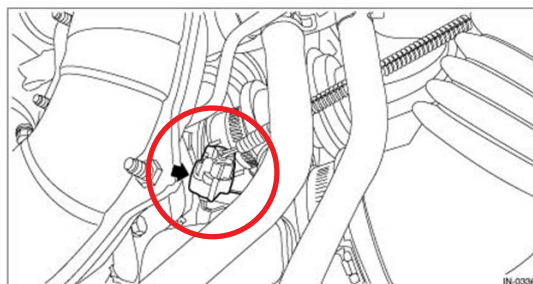
- Disconnect the wiring harness connector from the waste gate control solenoid valve.

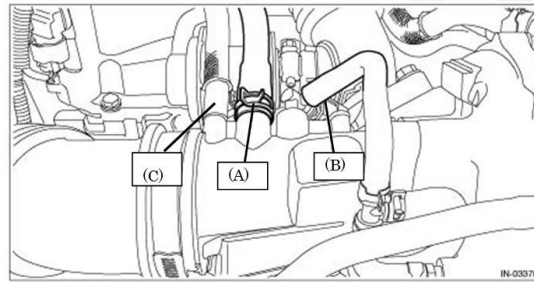
- Disconnect the PCV hose (A) and the vacuum hose (C) from the turbocharger air intake duct and remove the vacuum hose (B) from the waste gate control solenoid valve.

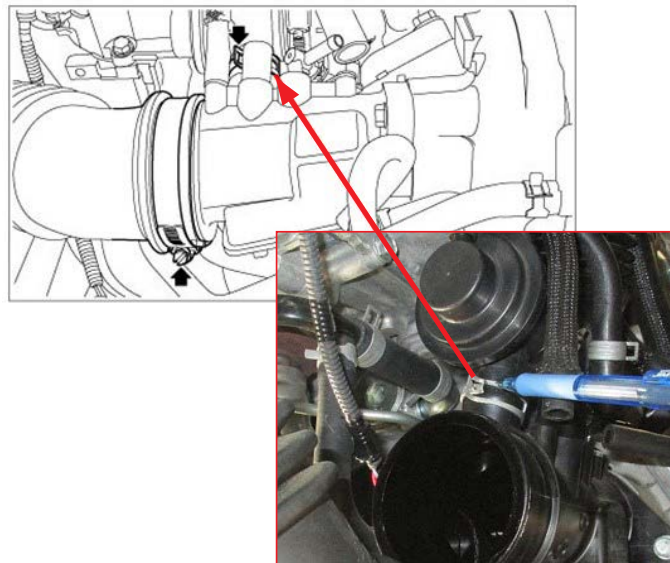
- Remove the hose clamp and the rubber intake boot from the turbocharger air intake duct. Disengage the spring clamp securing the by-pass valve to the turbocharger air intake duct as shown below.

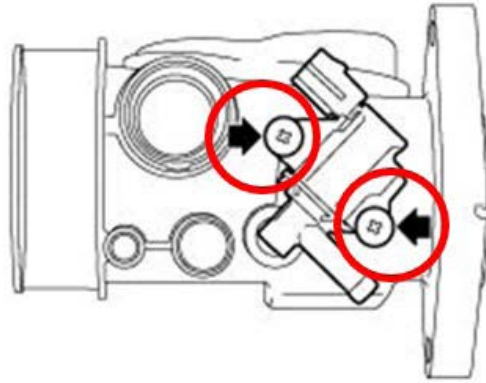
- Transfer the waste gate control solenoid valve over to the new turbocharger air intake duct.
NOTE: Always use a new o-ring. Make sure the waste gate control solenoid valve is fully seated into the new turbocharger air intake duct then torque the 2 retaining screws to 25 inch-pounds.

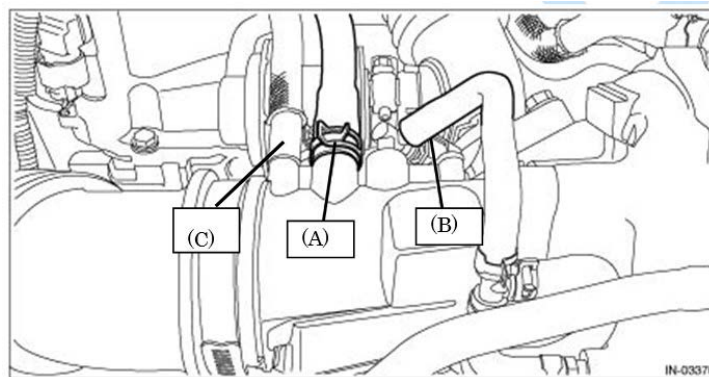
- Reinstall the new turbocharger air intake duct. Tighten the 2 retaining bolts to **4.7 ft. lbs. (57 inch-pounds) for 2015MY vehicles and 5.5 ft. lbs. (66 inch-pounds) for 2016MY vehicles.**
NOTE: Always use a new o-ring and be careful not to pinch it during installation.
- Reinstall the air by-pass valve to the new turbocharger air intake duct making sure it is fully inserted and refit the spring clamp.
- Refit the rubber intake boot to the new turbocharger air intake duct. Confirm the boot is properly seated. Reinstall the hose clamp and torque to 1.8 ft. lbs. (22 inch-pounds).
- Reconnect the PCV hose (A) and the vacuum hose (C) to the turbocharger air intake duct and the vacuum hose (B) to the waste gate control solenoid valve.

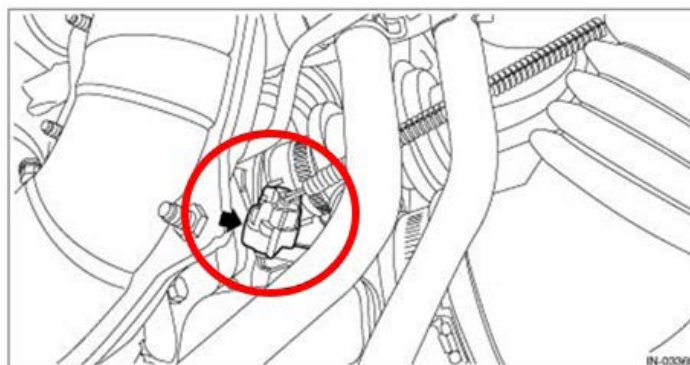
- Reconnect the wiring harness connector to the waste gate control solenoid valve.

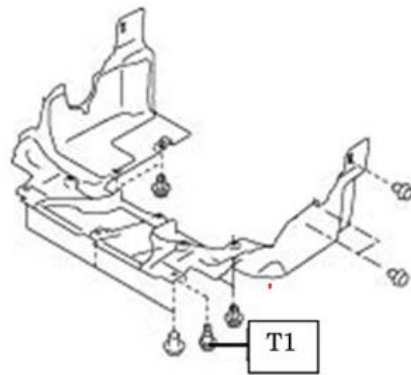
- Reinstall the undercover in reverse order of removal. Torque the bolts per the illustration below.

T1: 18 Nm (13.3 ft. lbs.)

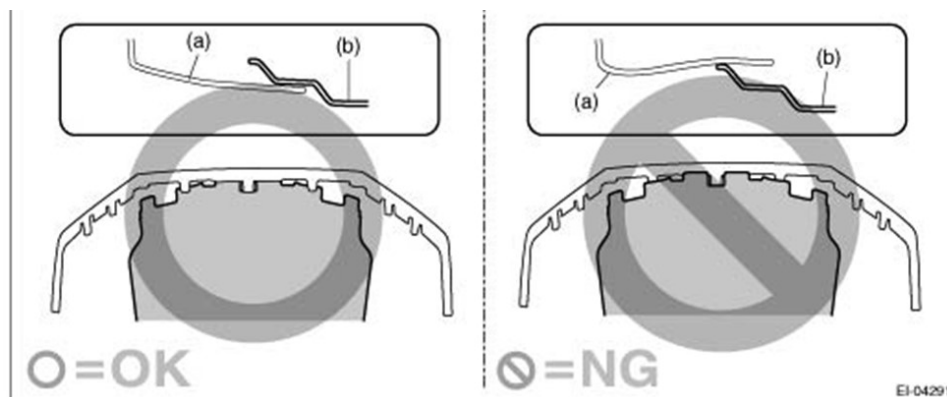
CAUTION: Make sure the front edge of the under cover (b) fits inside the the bumper cover (a) as shown in the illustrations below.
