PRODUCT CAMPAIGN BULLETIN

APPLICABILITY: 2015-2016 MY Forester 2.0XT
 2015-2016 MY WRX 2.0 DIT
SUBJECT: Turbocharger Air Intake Duct

NUMBER: WTA-62R
DATE: April 4, 2016
REVISED: July 11, 2017
NHTSA ID: 16V162

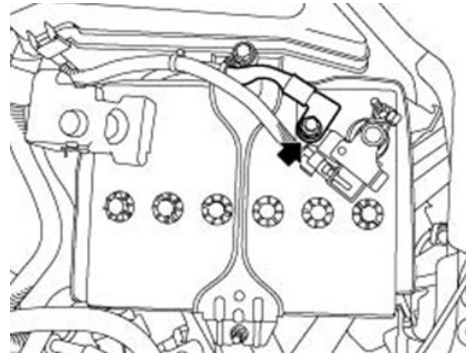
- Turn the ignition off and disconnect the battery from the battery sensor on the ground or **negative (-) terminal first**.

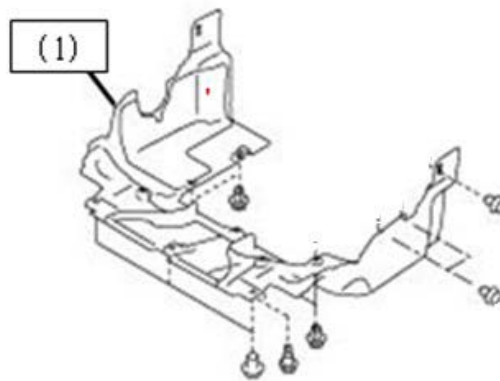
- Raise the vehicle and remove the bolts and clips securing the plastic under cover (1) following the procedure in the applicable Service Manual in order to gain access to the turbocharger air intake duct.

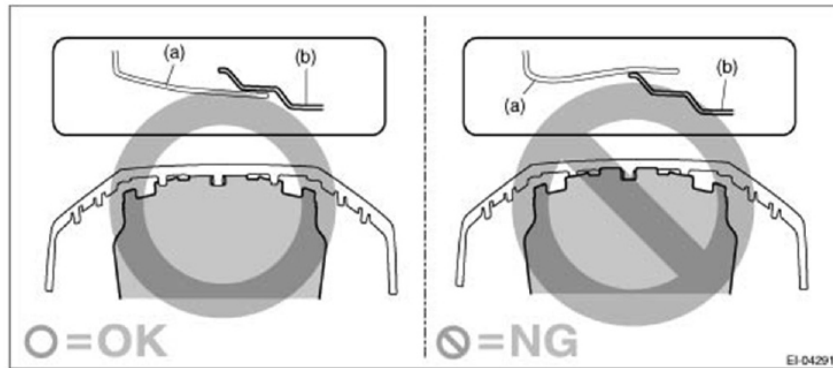
CAUTION: Make sure the front edge of the under cover (b) fits inside the bumper cover (a) as shown in the illustrations below.

- Reinstall the undercover following the procedure in the applicable Service Manual.

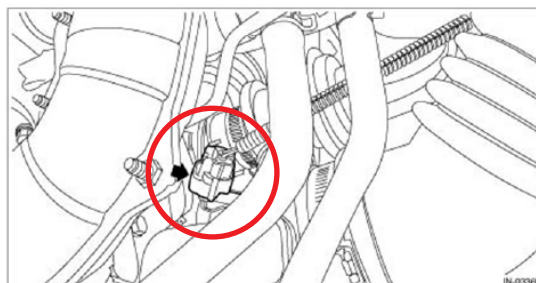
- Disconnect the wiring harness connector from the waste gate control solenoid valve.

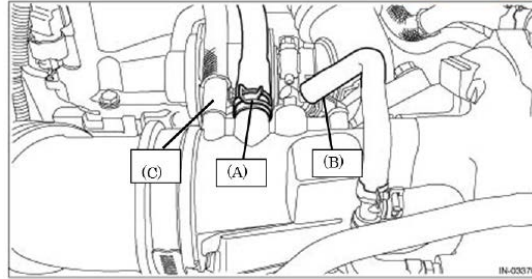
- Disconnect the PCV hose (A) and the vacuum hose (C) from the turbocharger air intake duct and remove the vacuum hose (B) from the waste gate control solenoid valve.

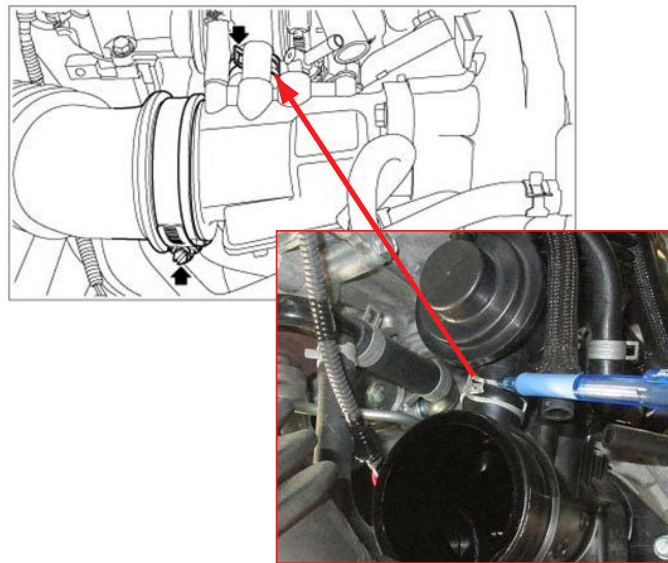
- Remove the hose clamp and the rubber intake boot from the turbocharger air intake duct. Disengage the spring clamp securing the by-pass valve to the turbocharger air intake duct as shown below.

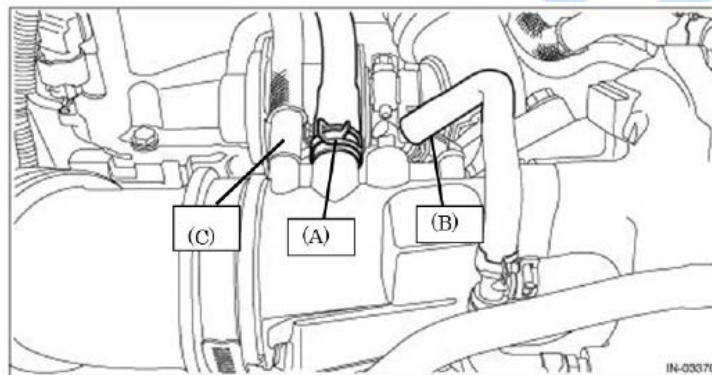
- Reinstall the air by-pass valve to the new turbocharger air intake duct making sure it is fully inserted and refit the spring clamp.
- Refit the rubber intake boot to the new turbocharger air intake duct. Confirm the boot is properly seated. Reinstall the hose clamp and torque to 1.8 ft. lbs. (22 inch-pounds).
- Reconnect the PCV hose (A) and the vacuum hose (C) to the turbocharger air intake duct and the vacuum hose (B) to the waste gate control solenoid valve.

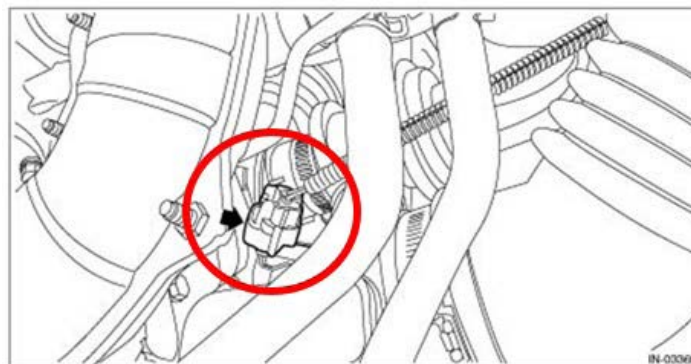
- Reconnect the wiring harness connector to the waste gate control solenoid valve.

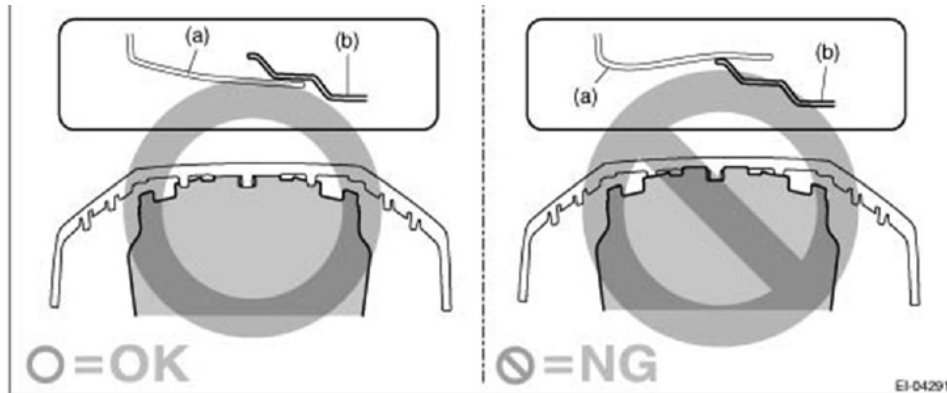
CAUTION: Make sure the front edge of the under cover (b) fits inside the bumper cover (a) as shown in the illustrations below.

- Reinstall the undercover following the procedure in the applicable Service Manual.
