# Safety Recall

## Code: 23T3

| Subject | Connector Seal |
| Affected Vehicles | <b>U.S.A. &amp; CANADA: 2012-2014 MY Volkswagen Passat with TDI (Diesel) Engine</b><br><i>Check Campaigns/Actions screen in Elsa on the day of repair to verify that a VIN qualifies for repair under this action. Elsa is the <u>only</u> valid campaign inquiry &amp; verification source.</i> <ul style="list-style-type: none"><li>✓ Campaign status must show "open."</li><li>✓ If Elsa shows other open action(s), inform your customer so that the work can also be completed at the same time the vehicle is in the workshop for this campaign.</li></ul> |

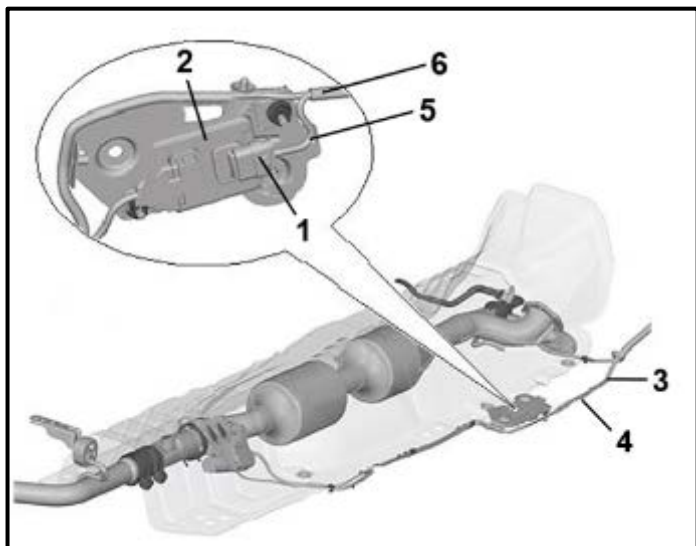
- Disconnect the connector <1> from the J583 control module <2>.
- Carefully remove the J583 control module harness <3> from the harness retainer <4>.

- Carefully begin to unwrap the J583 control module wiring <5> from the body harness <6>.
