HYUNDAI | NEW THINKING.
NEW POSSIBILITIES.

Technical Service Bulletin

GROUP CAMPAIGN	NUMBER 16-01-028-1
DATE JUNE 2016	MODEL(S) 2016 TUCSON (TL)

SUBJECT: HOOD SAFETY HOOK CATCH REPLACEMENT
AND CLUSTER UPDATE (RECALL 145)

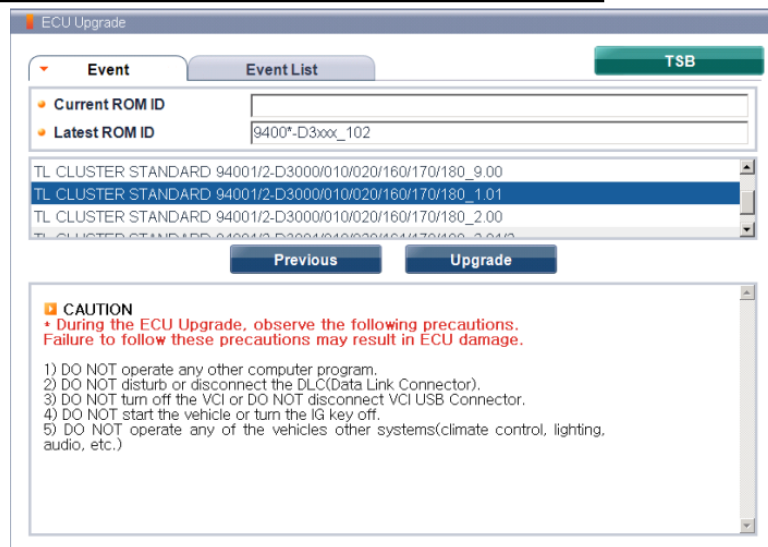
Ensure appropriate ROM ID and Cluster P/N is selected. Failing to do so may result in cluster damage.

5. Select the applicable cluster type (Super Vision or Standard). Confirm ROM ID is correct based on the ROM ID Table on page 2, then click **Upgrade**.
