**PRODUCT CAMPAIGN BULLETIN**

<p><b>APPLICABILITY:</b> 2003-2006 model year Baja          2003-2004 model year Legacy          2003-2004 model year Outback          2009-2011 model year Legacy          2009-2011 model year Outback          2009-2011 model year Forester          2006-2011 model year Tribeca          2006-2011 model year Impreza (including WRX and STI)</p>	<p><b>NUMBERS:</b> TKA-16R          TKB-16R          TKC-16R  <b>DATE:</b> 07/13/16  <b>REVISED:</b> 12/07/17  <b>NHTSA ID:</b> 16V-358          16V-359          16V-361</p>
---	---

**SUBJECT:** Takata Front Passenger Airbag Inflator Replacement

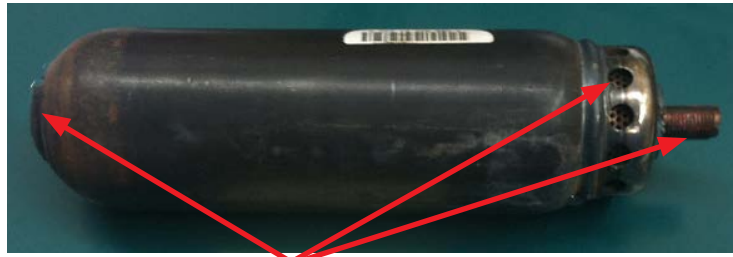
**The shape, holes, and copper-colored stud indicate this not a Genuine Subaru inflator.**

- **Do not proceed with this repair if your inspection reveals a non-Genuine Subaru air bag module has been installed in the vehicle.** Follow the instructions described in the “Counterfeit Air Bag Information” Dealer Advisory Bulletin.

- Document the presence of the aftermarket or counterfeit device on the repair order and with photos. Report this information immediately on a Quality Monitoring Report (QMR). **IMPORTANT:** When entering a related QMR, use failure code ULF and **NOT** the campaign fail code.

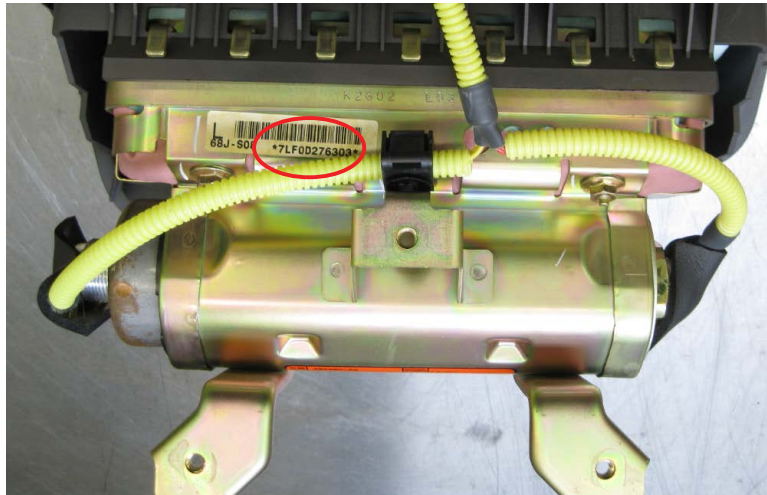
**Inflator WITHOUT Ammonium Nitrate- Serial Number Label Location (2003 Legacy, Outback and Baja models only): Record this **11-digit** number for claims purposes.**

- These early production 2003 MY vehicles (77,000) were equipped with inflators which do not contain ammonium nitrate.
- These inflators which do not contain ammonium nitrate do not require replacement as part of any Subaru airbag recall.

If the serial number label is missing, illegible or if there is any uncertainty if the airbag module is affected by this Recall Campaign, follow the Counterfeit / Non-Genuine airbag inspection process provided above. Always take photos of the module showing the entire inflator along with an additional photo showing the area where the label should be as seen in the photos below. Next, submit a Quality Monitoring Report (QMR) requesting SOA review. A member of the Claims Team will contact the Retailer following review of the QMR submission with information on how to proceed.

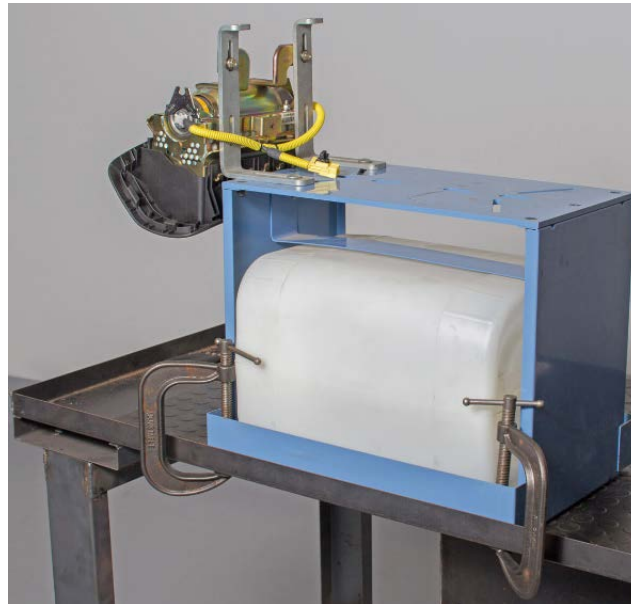
**REMINDER:** It is **STRONGLY RECOMMENDED** the removed airbag module **ALWAYS** be mounted to the Airbag Deployment Fixture (part number J-39401-B and file photo shown below) to better secure it during the inflator replacement procedure. When mounting the module to the fixture, pay close attention to the harness routing. Always perform this work in an area away from others to reduce chances of inadvertent injury should any deployment occur. Take your surroundings into account to avoid possible hazards should an inadvertent deployment occur or sources of static or other electricity that could potentially induce such a deployment.

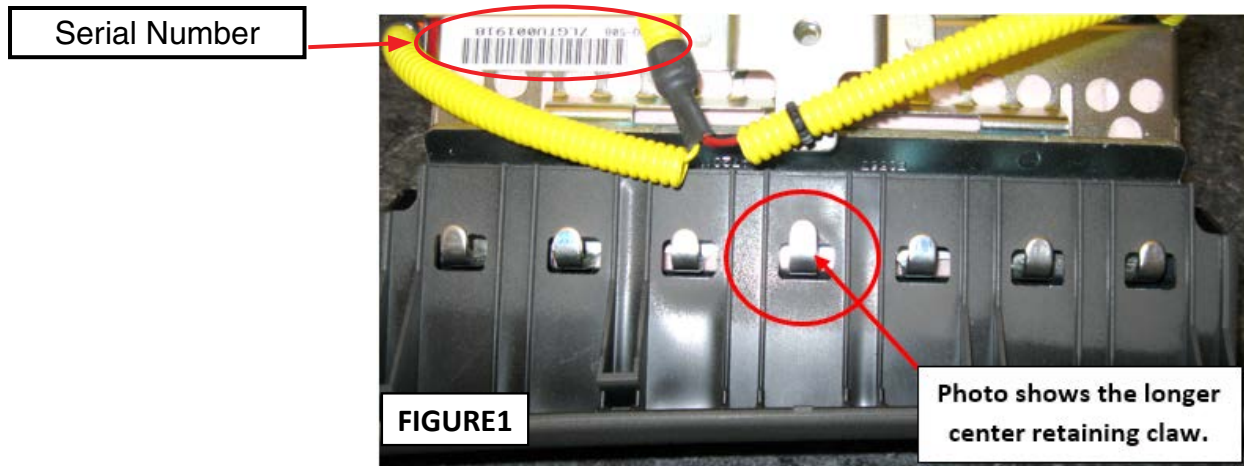
**FIGURE1**

**Photo shows the longer center retaining claw.**

- Using a trim clip removal tool and starting on the harness-side of the module assembly as shown in the sequence below, CAREFULLY insert the tool and twist ONLY AS MUCH AS IS REQUIRED to release the slightly longer center retaining claw from the trim cover. Once released with the tool, the other 6 claws will release easily by hand.
- Rotate the inflator portion of the assembly outward from the cover to release the 7 label-side claws and separate the cover from the module. No tool is required as all the 7 label-side claws are the same size.

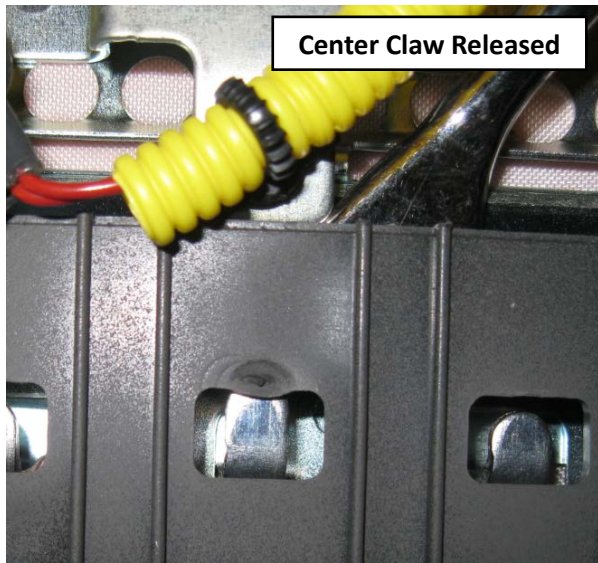
Center Claw Released

All Harness-Side Claws Released

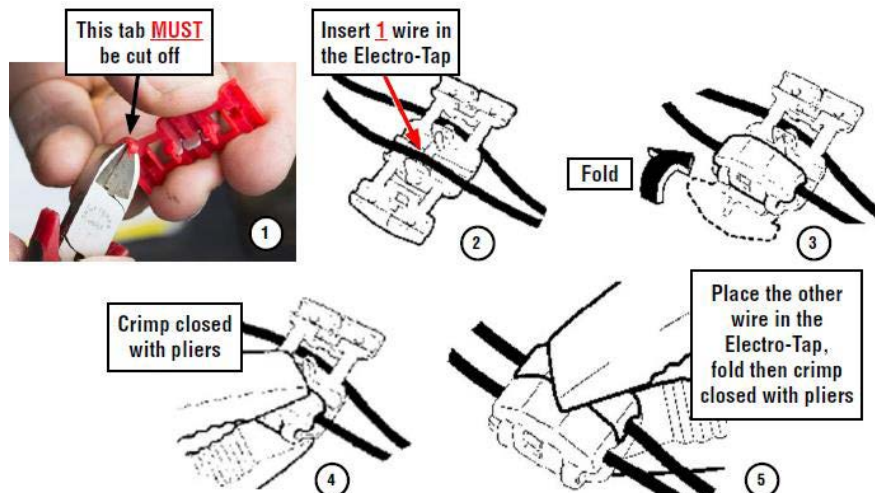
**STEP 5-** Short the yellow and red wires together by installing the Electro-Tap connector. The connector creates a short circuit which acts as a safeguard to prevent against static discharge that may deploy the removed inflator. The tab portion of the Electro-Tap connector **MUST** be cut off prior to use to insure a good short-circuit is made as shown in the illustration below. **Follow the sequence below** for installing the Electro-Tap connector. Use pliers to squeeze closed the two sections of the connector together, **one section at a time**.

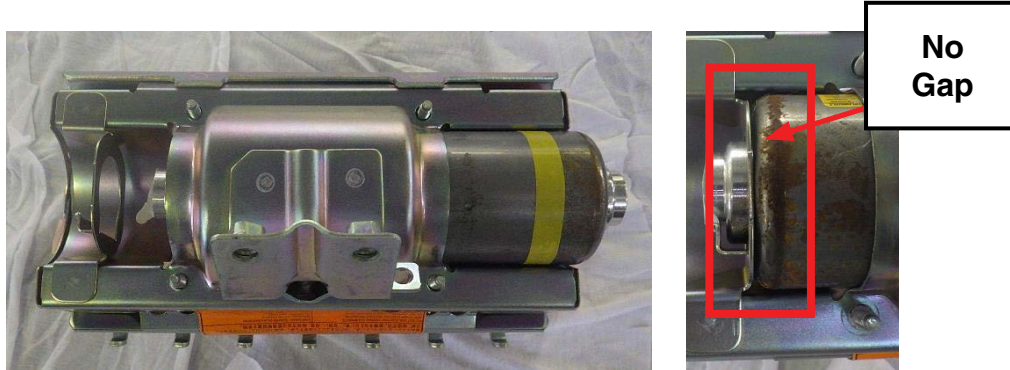
**STEP 10-** Install the new inflator into the mounting bracket so the yellow taped end will align with the stopper plate when reinstalled on the mounting bracket. When properly installed, both ends of the inflator will be seated tight against the stopper plates with no gaps.

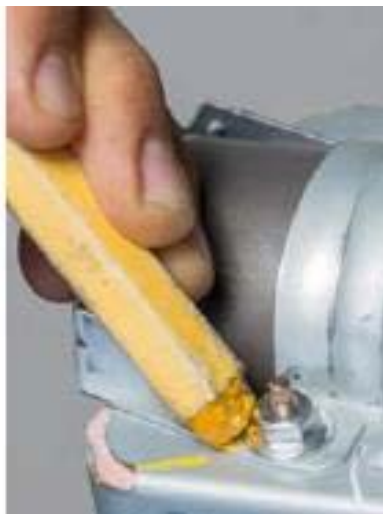
**STEP 11-** Reinstall the original stopper plate and the 4 **NEW** self-locking nuts. **SLOWLY** tighten (to prevent over-tightening) then torque the nuts to 31-38 inch-pounds. When complete, use a marker to indicate they have been fully tightened.

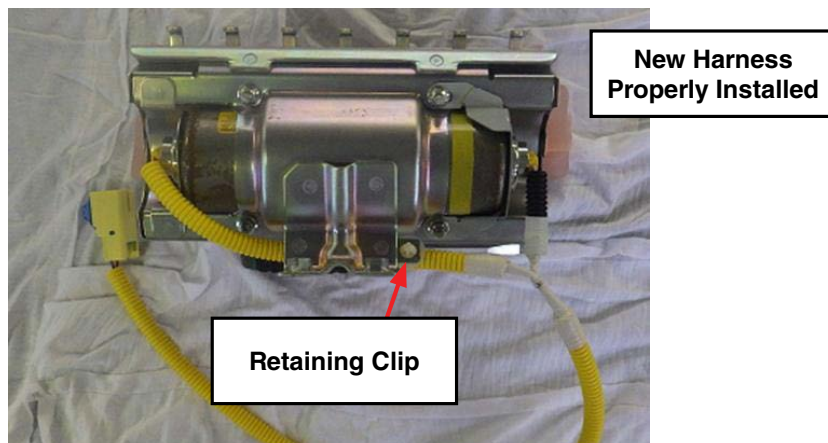
**CAREFULLY** align the pins of the inflator with the female terminals of the harness connector (red / yellow wires) as shown in the photos below. Once pin alignment is confirmed, push down firmly to engage the connector's 3 locking tangs into the locking groove inside the connector boss. Confirm the connector is locked by prying up **LIGHTLY** with a small flat-blade screwdriver. Repeat the procedure on the opposite "short" side with the blue / white wires.

**VERY IMPORTANT: When connecting the new harness to the inflator, both sides MUST be routed and the retaining clip installed** as shown in the "New Harness Properly Installed" photo below.

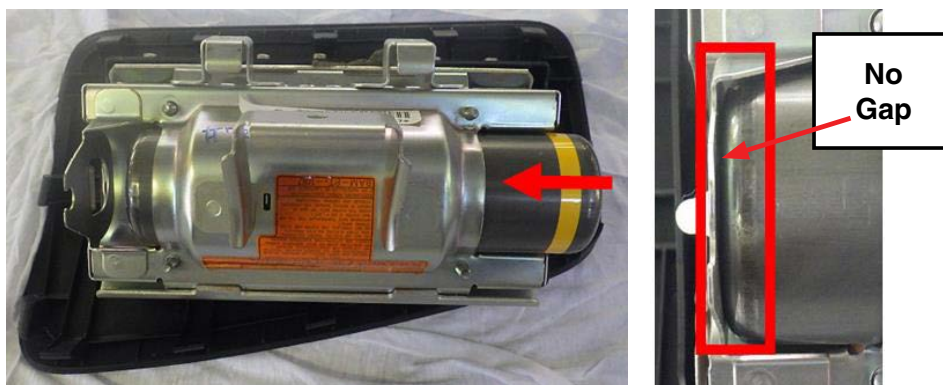
**STEP 9-** Install the new inflator into the mounting bracket so the yellow taped end will align with the stopper plate when reinstalled on the mounting bracket. When properly installed, both ends of the inflator will be seated tight against the stopper plates with no gaps.

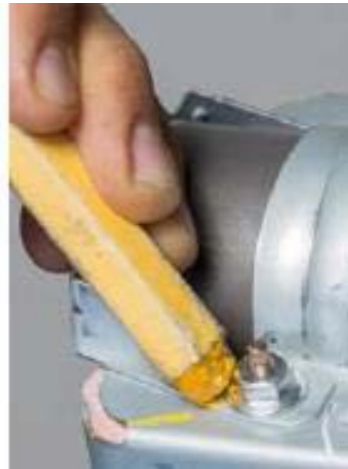
**STEP 10-** Reinstall the original stopper plate and the 4 **NEW** self-locking nuts. **SLOWLY** tighten (to prevent over-tightening) then torque the nuts to 31-38 inch-pounds. When complete, use a marker to indicate they have been fully tightened.

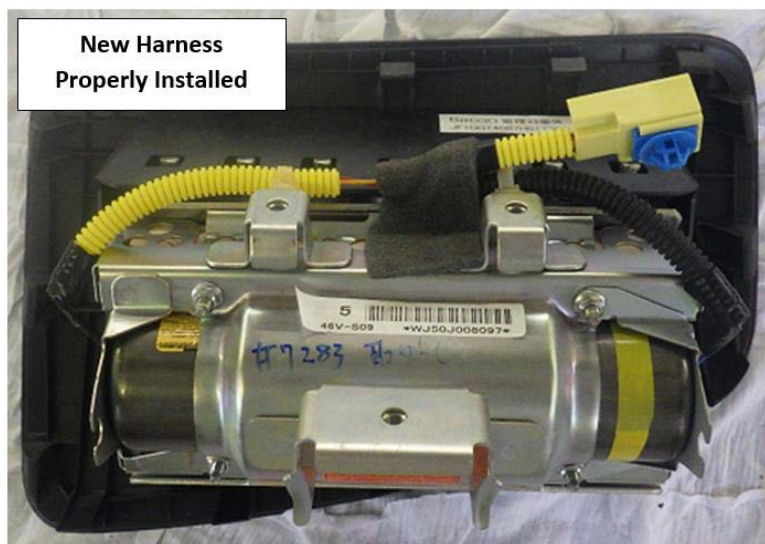
**CAREFULLY** align the pins of the inflator (end with yellow tape) with the female terminals of the harness connector (blue / white wires, **BLACK** harness tube) as shown in the photo below. Once pin alignment is confirmed, push down firmly to engage the connector's 3 locking tangs into the locking groove inside the connector boss. Confirm the connector is locked by prying up **LIGHTLY** with a small flat-blade screwdriver. Repeat the procedure on the opposite side (red / yellow wires, **YELLOW** harness tube). When complete, refit the harness retaining clips back into the mounting brackets.

**VERY IMPORTANT:** When connecting the new harness to the inflator, **both sides MUST be routed as shown** in the “New Harness Properly Installed” photo below.
