**SUBARU**

## PRODUCT CAMPAIGN BULLETIN

**NUMBERS:** TKA-16R  
 TKB-16R  
 TKC-16R  
**DATE:** 07/13/16  
**REVISED:** 10/31/16  
**NHTSA ID:** 16V-358  
 16V-359  
 16V-361

**SUBJECT:** Takata Front Passenger Airbag Inflator Replacement

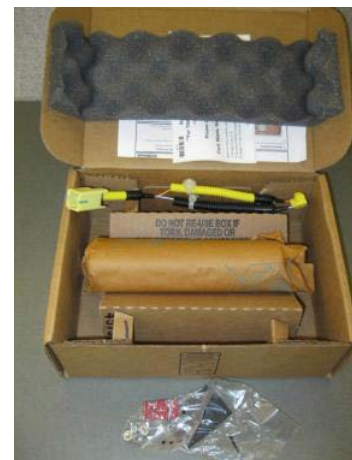
Open the Kit Box and confirm all the necessary components are included:

- 4 Self-Locking nuts
- 1 ½” X 2 ¼” piece of self-adhesive sponge tape
- New Inflator (yellow tape applied to one end to identify it as the replacement part)
- New Inflator Harness
- Electro-Tap (red shorting crimp connector)
- Shipping Documentation
