PRODUCT CAMPAIGN BULLETIN

<p>APPLICABILITY: 2003-2006 model year Baja 2003-2004 model year Legacy 2003-2004 model year Outback 2009-2011 model year Legacy 2009-2011 model year Outback 2009-2011 model year Forester 2006-2011 model year Tribeca 2006-2011 model year Impreza (including WRX and STI)</p>	<p>NUMBERS: TKA-16R TKB-16R TKC-16R</p> <p>DATE: 07/13/16</p> <p style="background-color: #f1c40f;">REVISED: 12/21/22</p> <p>NHTSA ID: 16V-358 16V-359 16V-361</p>
---	--

SUBJECT: Takata Front Passenger Airbag Inflator Replacement

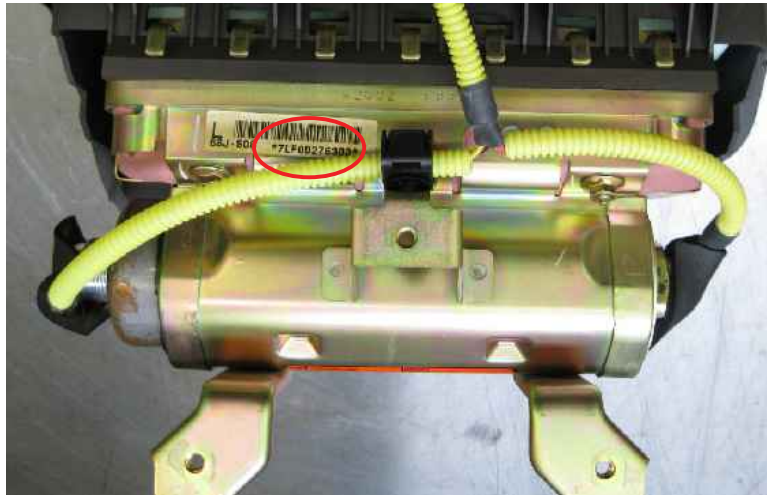
Inflator WITHOUT Ammonium Nitrate- Serial Number Label Location (2003 Legacy, Outback and Baja models only): Record this 11-digit number for claims purposes.

- These early production 2003 MY vehicles (77,000) were equipped with inflators which do not contain ammonium nitrate.
- These inflators which do not contain ammonium nitrate do not require replacement as part of any Subaru airbag recall.

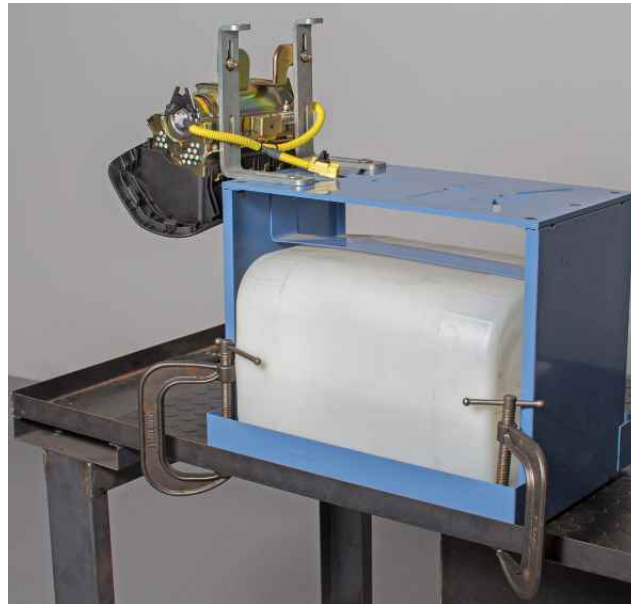
REMINDER: It is **STRONGLY RECOMMENDED** the removed airbag module **ALWAYS** be mounted to the Airbag Deployment Fixture (part number J-39401-B and file photo shown below) to better secure it during the inflator replacement procedure. When mounting the module to the fixture, pay close attention to the harness routing. Always perform this work in an area away from others to reduce chances of inadvertent injury should any deployment occur. Take your surroundings into account to avoid possible hazards should an inadvertent deployment occur or sources of static or other electricity that could potentially induce such a deployment.

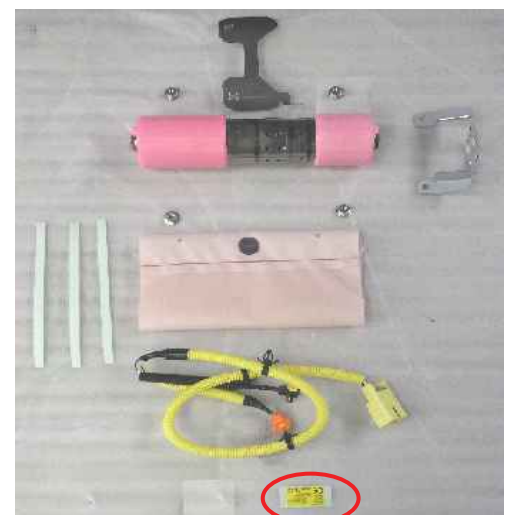
NOTE: Discard this CE label as it is not applicable to the US market.
