SERVICE INFORMATION BULLETIN

NUMBER: 07-116-16R

SUBJECT: Supplemental Service Procedure Information to be Used in Conjunction with Campaigns WQP-51, WQR-53R, TKA, B, C-16R and **TKA, B, C-17R**

DATE: 11/11/16

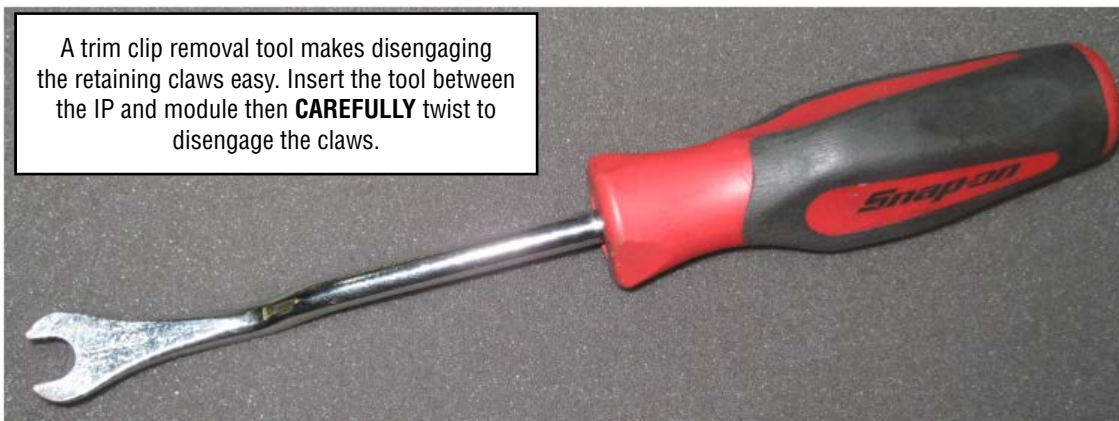
Retaining claws being CAREFULLY disengaged.

A trim clip removal tool makes disengaging the retaining claws easy. Insert the tool between the IP and module then **CAREFULLY** twist to disengage the claws.

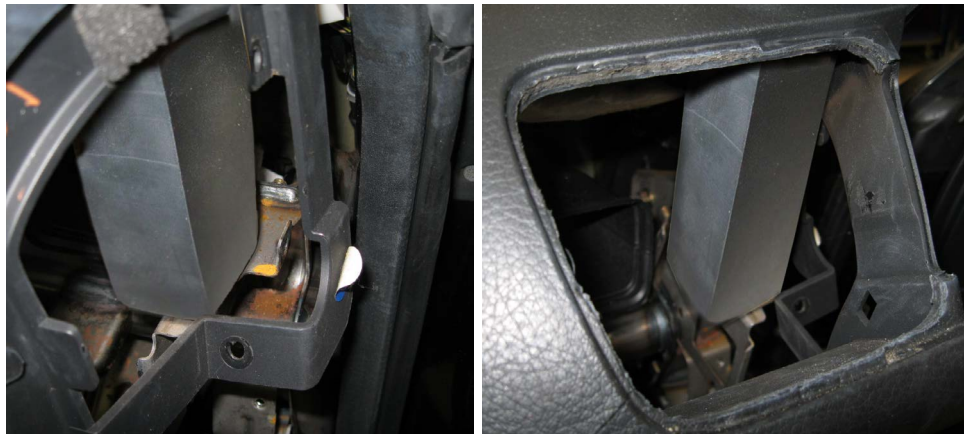
- Follow the Service Manual procedures for removing the IP but, once the IP is loose and moveable, support the passenger’s side end with the resin block as shown below. Use the velcro strap to hold the resin block in place if necessary.
- Lift the IP **only as much as is needed** to insert the resin block between the underside of the IP and the support brace on the steering column support bar as shown below.

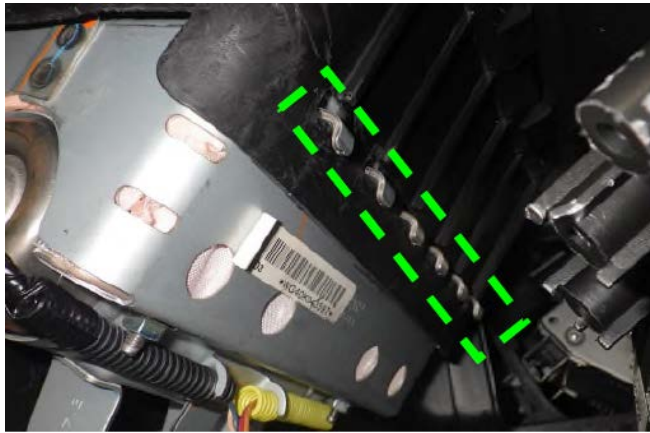
Module in position, retaining claws engaged.

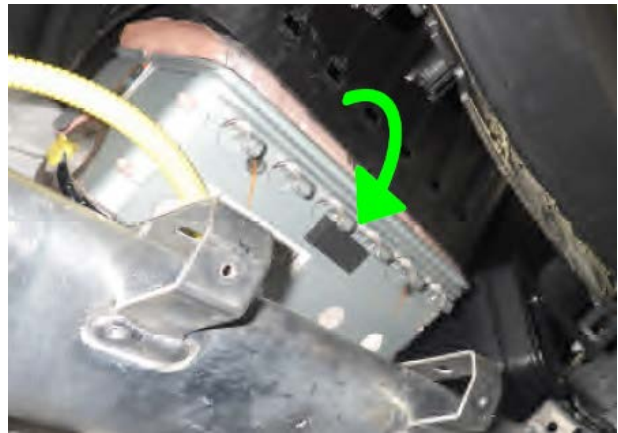
Retaining claws released and module rotated downward to release / remove.

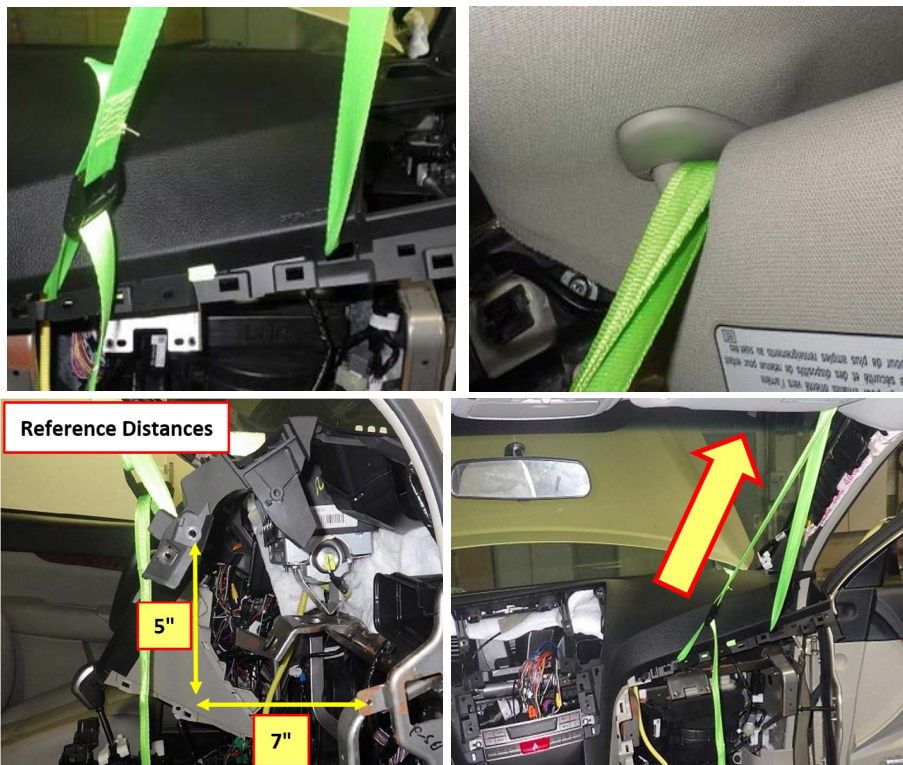
Use the photos below as a guide for positioning the support strap on the IP along with the upper securing point which is the mounting point for the sun visor.

- To avoid damaging the visor, always make sure the opposite end of the visor closest to the rear view mirror is securely clipped into place before adding any load from the IP to it.
- The dimensions shown in the photos are the **maximums** needed to access and remove the module. To avoid damaging the IP, **DO NOT EXCEED** these dimensions.

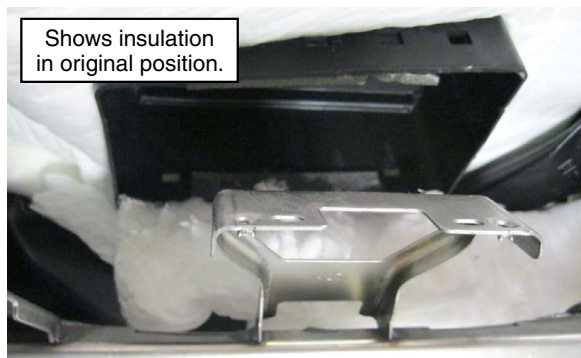
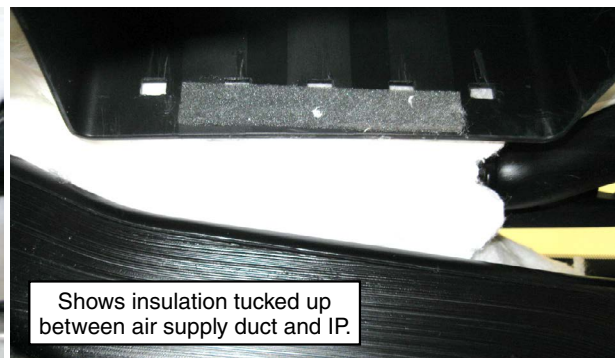
TIP: As shown in the photo below, there is a substantial amount of white poly-fill / insulation material around the airbag module location. Before reinstalling the module, **CAREFULLY** tuck the material up into the gap between the air supply duct and underside of the IP to get it out of the way of the “front” retaining claws. Once the module is locked back into position, reach up behind (ahead of) it, **CAREFULLY** pull the insulation back out and put it back into its original position.

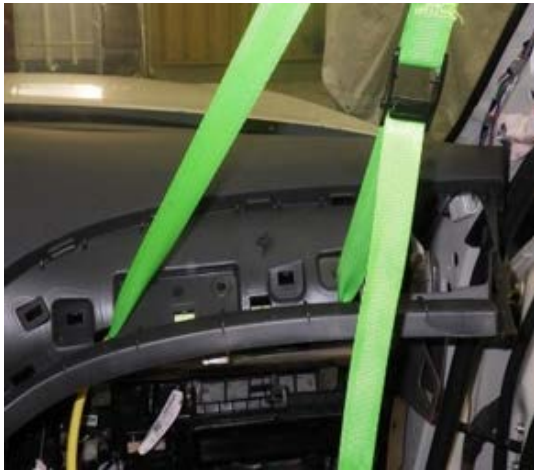
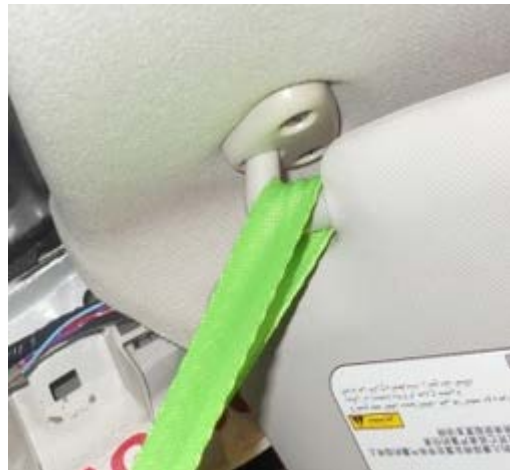
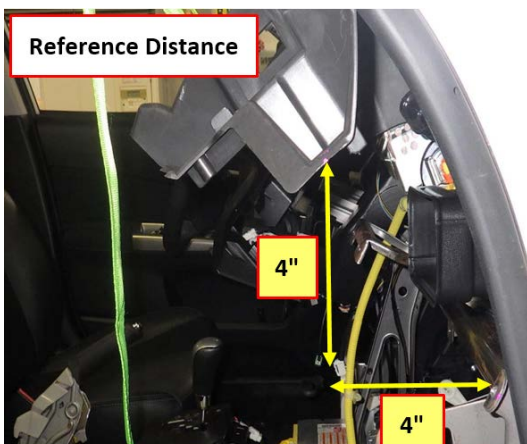
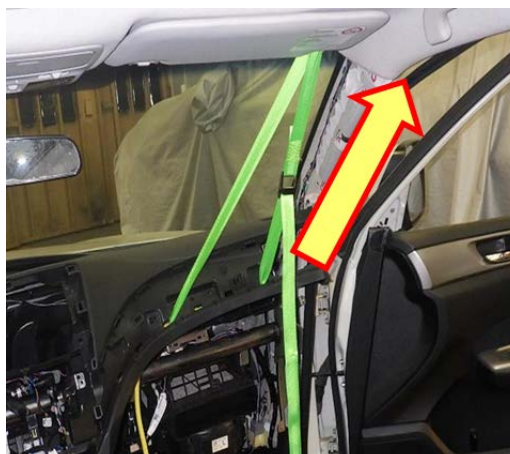
- Once the support strap is installed through the holes on the IP, lift the end of the IP only as much as is needed **without exceeding the Reference Distances** as shown below.
