PRODUCT CAMPAIGN BULLETIN

<p>APPLICABILITY: 2003-2006 model year Baja 2003-2004 model year Legacy 2003-2004 model year Outback 2009-2011 model year Legacy 2009-2011 model year Outback 2009-2011 model year Forester 2006-2011 model year Tribeca 2006-2011 model year Impreza (including WRX and STI)</p>	<p>NUMBERS: TKA-16R TKB-16R TKC-16R</p> <p>DATE: 07/13/16</p> <p style="background-color: yellow;">REVISED: 12/28/23</p> <p>NHTSA ID: 16V-358 16V-359 16V-361</p>
---	---

SUBJECT: Takata Front Passenger Airbag Inflator Replacement

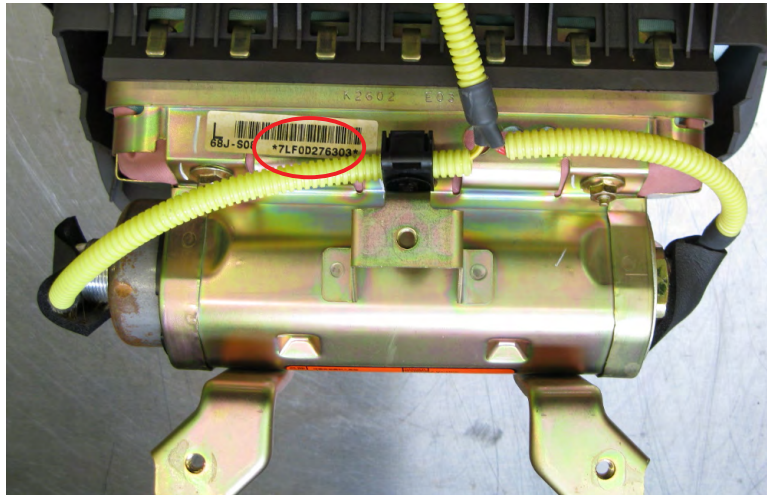
Inflator WITHOUT Ammonium Nitrate- Serial Number Label Location (2003 Legacy, Outback and Baja models only): Record this 11-digit number for claims purposes.

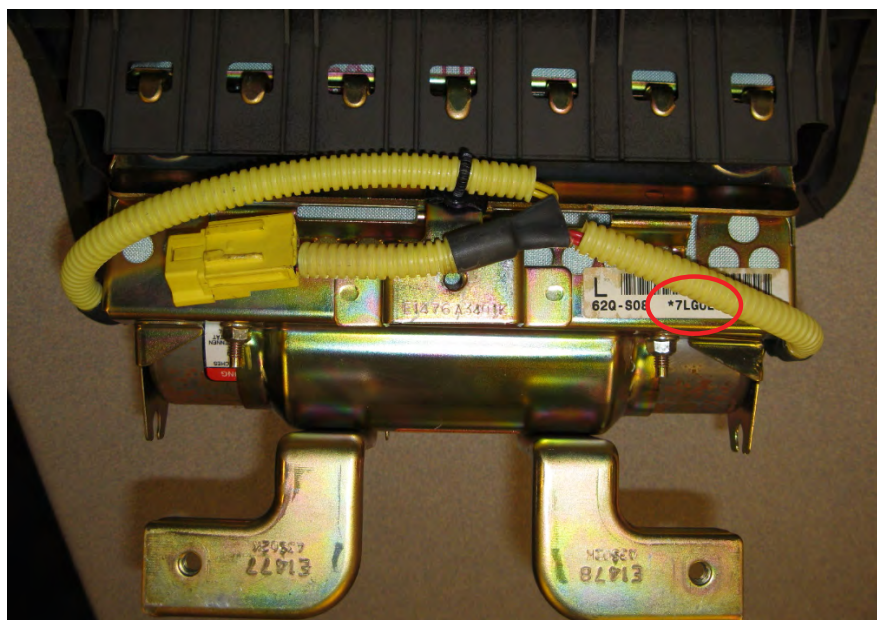
Inflator WITH Ammonium Nitrate- Serial Number Label Location

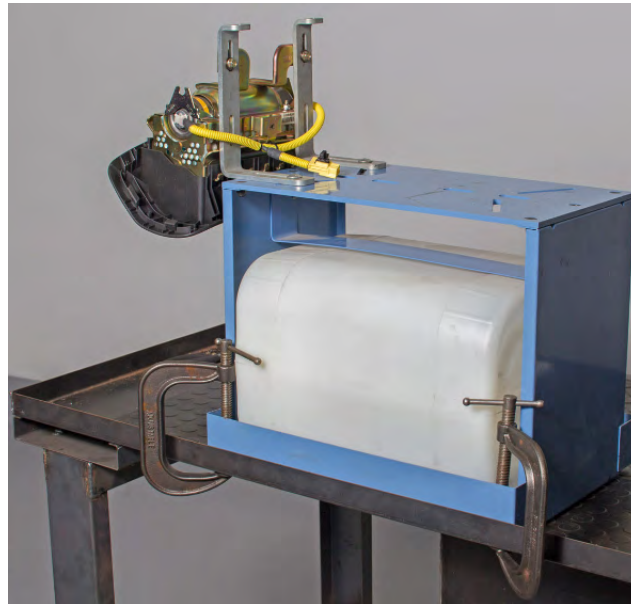
REMINDER: It is **STRONGLY RECOMMENDED** the removed airbag module **ALWAYS** be mounted to the Airbag Deployment Fixture (part number J-39401-B and file photo shown below) to better secure it during the inflator replacement procedure. When mounting the module to the fixture, pay close attention to the harness routing. Always perform this work in an area away from others to reduce chances of inadvertent injury should any deployment occur. Take your surroundings into account to avoid possible hazards should an inadvertent deployment occur or sources of static or other electricity that could potentially induce such a deployment.

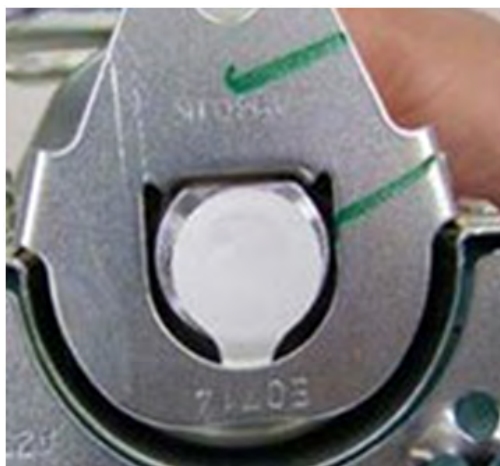
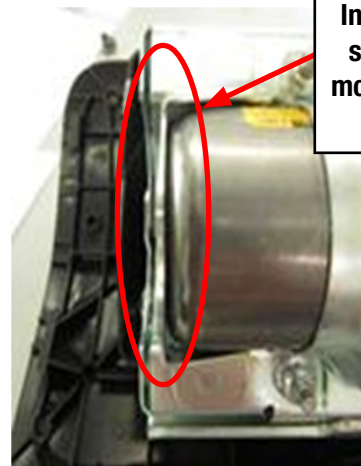
Inflator properly seated against mounting bracket (NO GAP)

STEP 9- Install the new inflator into the mounting bracket so the yellow taped end aligns with the removed stopper plate. Make sure the “D-shaped” portion of the inflator harness connector boss aligns with the “D-shaped” portion of the hole in the end of the mounting bracket as shown below. When properly installed, the end of the inflator will be seated tight against the mounting bracket. Do not peel the white harness connection dust cover at this time.

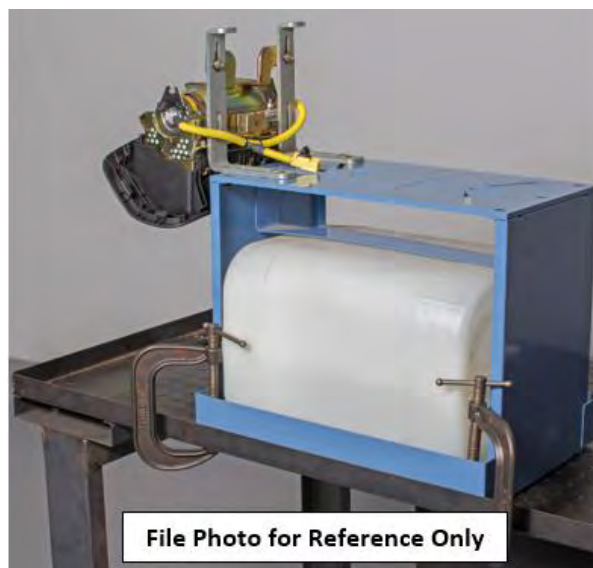
REMINDER: It is **STRONGLY RECOMMENDED** the removed airbag module **ALWAYS** be mounted to the Airbag Deployment Fixture (part number J-39401-B and file photo shown below) to better secure it during the inflator replacement procedure. When mounting the module to the fixture, pay close attention to the harness routing. Always perform this work in an area away from others to reduce chances of inadvertent injury should any deployment occur. Take your surroundings into account to avoid possible hazards should an inadvertent deployment occur or sources of static or other electricity that could potentially induce such a deployment.

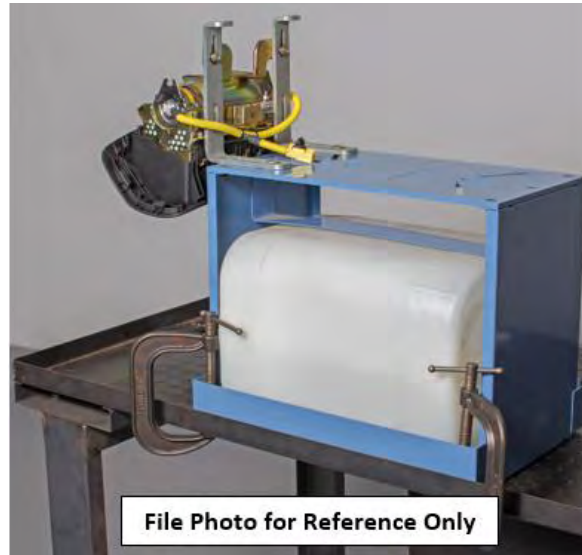
REMINDER: It is **STRONGLY RECOMMENDED** the removed airbag module **ALWAYS** be mounted to the Airbag Deployment Fixture (part number J-39401-B and file photo shown below) to better secure it during the inflator replacement procedure. When mounting the module to the fixture, pay close attention to the harness routing. Always perform this work in an area away from others to reduce chances of inadvertent injury should any deployment occur. Take your surroundings into account to avoid possible hazards should an inadvertent deployment occur or sources of static or other electricity that could potentially induce such a deployment.

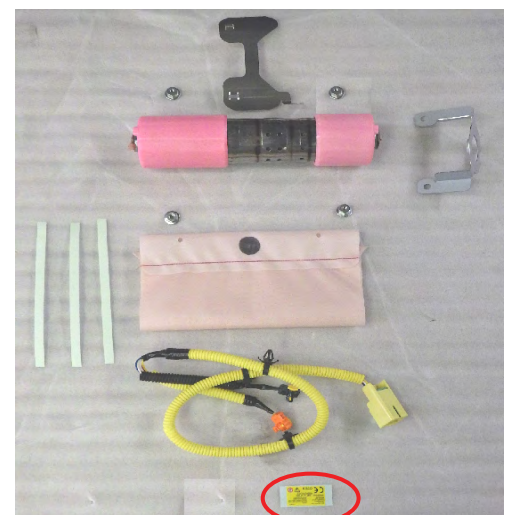
NOTE: Discard this CE label as it is not applicable to the US market.

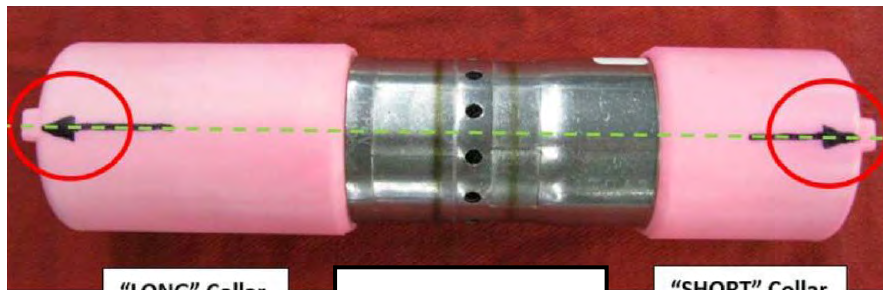
File photo, actual replacement inflator may differ slightly.

STEP 16- Inspect the new inflator to confirm the locating protrusions on each of the pink collars are aligned as shown below. The “short” collar can be rotated as needed to align it with the protrusion on the “long” collar if necessary.
