PRODUCT CAMPAIGN BULLETIN

<p>APPLICABILITY: 2003-2006 model year Baja 2003-2004 model year Legacy 2003-2004 model year Outback 2009-2011 model year Legacy 2009-2011 model year Outback 2009-2011 model year Forester 2006-2011 model year Tribeca 2006-2011 model year Impreza (including WRX and STI)</p>	<p>NUMBERS: TKA-16R TKB-16R TKC-16R</p> <p>DATE: 07/13/16</p> <p style="background-color: #ffeb3b;">REVISED: 07/20/18</p> <p>NHTSA ID: 16V-358 16V-359 16V-361</p>
---	--

SUBJECT: Takata Front Passenger Airbag Inflator Replacement

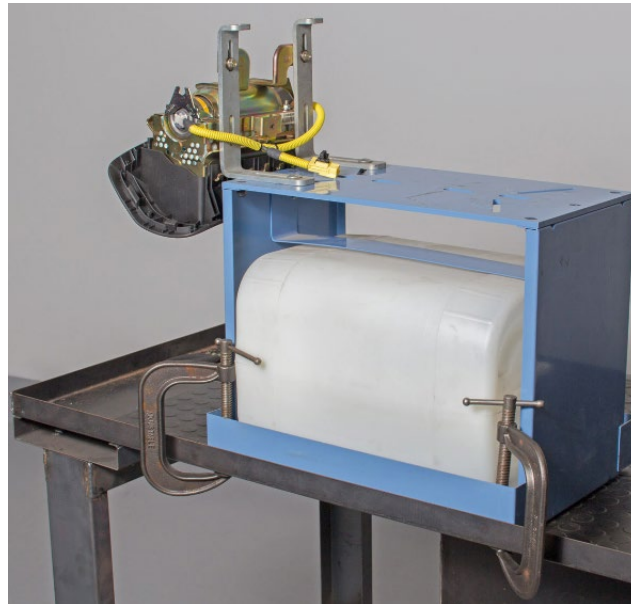
REMINDER: It is **STRONGLY RECOMMENDED** the removed airbag module **ALWAYS** be mounted to the Airbag Deployment Fixture (part number J-39401-B and file photo shown below) to better secure it during the inflator replacement procedure. When mounting the module to the fixture, pay close attention to the harness routing. Always perform this work in an area away from others to reduce chances of inadvertent injury should any deployment occur. Take your surroundings into account to avoid possible hazards should an inadvertent deployment occur or sources of static or other electricity that could potentially induce such a deployment.

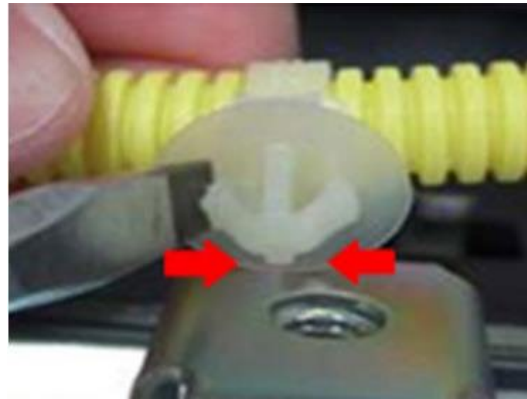
STEP 3- Remove the harness clip from the retainer bracket by pushing the tangs inward with a flat-blade screwdriver as shown below.

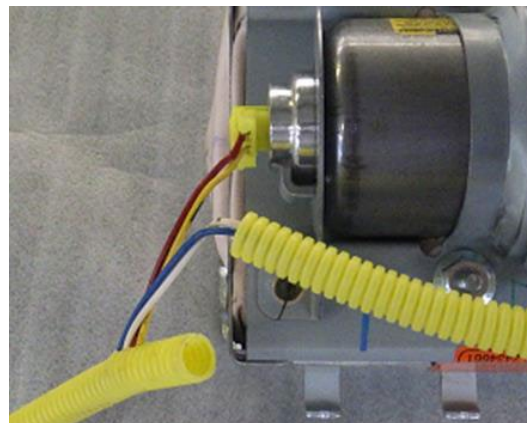
STEP 4- Using a scissor or wire cutter (no knives or razors) **CAREFULLY** cut the yellow harness cover tube (approximately 1 1/2 inches) enough to expose the yellow and red wires inside and provide enough room to install the Electro-Tap (shorting) connector.

TAKE YOUR TIME AND BE CAREFUL TO NOT CUT THE 2 WIRES!

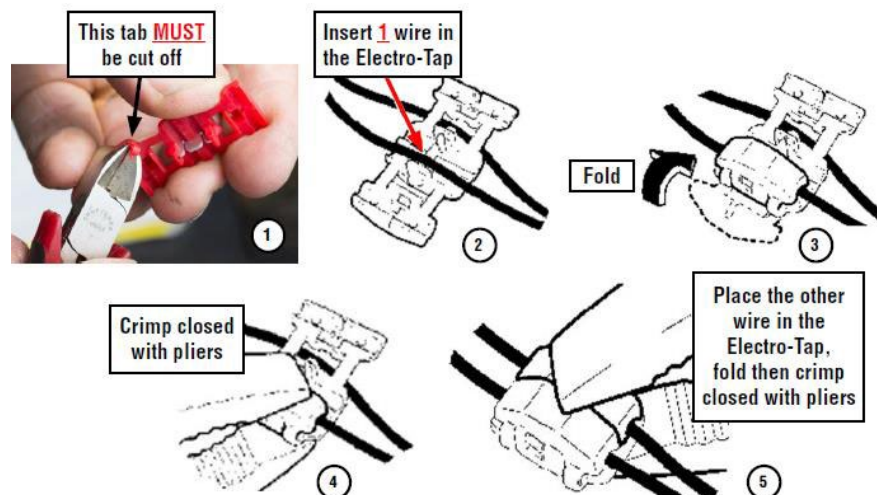
STEP 5- Short the yellow and red wires together by installing the Electro-Tap connector. The connector creates a short circuit which acts as a safeguard to prevent against static discharge that may deploy the removed inflator. The tab portion of the Electro-Tap connector **MUST** be cut off prior to use to insure a good short-circuit is made as shown in the illustration below. **Follow the sequence below** for installing the Electro-Tap connector. Use pliers to squeeze closed the two sections of the connector together, **one section at a time**.

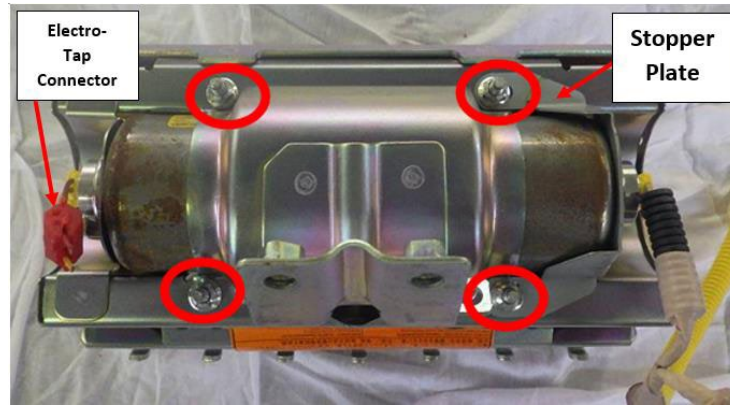
STEP 6- Once the Electro-Tap connector is fully crimped in place, cut the yellow and red wires **on the body harness connector side** of the Electro-Tap connector.

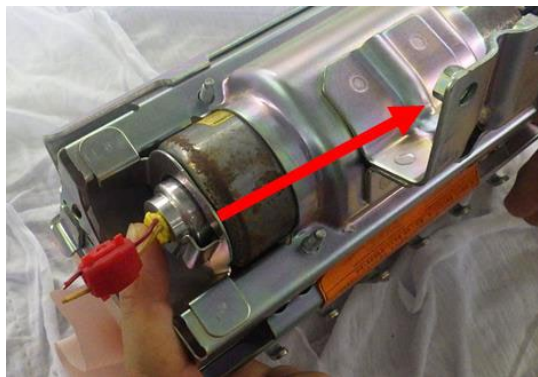
STEP 8- With the self-locking nuts and stopper plate removed, slide the original inflator out of the mounting bracket while feeding the cut off portion of the wiring harness under the remaining stopper plate. Place the removed original air bag inflator back into the “cradle” of the Kit Box insert.

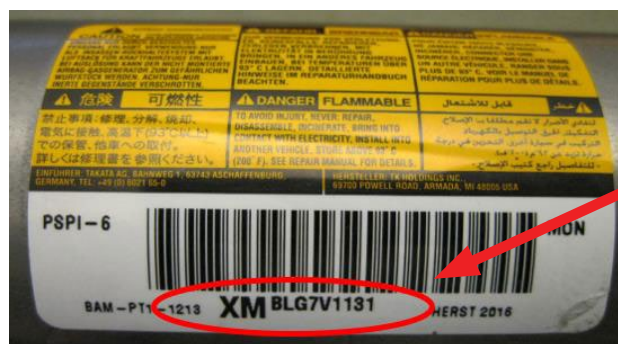
STEP 9 - VERY IMPORTANT: Record the **11-digit alpha-numeric serial number for both the new and the removed inflators** on the hard copy of the Repair Order. **For SOA and SDC Retailers ONLY**, this information will be required for claim approval. **For SNE retailers**, this information will be required for completion of the Part Return Notice which will be forwarded by the retailer to the PCC.

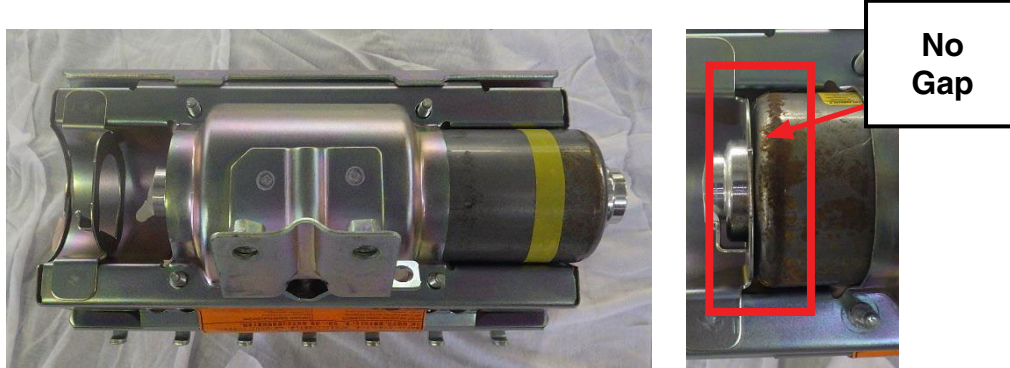
STEP 10- Install the new inflator into the mounting bracket so the yellow taped end will align with the stopper plate when reinstalled on the mounting bracket. When properly installed, both ends of the inflator will be seated tight against the stopper plates with no gaps.

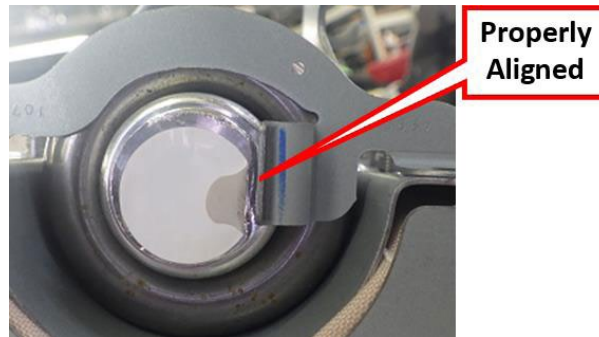
Make sure the “D-shaped” portion of the inflator harness connector boss aligns with the “D-shaped” portion of the original stopper plate as shown below. Do not peel the white harness connection dust cover at this time.

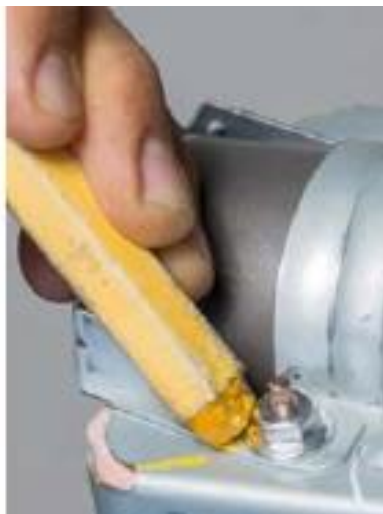
STEP 11- Reinstall the original stopper plate and the 4 **NEW** self-locking nuts. **SLOWLY** tighten (to prevent over-tightening) then torque the nuts to 31-38 inch-pounds. When complete, use a marker to indicate they have been fully tightened.

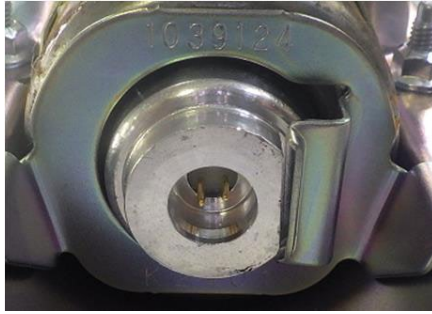
STEP 12- Peel the white dust cover from the d-shaped end of the new inflator. The new inflator wiring harness has 2 “sides” with round 2-pin connectors on both ends. The “long” side with the yellow / red wires will connect to the end of the inflator with the D-Shaped wiring harness connector boss as shown below. Peel the white dust cover from the D-Shaped end of the inflator **ONLY**.

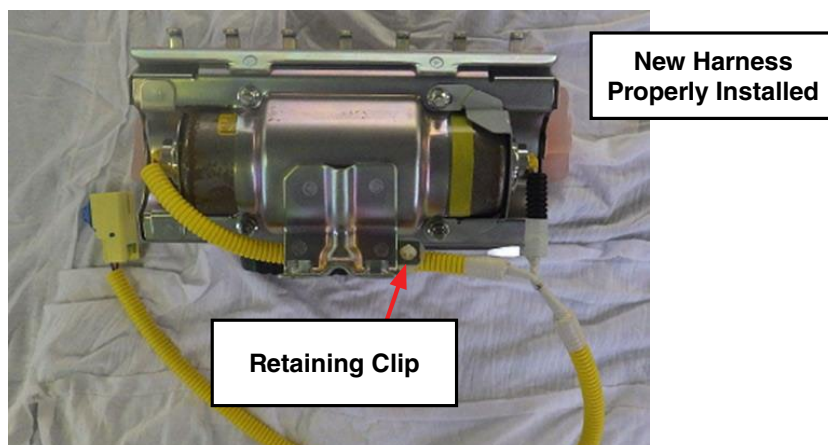
CAREFULLY align the pins of the inflator with the female terminals of the harness connector (red / yellow wires) as shown in the photos below. Once pin alignment is confirmed, push down firmly to engage the connector's 3 locking tangs into the locking groove inside the connector boss. Confirm the connector is locked by prying up **LIGHTLY** with a small flat-blade screwdriver. Repeat the procedure on the opposite "short" side with the blue / white wires.

VERY IMPORTANT: When connecting the new harness to the inflator, both sides MUST be routed and the retaining clip installed as shown in the "New Harness Properly Installed" photo below.

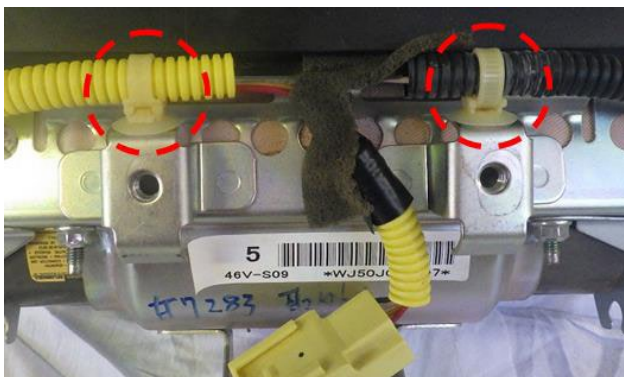
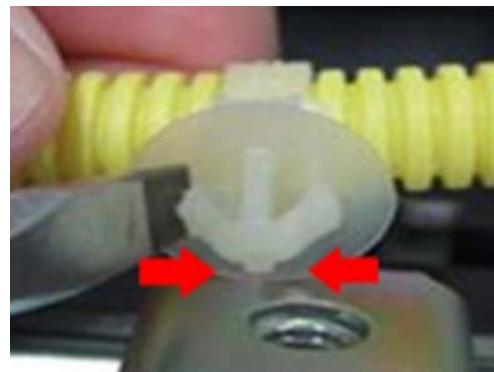
STEP 2- Peel the sponge tape and remove the harness clips from the retainer bracket by pushing the tangs inward with a flat-blade screwdriver as shown below. Always remove any sponge tape adhesive residue from the airbag mounting bracket using mild solvent on a clean shop cloth.

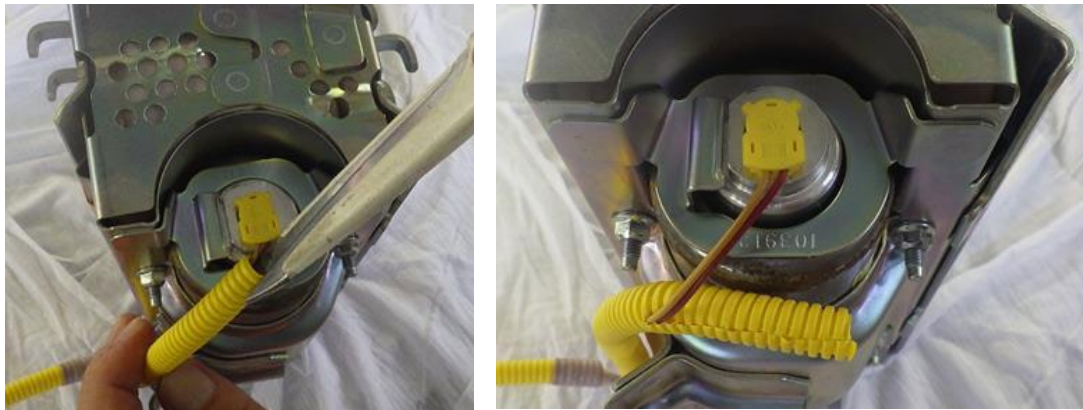
STEP 3- Using a scissor or wire cutter (no knives or razors) **CAREFULLY** cut the yellow harness cover tube (approximately 1 1/2 inches) enough to expose the red and yellow wires inside and provide enough room to install the Electro-Tap (shorting) connector.

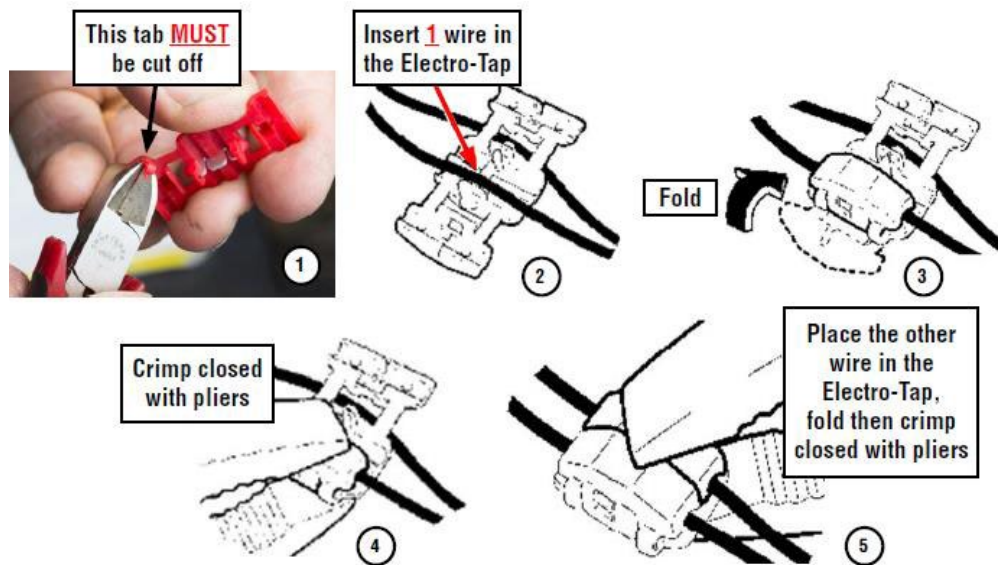
STEP 4- Short the yellow and red wires together by installing the Electro-Tap connector. The connector creates a short circuit which acts as a safeguard to prevent against static discharge that may deploy the removed inflator. The tab portion of the Electro-Tap connector **MUST** be cut off prior to use to insure a good short-circuit is made as shown in the illustration below. **Follow the sequence below** for installing the Electro-Tap connector. Use pliers to squeeze closed the two sections of the connector together, **one section at a time**.

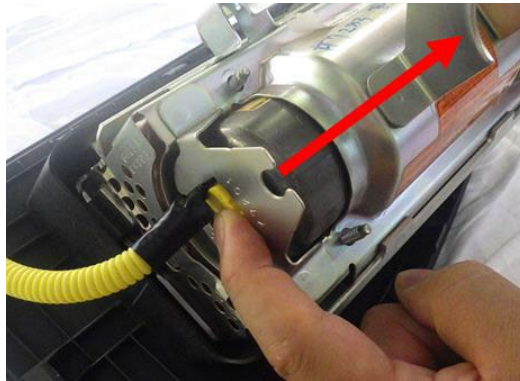
STEP 7- With the self-locking nuts and stopper plate removed, slide the original inflator out of the mounting bracket while feeding the cut off portion of the wiring harness under the remaining stopper plate. Place the removed original air bag inflator back into the “cradle” of the Kit Box insert.

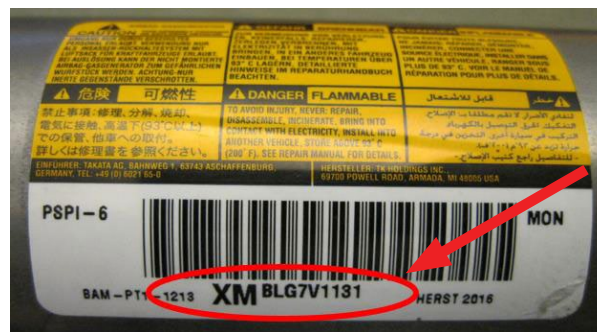
STEP 8 - VERY IMPORTANT: Record the **11-digit alpha-numeric serial number** for both the **new and the removed inflators** on the hard copy of the Repair Order. **For SOA and SDC Retailers ONLY**, this information will be required for claim approval. **For SNE retailers**, this information will be required for completion of the Part Return Notice which will be forwarded by the retailer to the PCC.

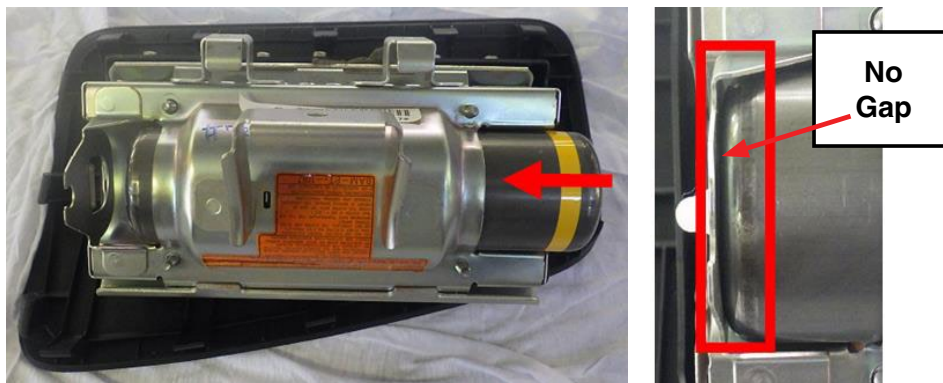
STEP 9- Install the new inflator into the mounting bracket so the yellow taped end will align with the stopper plate when reinstalled on the mounting bracket. When properly installed, both ends of the inflator will be seated tight against the stopper plates with no gaps.

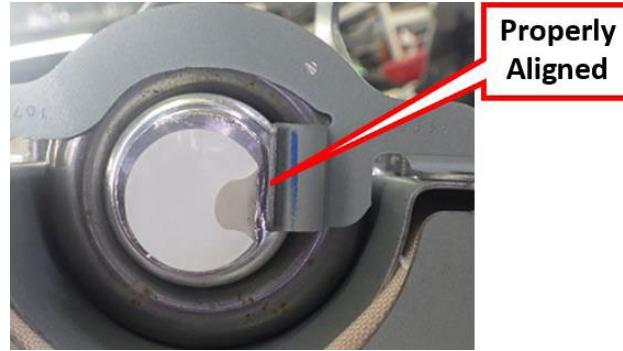
Make sure the “D-shaped” portion of the inflator harness connector boss aligns with the “D-shaped” portion of the original stopper plate as shown below. **Do not peel the white harness connection dust cover at this time.**

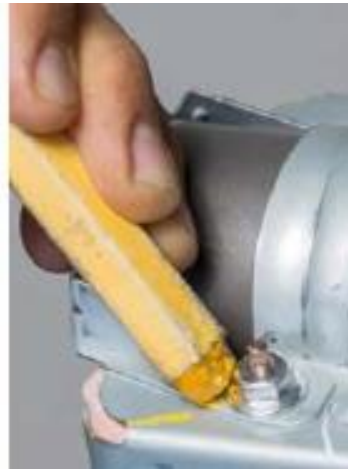
STEP 10- Reinstall the original stopper plate and the 4 **NEW** self-locking nuts. **SLOWLY** tighten (to prevent over-tightening) then torque the nuts to 31-38 inch-pounds. When complete, use a marker to indicate they have been fully tightened.

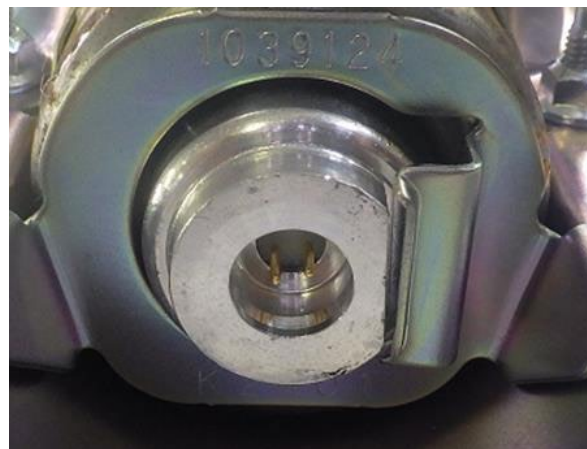
STEP 11- Peel the white dust cover from the d-shaped end of the new inflator. The new inflator wiring harness has 2 “sides” with round 2-pin connectors on both ends. The side with the yellow harness tube and red / yellow wires will connect to the end of the inflator with the “D-shaped” wiring harness connector boss as shown below. Peel the white dust cover from the “D-shaped” end of the inflator **ONLY**.

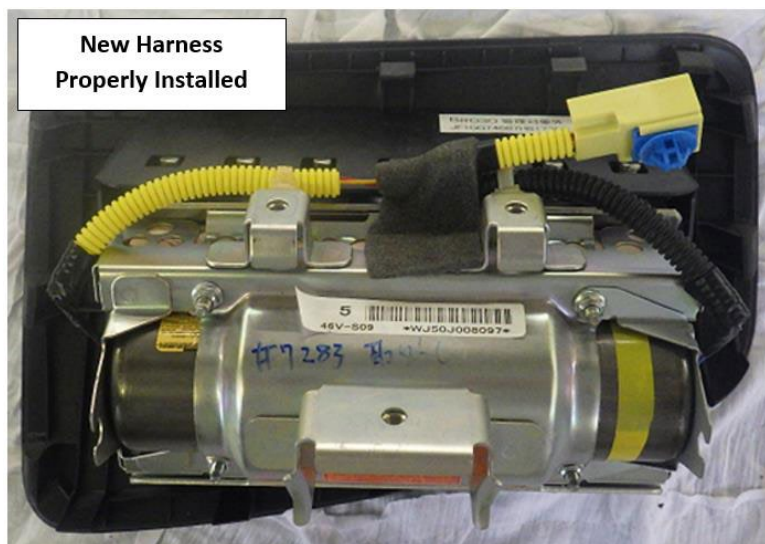
CAREFULLY align the pins of the inflator (end with yellow tape) with the female terminals of the harness connector (blue / white wires, **BLACK** harness tube) as shown in the photo below. Once pin alignment is confirmed, push down firmly to engage the connector's 3 locking tangs into the locking groove inside the connector boss. Confirm the connector is locked by prying up **LIGHTLY** with a small flat-blade screwdriver. Repeat the procedure on the opposite side (red / yellow wires, **YELLOW** harness tube). When complete, refit the harness retaining clips back into the mounting brackets.

VERY IMPORTANT: When connecting the new harness to the inflator, **both sides MUST be routed as shown** in the “New Harness Properly Installed” photo below.

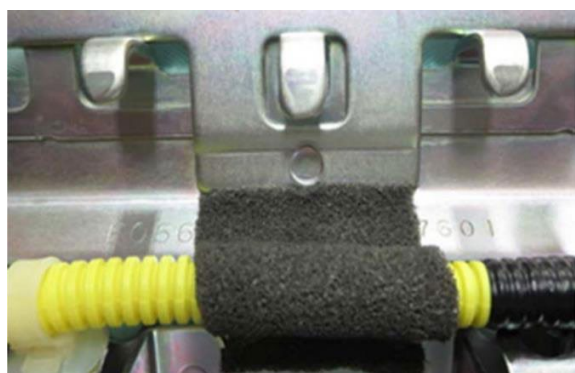
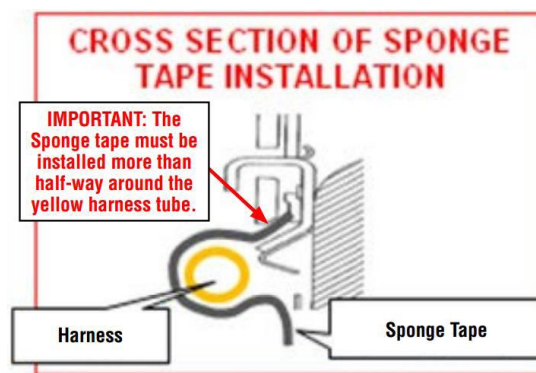
STEP 12- Peel the adhesive backing and install the new sponge tape onto the yellow harness tube first then adhere it to the airbag mounting bracket as shown in the illustrations below.
