PRODUCT CAMPAIGN BULLETIN

<p>APPLICABILITY: 2003-2006 model year Baja 2003-2004 model year Legacy 2003-2004 model year Outback 2009-2011 model year Legacy 2009-2011 model year Outback 2009-2011 model year Forester 2006-2011 model year Tribeca 2006-2011 model year Impreza (including WRX and STI)</p>	<p>NUMBERS: TKA-16R TKB-16R TKC-16R</p> <p>DATE: 07/13/16</p> <p style="background-color: yellow;">REVISED: 05/11/17</p> <p>NHTSA ID: 16V-358 16V-359 16V-361</p>
---	---

SUBJECT: Takata Front Passenger Airbag Inflator Replacement

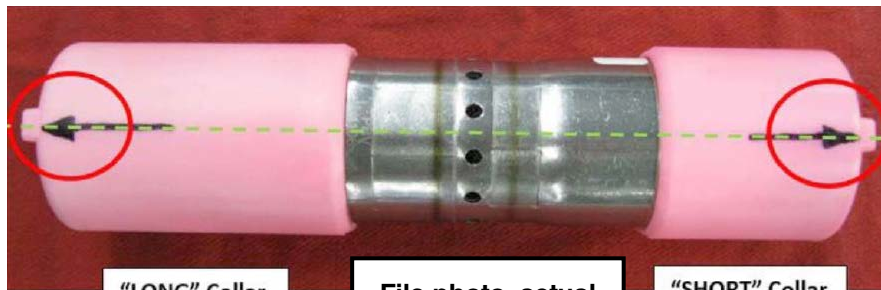
“LONG” Collar

STEP 16- Inspect the new inflator to confirm the locating protrusions on each of the pink collars are aligned as shown below. The “short” collar can be rotated as needed to align it with the protrusion on the “long” collar if necessary.

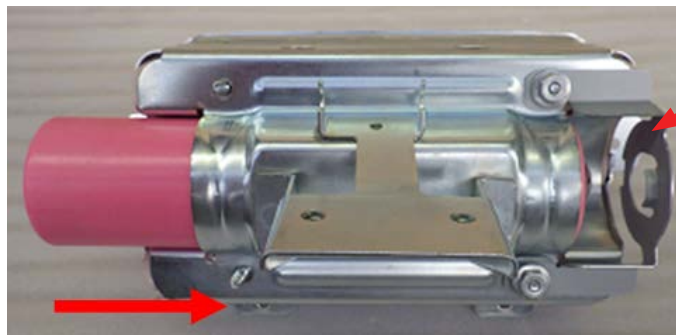
New Stopper Plate Supplied with Kit.

STEP 18- Slide the new inflator back into the mounting bracket, short collar end first. Align the tab on the new stopper plate with the notch on the end of the collar. When properly installed, the inflator will be tight against the stopper plate with no gap.

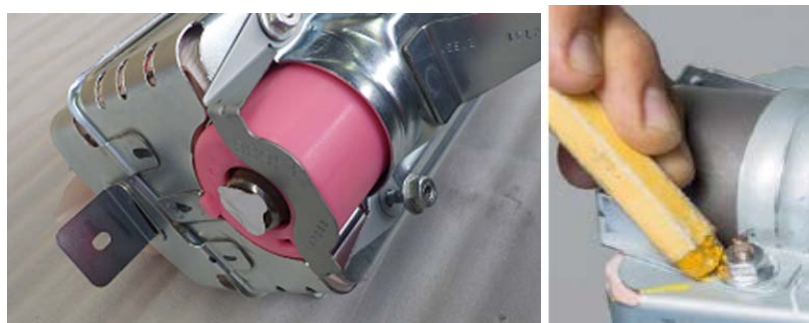
STEP 19- Reinstall the original (retained from **STEP 7**) stopper plate and the other 2 **NEW** self-locking nuts. **SLOWLY** tighten (to prevent over-tightening) while making sure both stopper plates stay tight against both ends of the inflator. **HAND TOOLS ONLY!** Torque the nuts to 31-38 inch-pounds. When complete, use a marker to indicate they have been fully tightened.

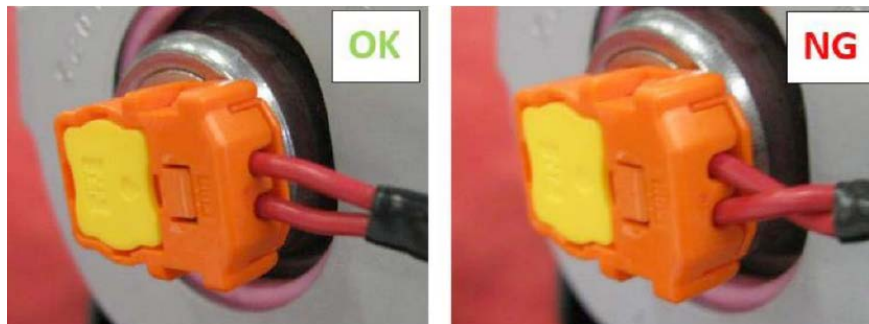
BEFORE connecting the harness to the inflator, make sure the harness is not twisted as shown below.

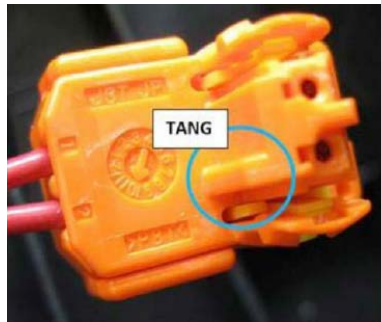
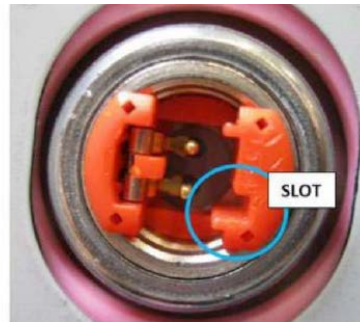
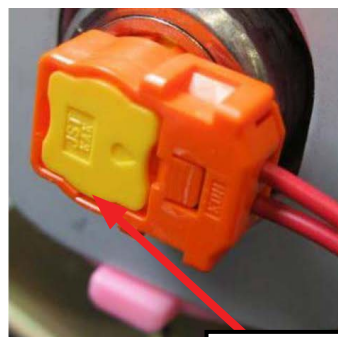
Lock Tab

CAREFULLY align the tang of the inflator with the slot on the inflator harness connector as shown below. Push down firmly on the yellow lock tab to engage the connector's locking claws into the groove inside the connector boss on the inflator end. Confirm the connector is locked by prying up **LIGHTLY** with a small flat-blade screwdriver. Repeat the procedure on the opposite end.

Once alignment is confirmed, push down firmly to engage the connector. When fully seated, press down on the yellow tab locking the connector to the inflator.
