PRODUCT CAMPAIGN BULLETIN

APPLICABILITY: 2003-2006 model year Baja
 2003-2004 model year Legacy
 2003-2004 model year Outback
 2009-2011 model year Legacy
 2009-2011 model year Outback
 2009-2011 model year Forester
 2006-2011 model year Tribeca
 2006-2011 model year Impreza (including WRX and STI)

NUMBERS: TKA-16R
 TKB-16R
 TKC-16R
DATE: 07/13/16
REVISED: 08/09/16
NHTSA ID: 16V-358
 16V-359
 16V-361

SUBJECT: Takata Front Passenger Airbag Inflator Replacement

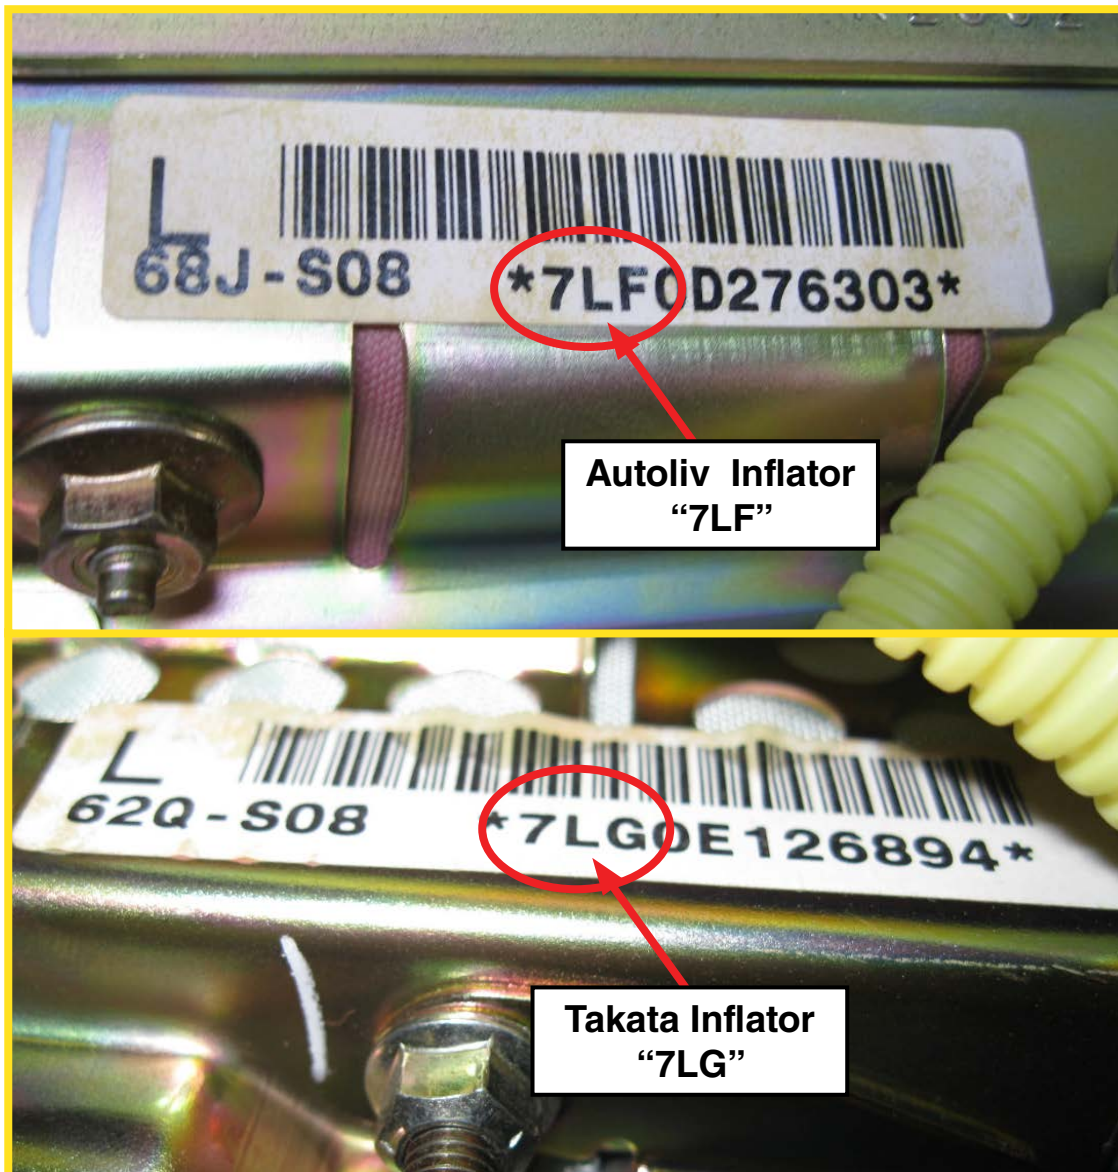
Label Detail

IMPORTANT NOTE: The **complete** 11-digit airbag module Serial Number **MUST** be recorded during inspection and entered into the Miscellaneous Detail field as part of the campaign completion / claim entry process.
