PRODUCT CAMPAIGN BULLETIN

<p>APPLICABILITY: 2003-2006 model year Baja 2003-2004 model year Legacy 2003-2004 model year Outback 2009-2011 model year Legacy 2009-2011 model year Outback 2009-2011 model year Forester 2006-2011 model year Tribeca 2006-2011 model year Impreza (including WRX and STI)</p>	<p>NUMBERS: TKA-16R TKB-16R TKC-16R</p> <p>DATE: 07/13/16</p> <p>REVISED: 09/27/16</p> <p>NHTSA ID: 16V-358 16V-359 16V-361</p>
---	---

SUBJECT: Takata Front Passenger Airbag Inflator Replacement

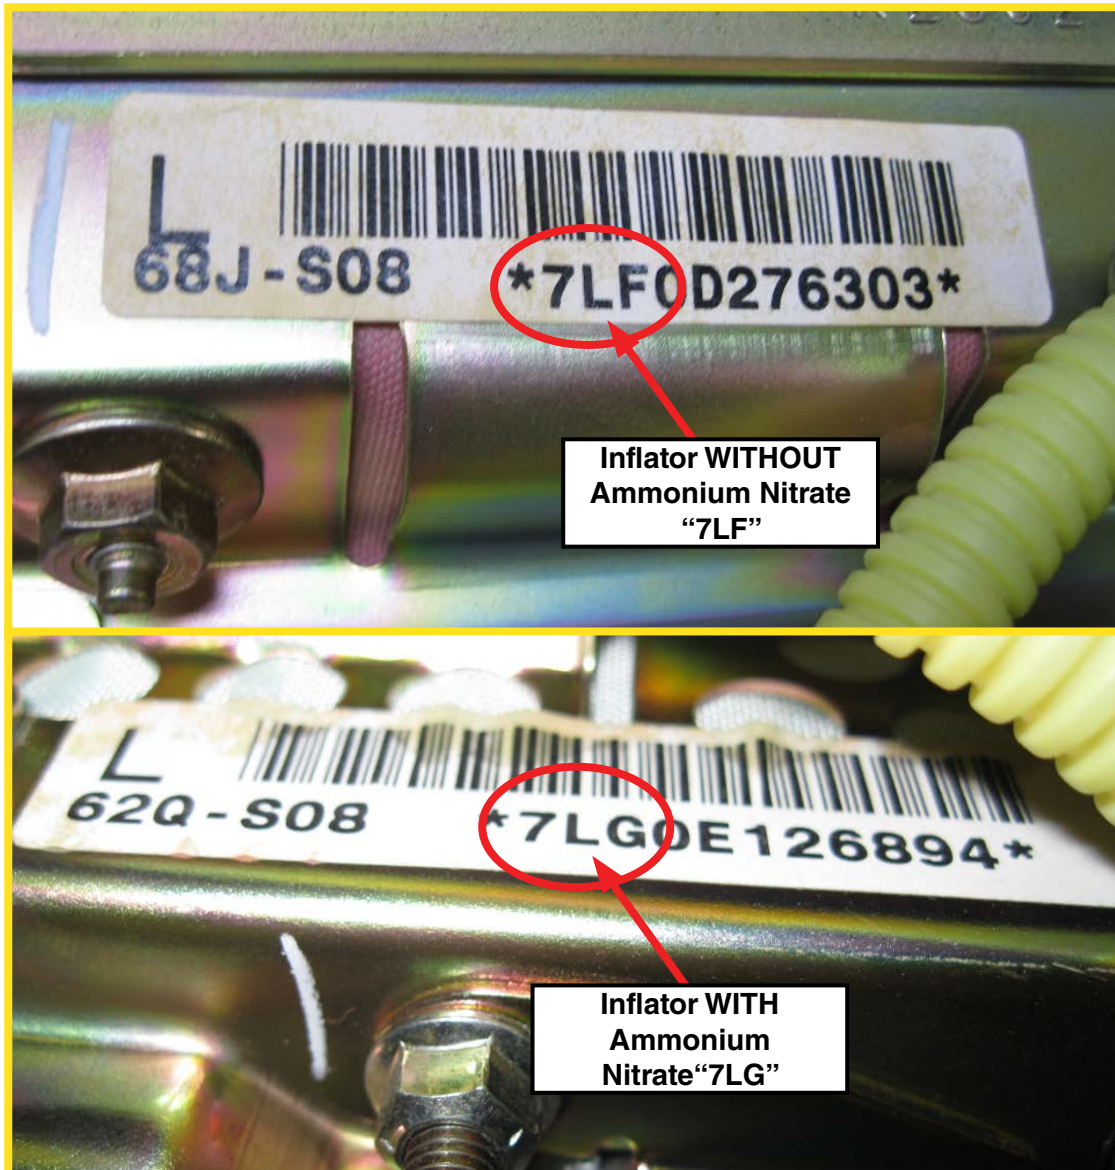
Label Detail

IMPORTANT NOTE: The **complete** 11-digit airbag module Serial Number **MUST** be recorded during inspection and entered into the Miscellaneous Detail field as part of the campaign completion / claim entry process.
