PRODUCT CAMPAIGN BULLETIN

<p>APPLICABILITY: 2003-2006 model year Baja 2003-2004 model year Legacy 2003-2004 model year Outback 2009-2011 model year Legacy 2009-2011 model year Outback 2009-2011 model year Forester 2006-2011 model year Tribeca 2006-2011 model year Impreza (including WRX and STI)</p>	<p>NUMBERS: TKA-16R TKB-16R TKC-16R</p> <p>DATE: 07/13/16</p> <p style="background-color: #f1c40f;">REVISED: 03/06/18</p> <p>NHTSA ID: 16V-358 16V-359 16V-361</p>
---	--

SUBJECT: Takata Front Passenger Airbag Inflator Replacement

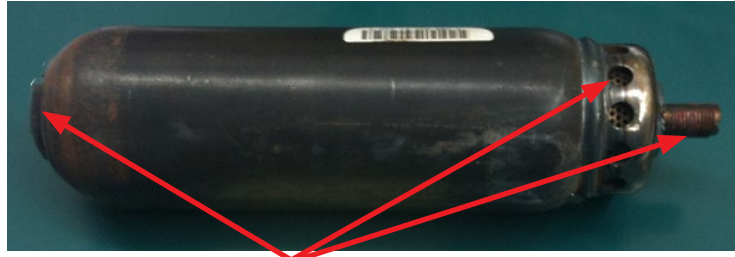
The shape, holes, and copper-colored stud indicate this not a Genuine Subaru inflator.

- Document the presence of the aftermarket or counterfeit device on the repair order and with photos. Report this information immediately on a Quality Monitoring Report (QMR). **IMPORTANT:** When entering a related QMR, use failure code ULF and **NOT** the campaign fail code.

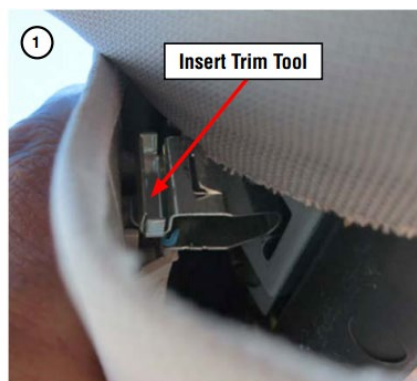
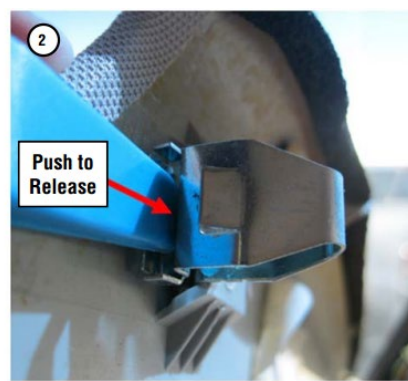
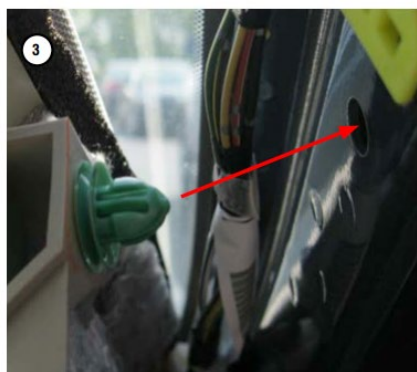
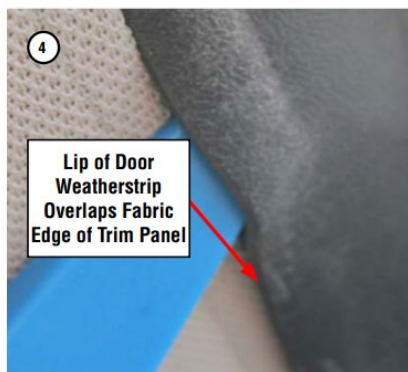
NOTE: When removing the “A” pillar trim, be **VERY CAREFUL** not to damage the upper metal retaining clip. The clip is located just below where the trim panel meets the head liner. If the metal retaining clip becomes damaged or separated from the trim panel, the trim panel **MUST** be replaced as the clip is not available separately. Use a plastic trim tool to push and release the upper portion of the metal clip from the body. Be careful to not pull the trim panel open any further than necessary to gain access for releasing the clip. There is a plastic retaining clip in the lower portion of the trim panel which will release easily once the upper retaining clip is loose. At reassembly and using a plastic trim tool, make sure the inner lip of the door weatherstrip overlaps the outer fabric edge of the trim panel to help secure it.

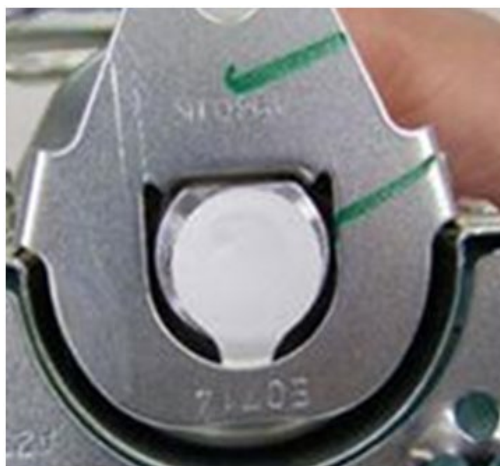
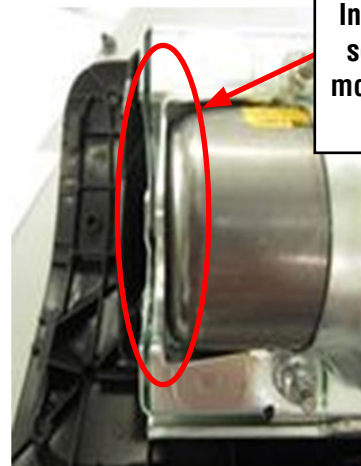
Inflator properly seated against mounting bracket (NO GAP)

STEP 9- Install the new inflator into the mounting bracket so the yellow taped end aligns with the removed stopper plate. Make sure the “D-shaped” portion of the inflator harness connector boss aligns with the “D-shaped” portion of the hole in the end of the mounting bracket as shown below. When properly installed, the end of the inflator will be seated tight against the mounting bracket. Do not peel the white harness connection dust cover at this time.

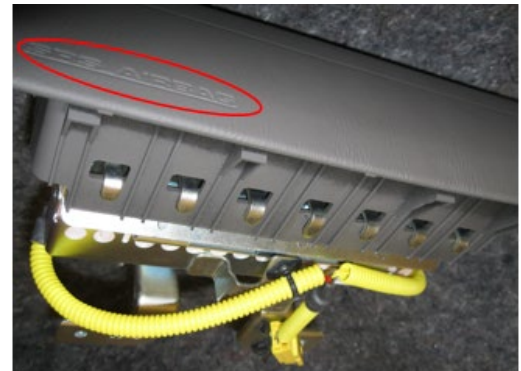
VERY IMPORTANT: Before removing the original trim cover / lid from the module, note the orientation of the cover in relation to the module as the module can be installed upside down in the cover. (TIP: The bottom or harness side goes toward the “SRS AIRBAG” side of the cover as shown.)

CAUTION: During cold temperatures always let the cover warm to room temperature before attempting claw removal. In all cases, limit any distortion of the airbag cover to avoid damaging it.

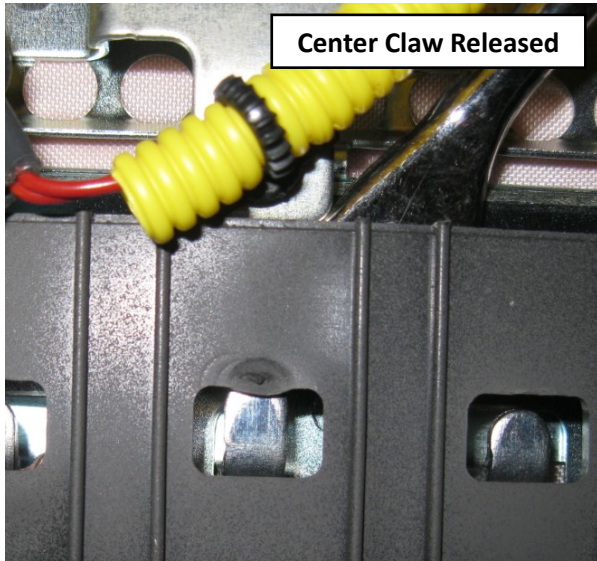
Center Claw Released

All Harness-Side Claws Released

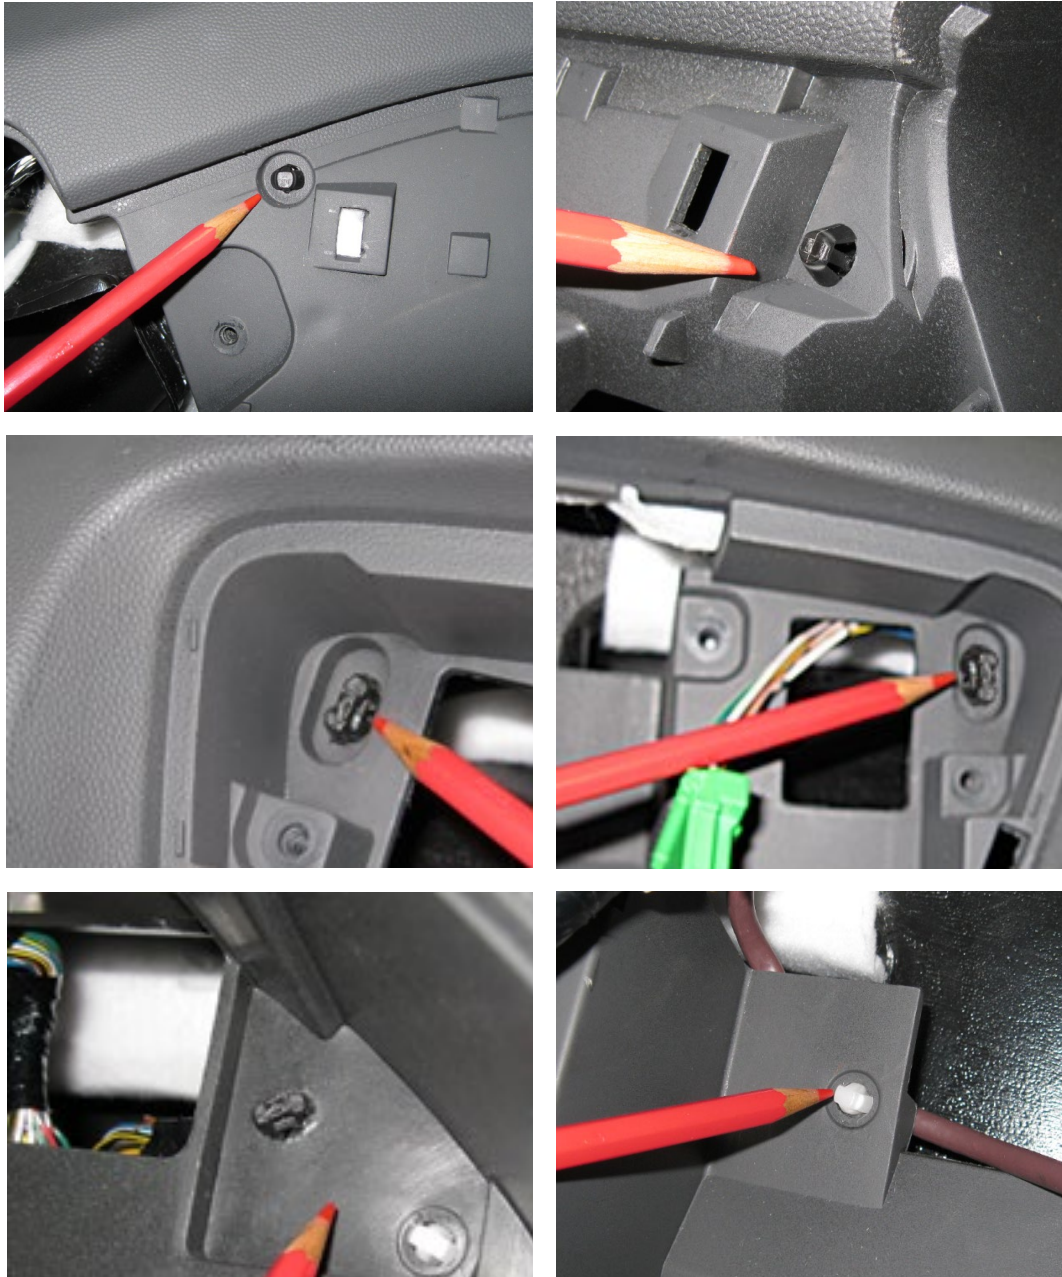
- Remove the harness connectors from components as needed to access the IP retaining screws as per the Service Manual. Release the harness retaining clips shown below using needle-nosed pliers and push them through to allow additional movement of the IP.

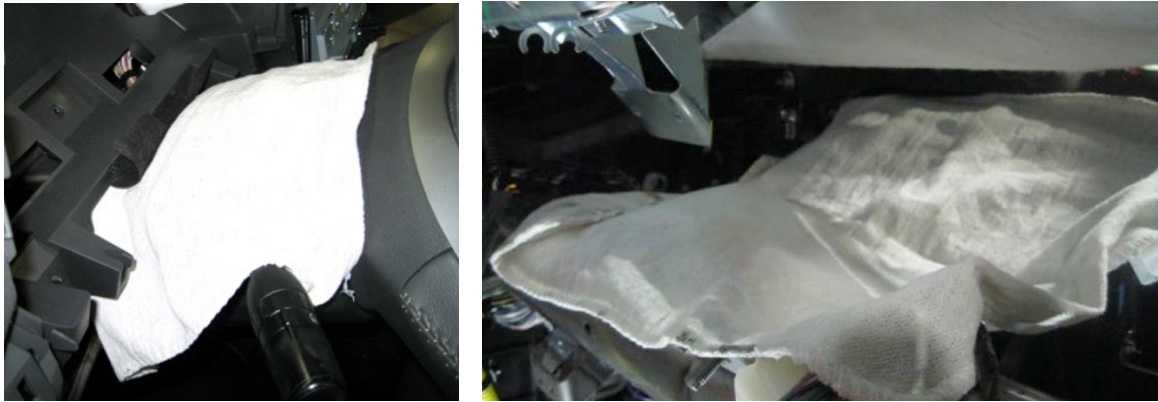
- **IMPORTANT:** Always cover the steering column cover to protect it along with the top of the HVAC blower case to keep out any removed hardware (e.g. airbag module retaining bolts) with clean shop cloth.

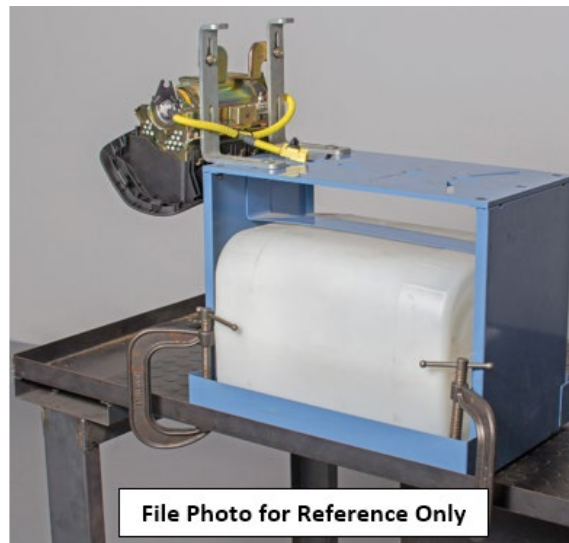
REMINDER: It is **STRONGLY RECOMMENDED** the removed airbag module **ALWAYS** be mounted to the Airbag Deployment Fixture (part number J-39401-B and file photo shown below) to better secure it during the inflator replacement procedure. When mounting the module to the fixture, pay close attention to the harness routing. Always perform this work in an area away from others to reduce chances of inadvertent injury should any deployment occur. Take your surroundings into account to avoid possible hazards should an inadvertent deployment occur or sources of static or other electricity that could potentially induce such a deployment.

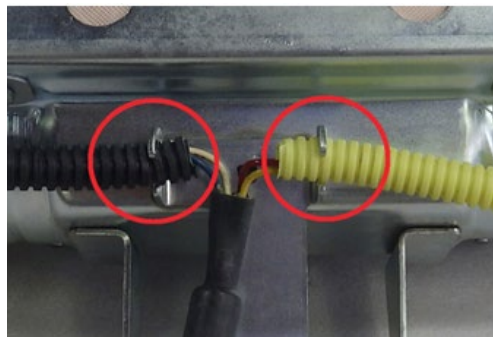
STEP 3- Remove both harness tubes from the retainer bracket.

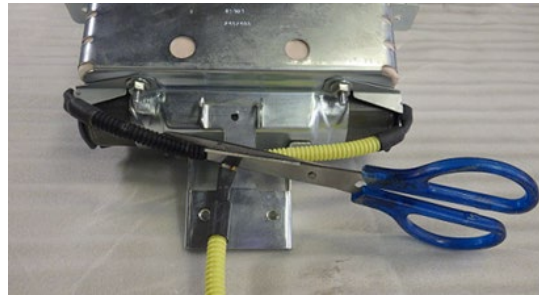
STEP 4- Using a scissor or wire cutter (no knives or razors) **CAREFULLY** cut the black harness cover tube (approximately 1 1/2 inches) enough to expose the blue and white wires inside. Provide enough room to install the Electro-Tap (shorting) connector.

TAKE YOUR TIME AND BE CAREFUL TO NOT CUT THE 2 WIRES!

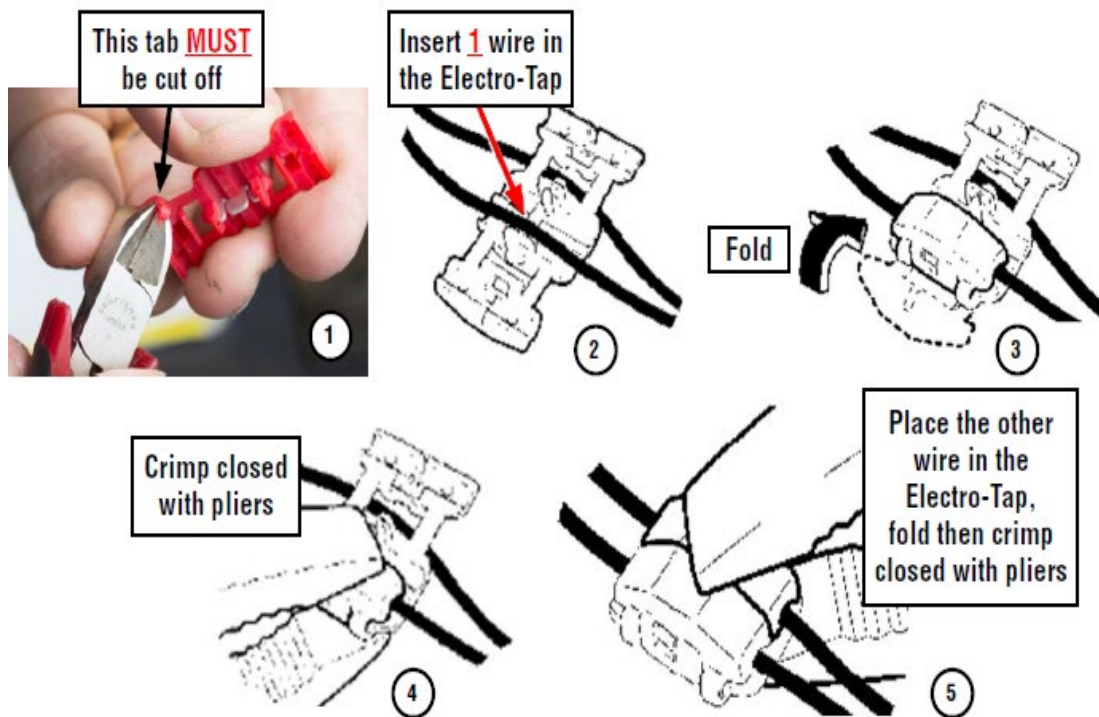
STEP 5- Short the blue and white wires together by installing the Electro-Tap connector. The connector creates a short circuit which acts as a safeguard to prevent against static discharge that may deploy the removed inflator. The tab portion of the Electro-Tap connector **MUST** be cut off prior to use to insure a good short-circuit is made as shown in the illustration below. **Follow the sequence below** for installing the Electro-Tap connector. Use pliers to squeeze closed the two sections of the connector together, **one section at a time**.

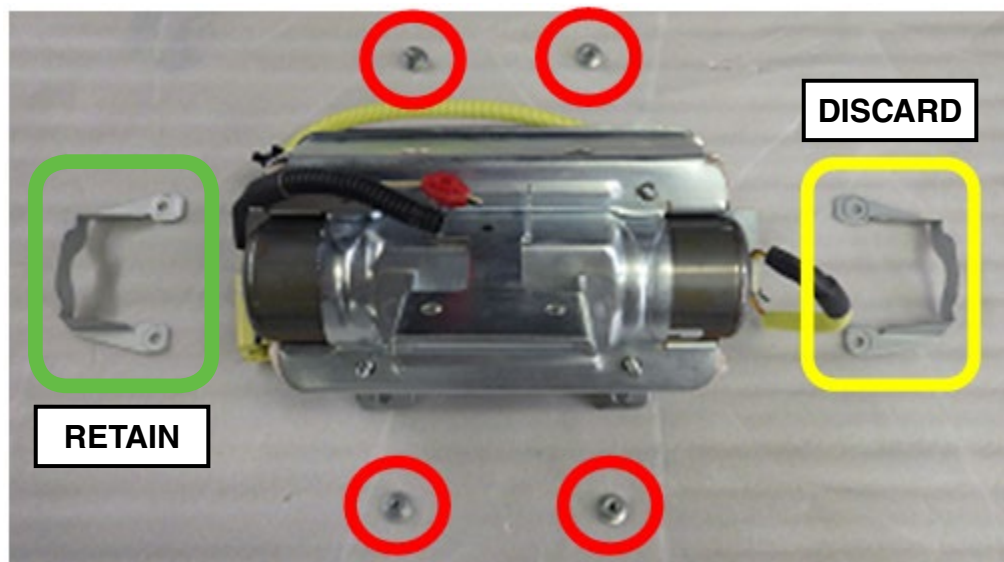
STEP 7- USING HAND TOOLS ONLY, loosen and remove the four (4) 10mm self-locking nuts along with both stopper plates. **RETAIN the stopper plate circled in GREEN** (Left-side bracket in image below) as it will be used during reassembly. Discard the removed stopper plate circled in **YELLOW** as it is no longer needed along with the 4 removed 10mm nuts.

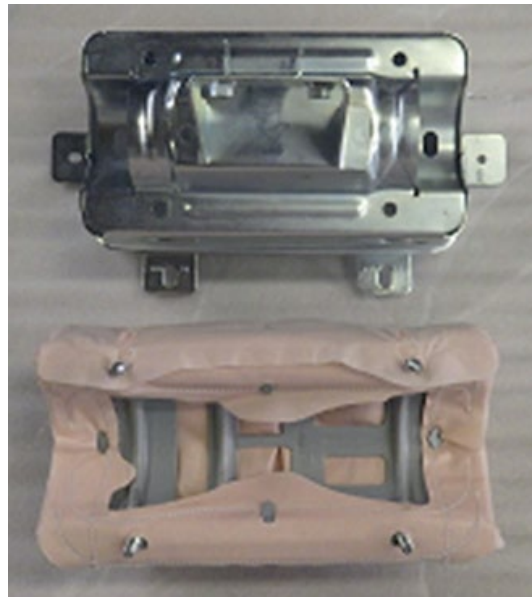
STEP 10- CAREFULLY remove the airbag from the mounting bracket (case).

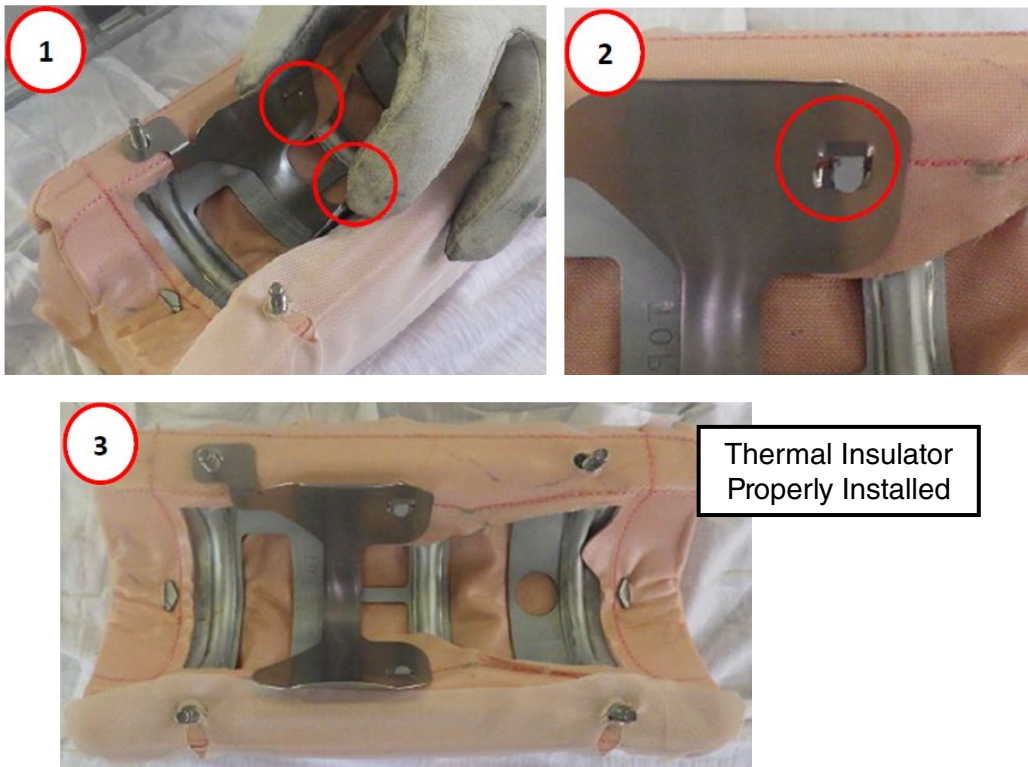
STEP 11- CAREFULLY install the black thermal insulator into the back (inflator) side of the airbag as shown in photo 1 below. **CAUTION:** Gloves are recommended when doing this as edges of the thermal insulator can be very sharp. **TAKE YOUR TIME** and do not bend or twist the insulator any more than necessary to make it fit. The insulator can only be installed in one direction as shown in photo 3 otherwise, the airbag will not fit back into the module frame properly. Confirm both retaining claws come through the corresponding insulator holes like the example shown in photo 2.

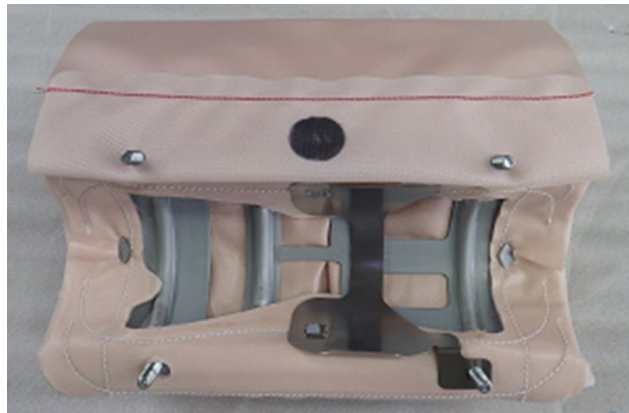
STEP 12- Install the protective sheet onto the studs of the airbag with the black mark in the position specified in the photo below. Due to the different spacing of the studs, the protective sheet will only fit properly when installed in this manner.

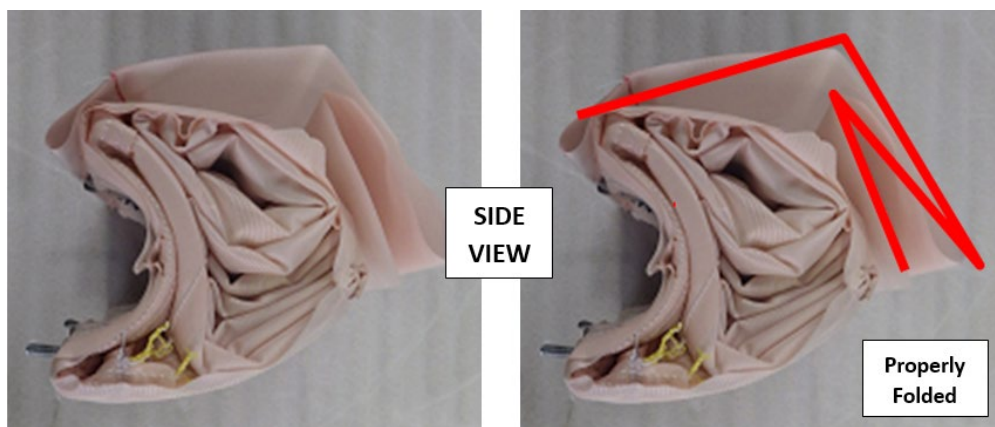
STEP 13- The protective sheet is properly installed when: **a)** it fits squarely on the studs, **b)** the black oval-shaped mark is facing up and **c)** the excess is laying over the top of the airbag and folded as shown in the side view photos below.

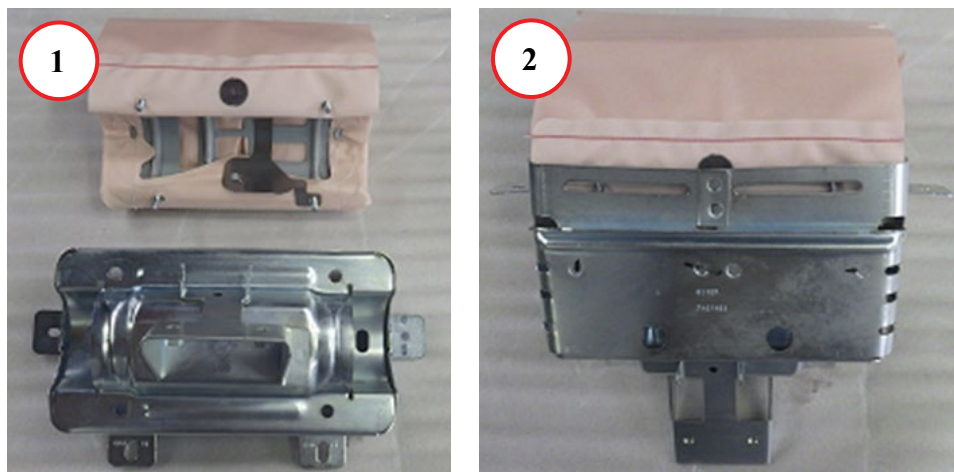
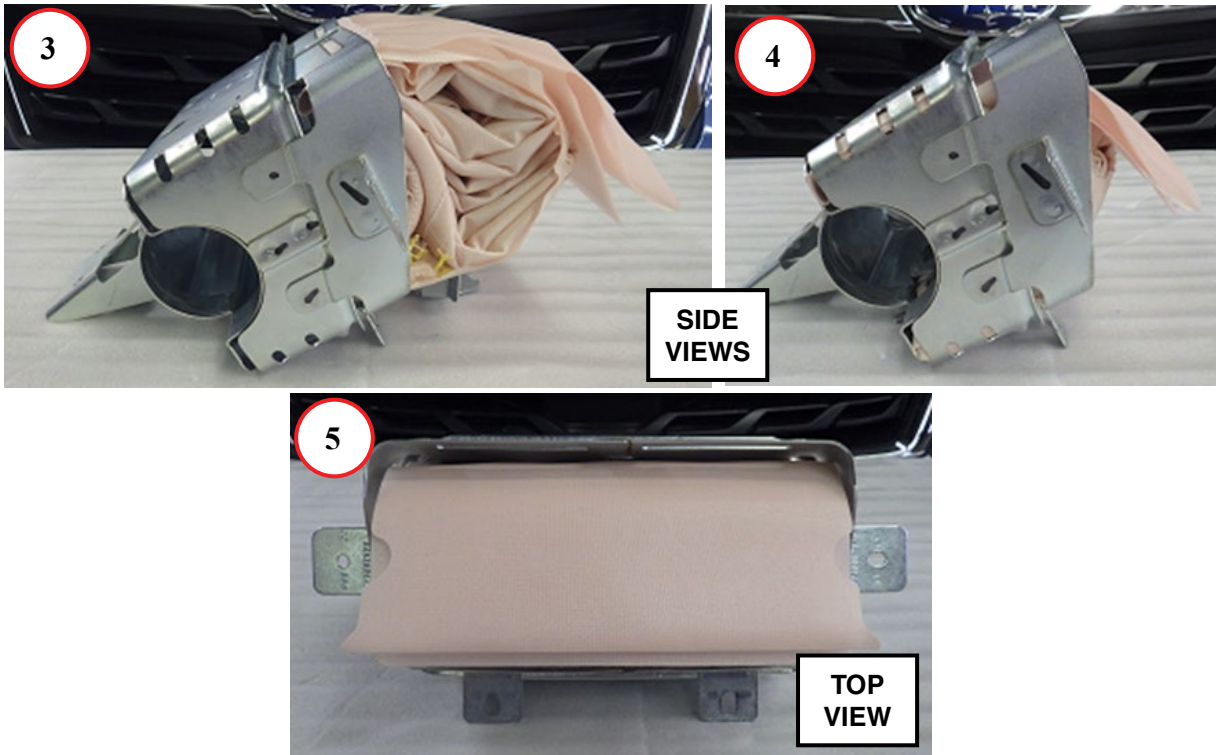
STEP 14- CAREFULLY refit the airbag back into the mounting bracket as shown in the sequence below.

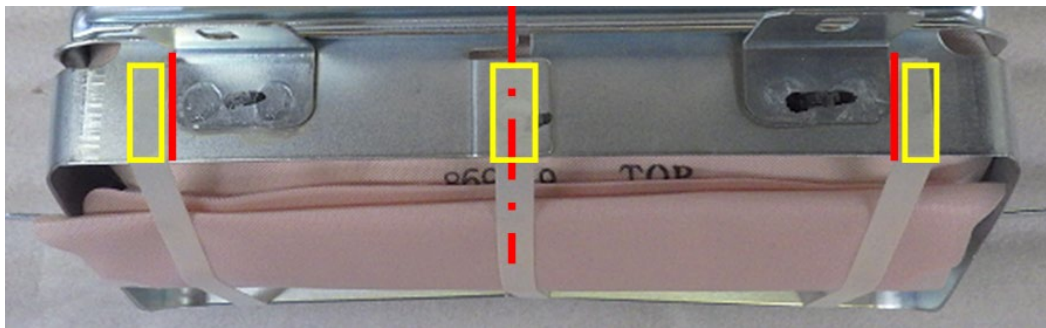
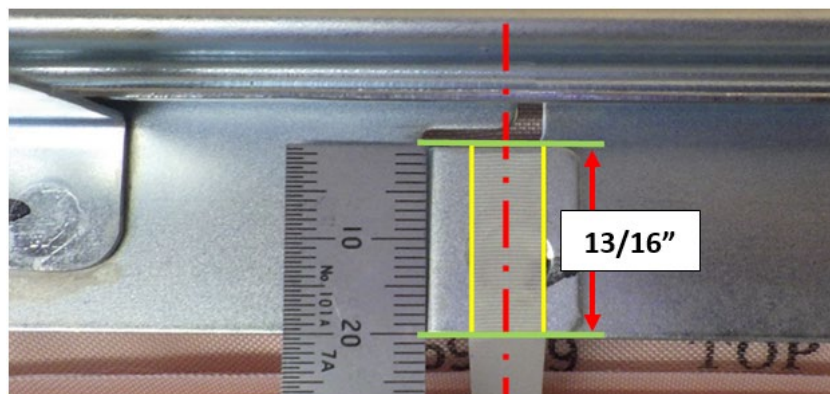
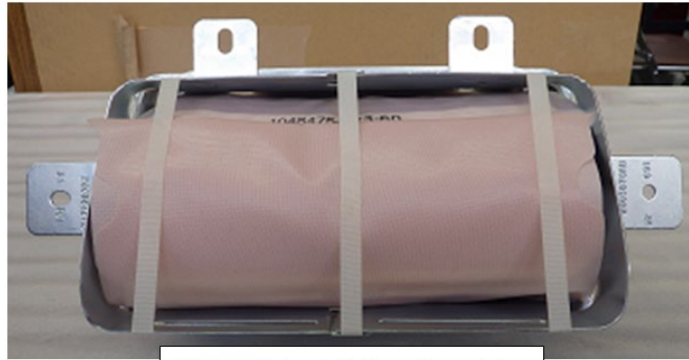
STEP 15- Apply the 3 anti-wrinkling tapes to the module frame as shown below to retain the protective sheet. The yellow rectangles represent the tapes and the red lines indicate where the tapes are to be positioned. Approximately 200mm (13/16") from each end of the 2tape should be applied to the module frame.

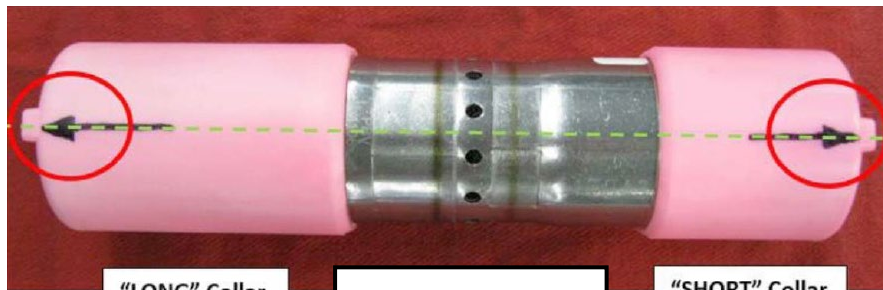
STEP 16- Inspect the new inflator to confirm the locating protrusions on each of the pink collars are aligned as shown below. The “short” collar can be rotated as needed to align it with the protrusion on the “long” collar if necessary.

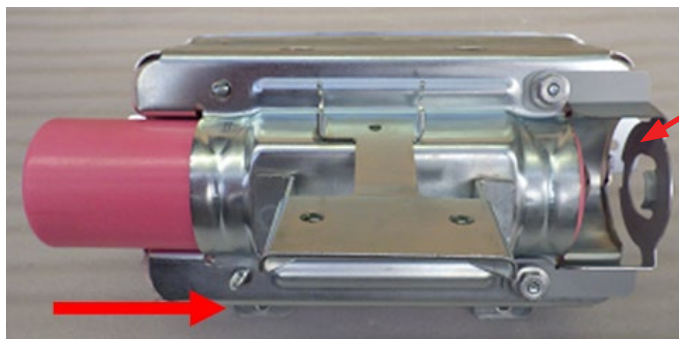
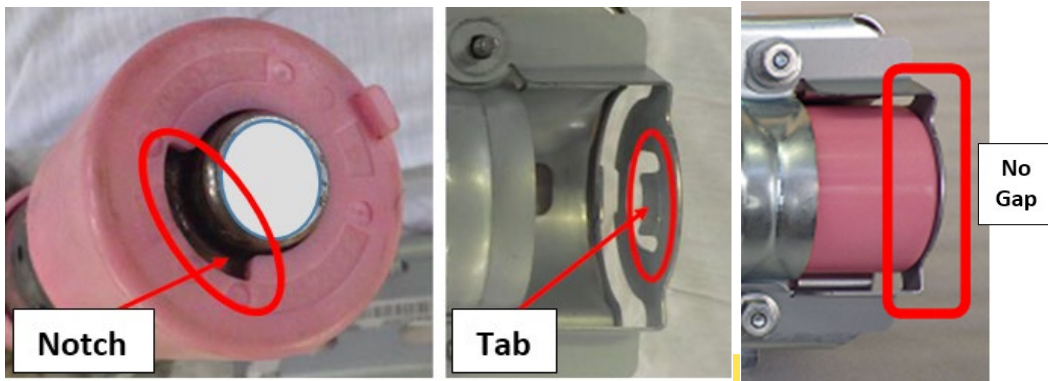
New Stopper Plate Supplied with Kit.

STEP 18- Slide the new inflator back into the mounting bracket, short collar end first. Align the tab on the new stopper plate with the notch on the end of the collar. When properly installed, the inflator will be tight against the stopper plate with no gap.

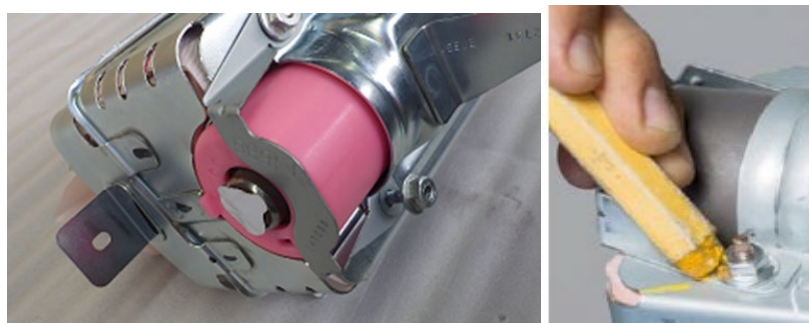
STEP 19- Reinstall the original (retained from **STEP 7**) stopper plate and the other 2 **NEW** self-locking nuts. **SLOWLY** tighten (to prevent over-tightening) while making sure both stopper plates stay tight against both ends of the inflator. **HAND TOOLS ONLY!** Torque the nuts to 31-38 inch-pounds. When complete, use a marker to indicate they have been fully tightened.

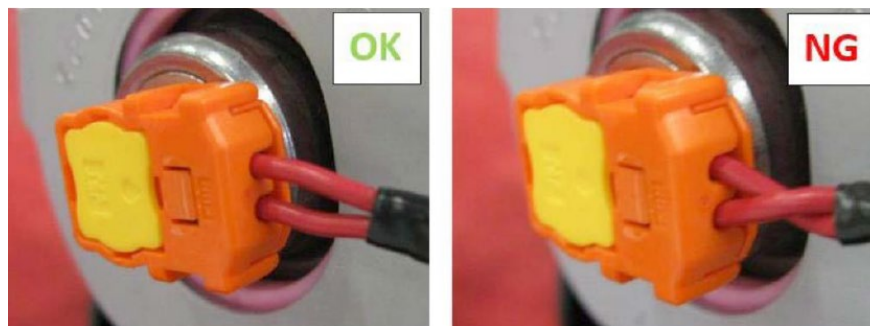
BEFORE connecting the harness to the inflator, make sure the harness is not twisted as shown below.

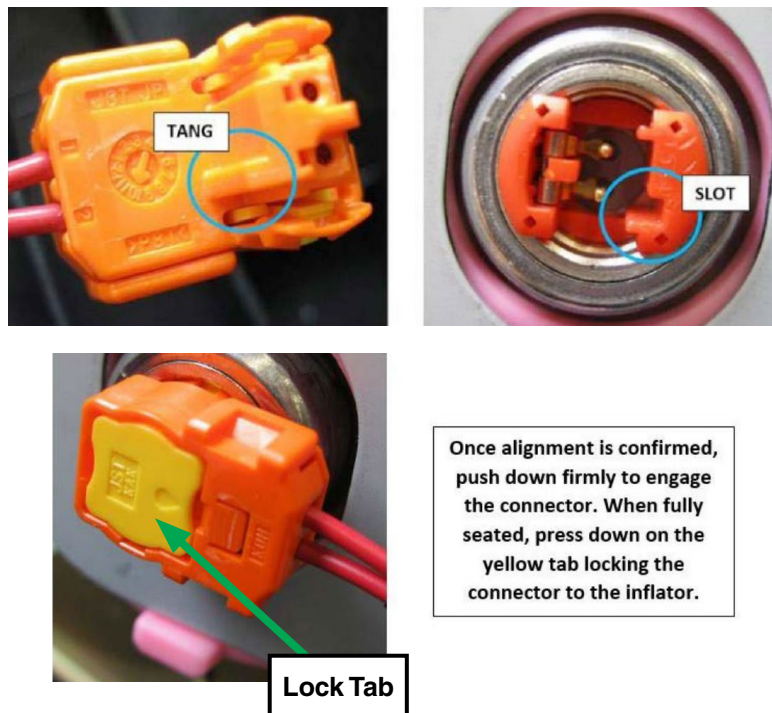
CAREFULLY align the tang of the inflator with the slot on the inflator harness connector as shown below. Push down firmly on the yellow lock tab to engage the connector's locking claws into the groove inside the connector boss on the inflator end. Confirm the connector is locked by prying up **LIGHTLY** with a small flat-blade screwdriver. Repeat the procedure on the opposite end.

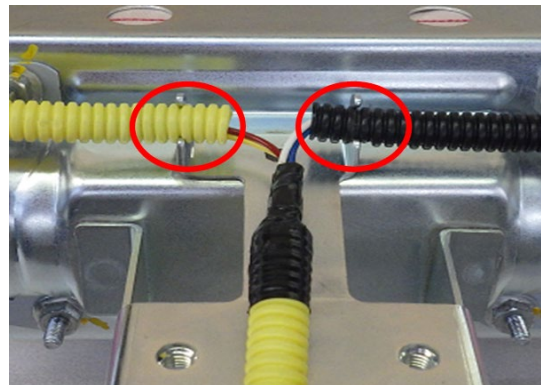
STEP 21- After connecting both sides of the harness, refit the harness cover tube back into the retaining bracket.
