## PRODUCT CAMPAIGN BULLETIN

**NUMBERS:** TKA-16R  
 TKB-16R  
 TKC-16R  
**DATE:** 07/13/16  
**REVISED:** 01/05/17  
**NHTSA ID:** 16V-358  
 16V-359  
 16V-361

**SUBJECT:** Takata Front Passenger Airbag Inflator Replacement

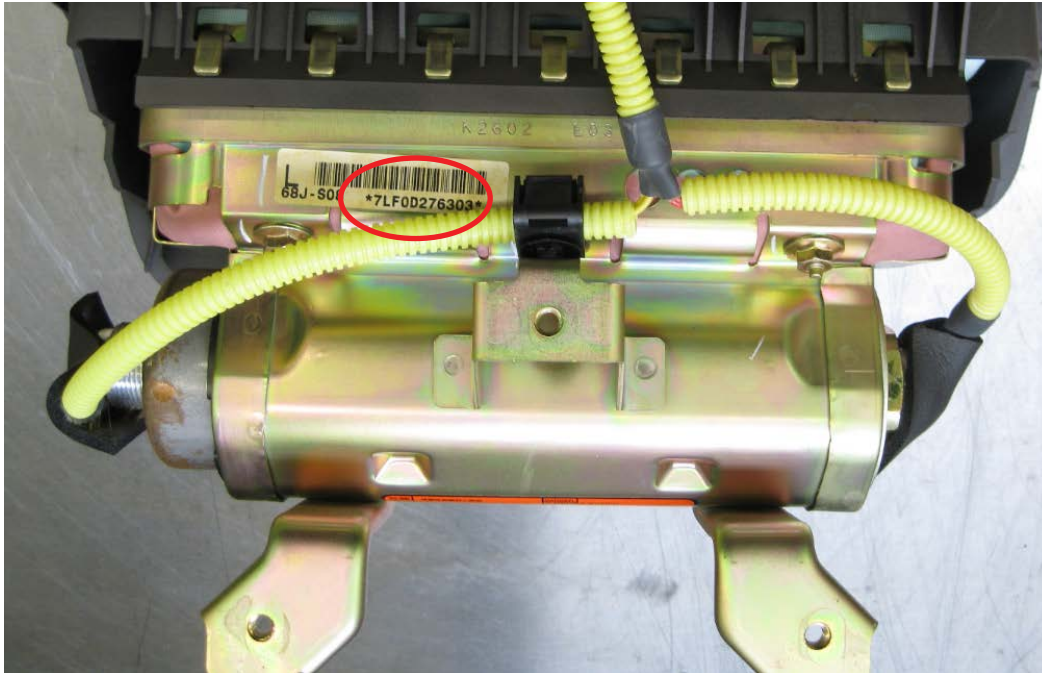
**Inflator WITHOUT Ammonium Nitrate- Serial Number Label Location (2003 Legacy, Outback and Baja models only):** Record this 12-digit number for claims purposes.

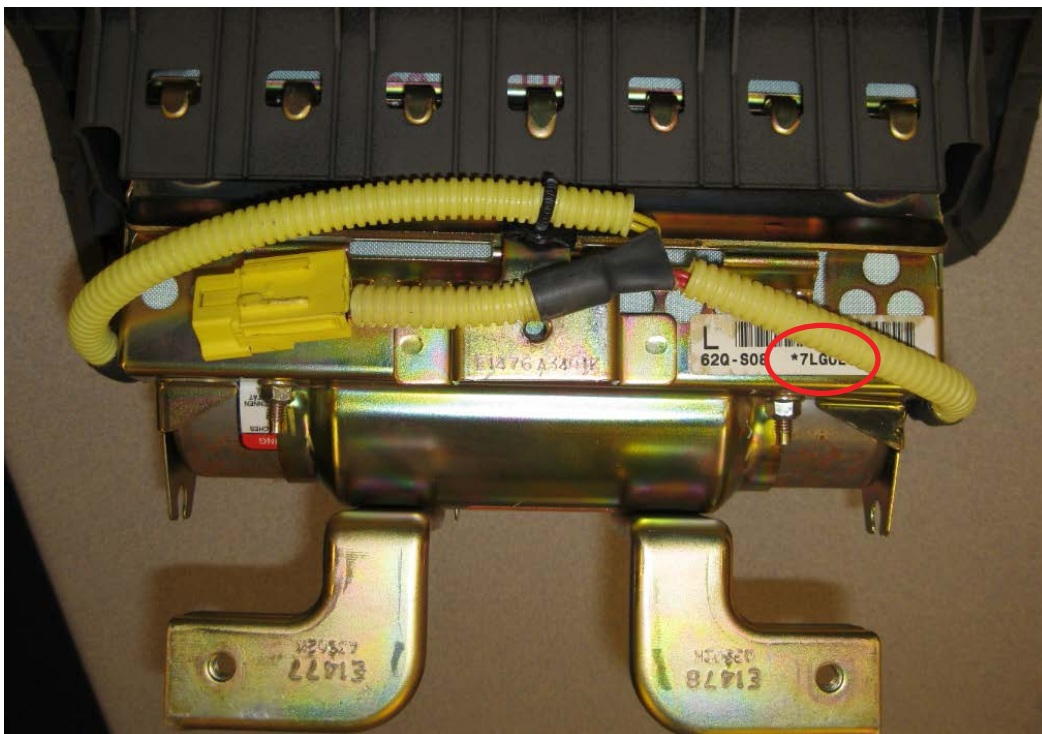
**Inflator WITH Ammonium Nitrate- Serial Number Label Location**

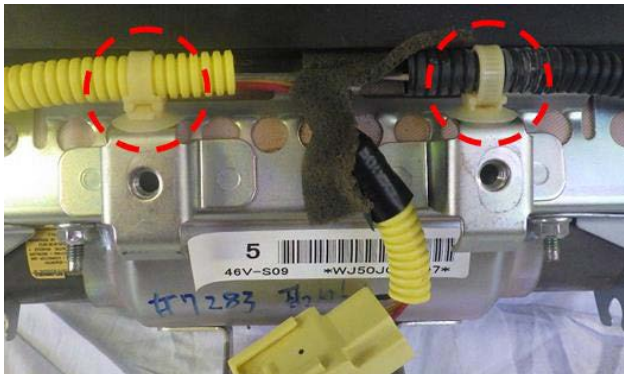
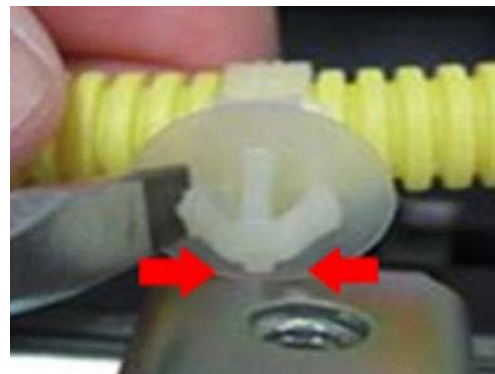
**STEP 2-** Peel the sponge tape and remove the harness clips from the retainer bracket by pushing the tangs inward with a flat-blade screwdriver as shown below. Always remove any sponge tape adhesive residue from the airbag mounting bracket using mild solvent on a clean shop cloth.

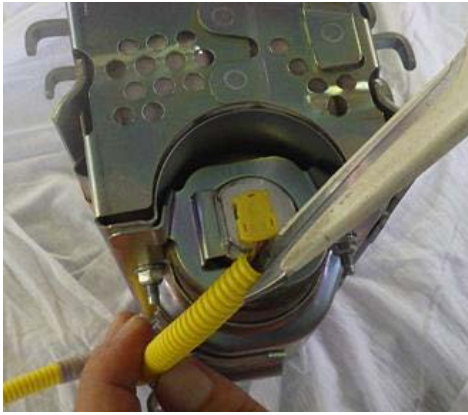
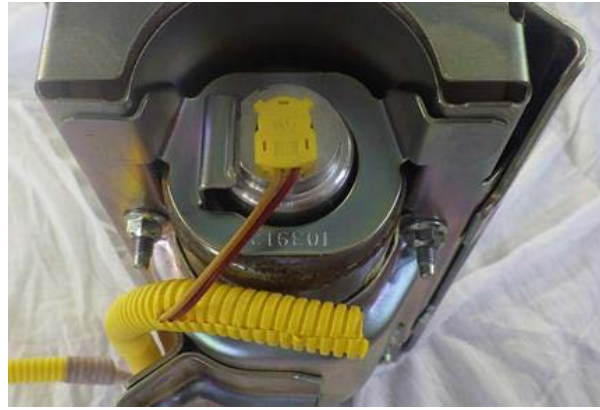
**STEP 3-** Using a scissor or wire cutter (no knives or razors) **CAREFULLY** cut the yellow harness cover tube (approximately 1 1/2 inches) enough to expose the red and yellow wires inside and provide enough room to install the Electro-Tap (shorting) connector.

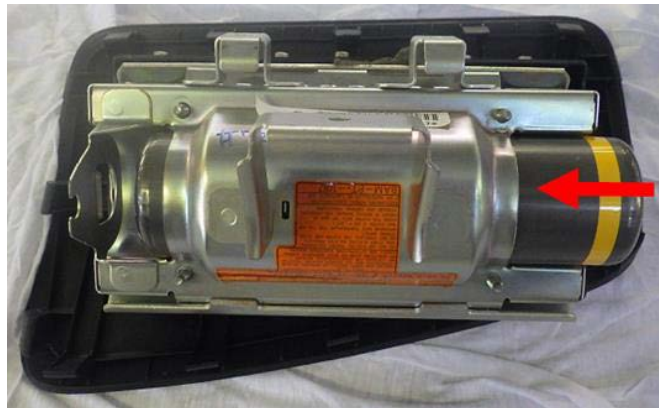
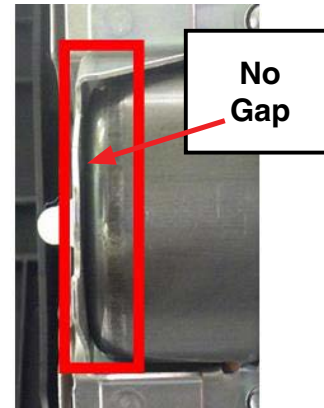
**STEP 9-** Install the new inflator into the mounting bracket so the yellow taped end will align with the stopper plate when reinstalled on the mounting bracket. When properly installed, both ends of the inflator will be seated tight against the stopper plates with no gaps.

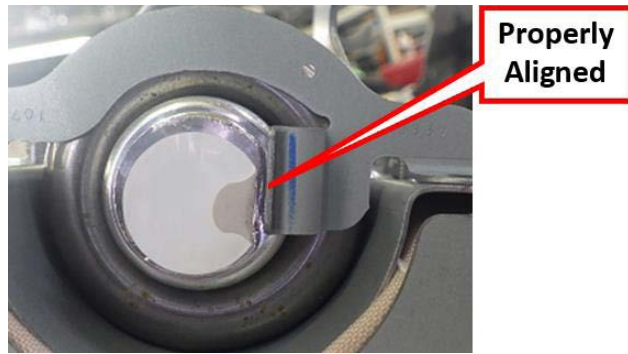
Make sure the “D-shaped” portion of the inflator harness connector boss aligns with the “D-shaped” portion of the original stopper plate as shown below. **Do not peel the white harness connection dust cover at this time.**

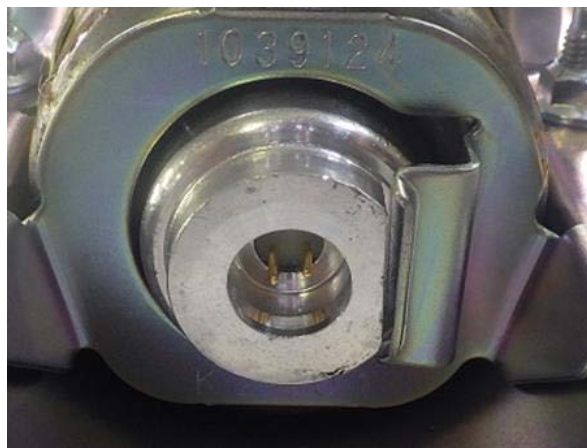
**STEP 11-** Peel the white dust cover from the d-shaped end of the new inflator. The new inflator wiring harness has 2 “sides” with round 2-pin connectors on both ends. The side with the yellow harness tube and red / yellow wires will connect to the end of the inflator with the “D-shaped” wiring harness connector boss as shown below. Peel the white dust cover from the “D-shaped” end of the inflator **ONLY**.

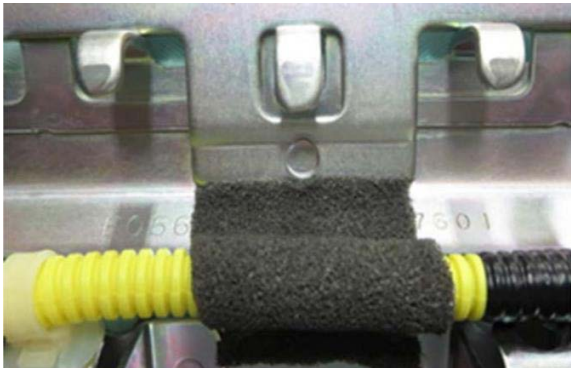
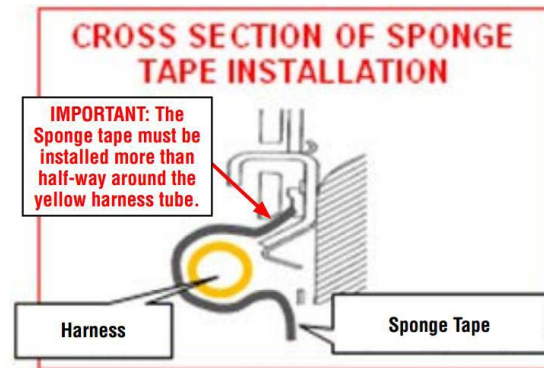
**STEP 12-** Peel the adhesive backing and install the new sponge tape onto the yellow harness tube first then adhere it to the airbag mounting bracket as shown in the illustrations below.

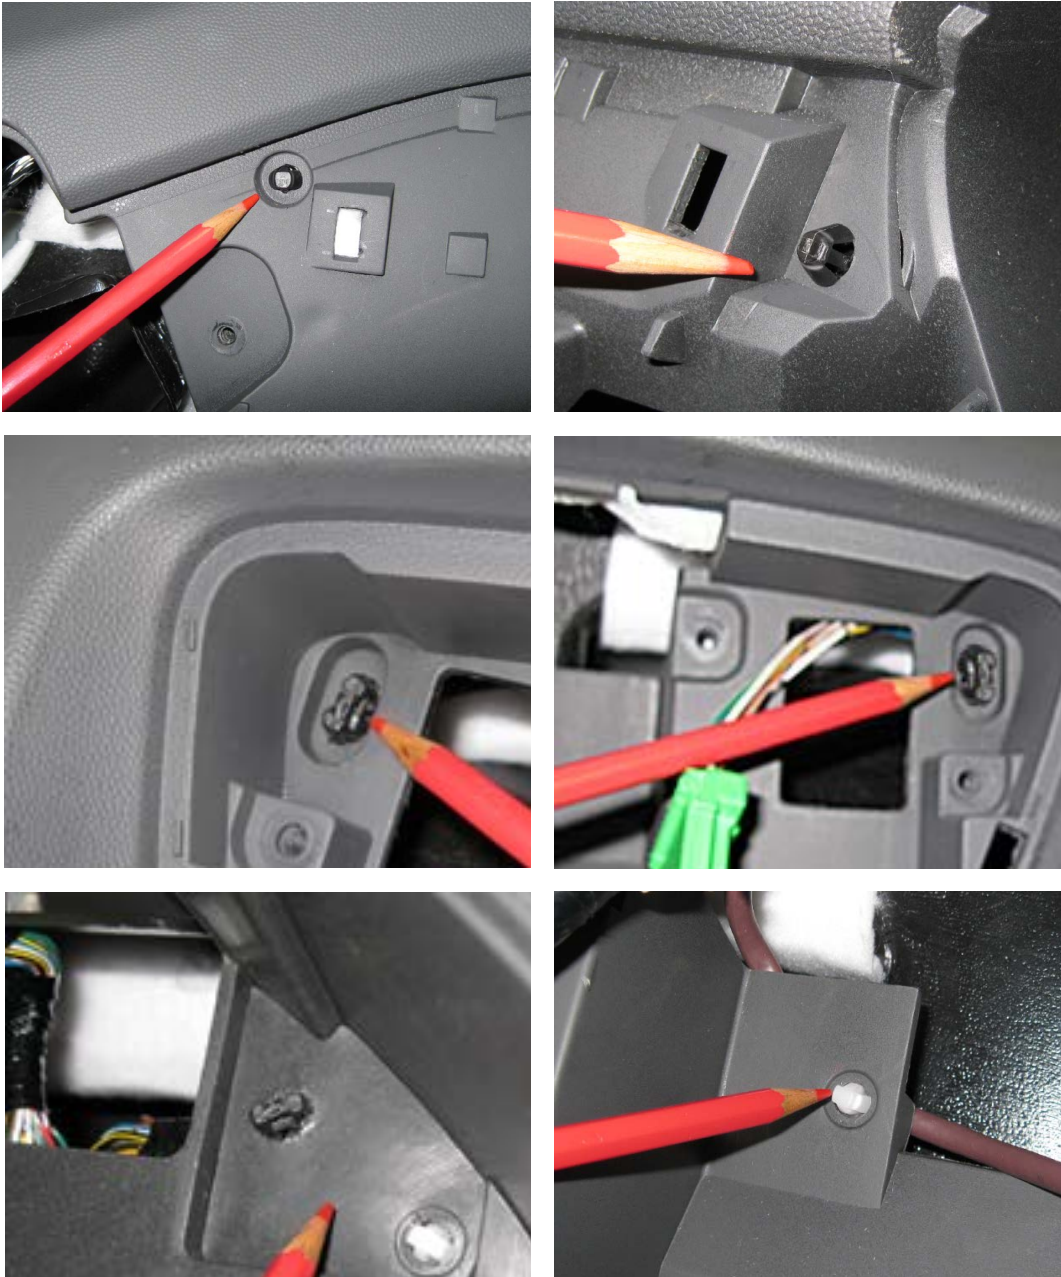
- Remove the harness connectors from components as needed to access the IP retaining screws as per the Service Manual. Release the harness retaining clips shown below using needle-nosed pliers and push them through to allow additional movement of the IP.

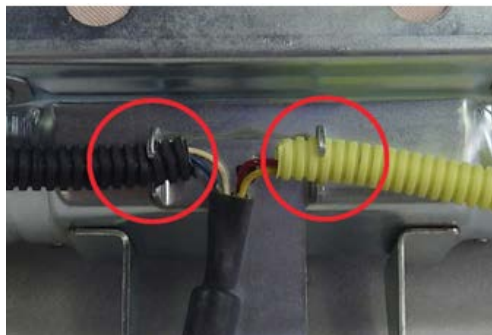
**STEP 3-** Remove both harness tubes from the retainer bracket.

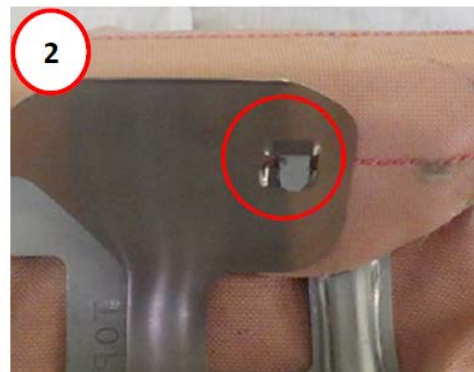
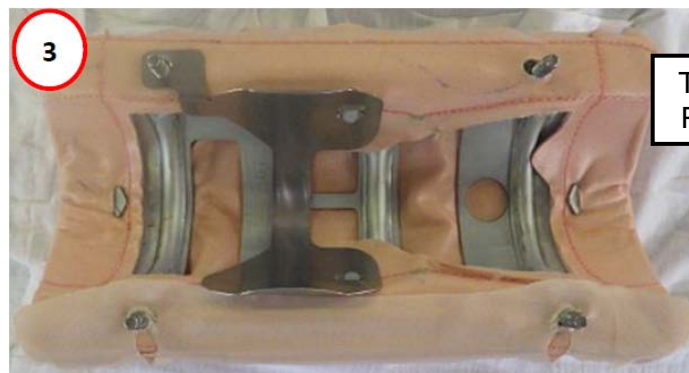
Thermal Insulator  
Properly Installed

**STEP 11- CAREFULLY** install the black thermal insulator into the back (inflator) side of the airbag as shown in photo 1 below. **CAUTION:** Gloves are recommended when doing this as edges of the thermal insulator can be very sharp. **TAKE YOUR TIME** and do not bend or twist the insulator any more than necessary to make it fit. The insulator can only be installed in one direction as shown in photo 3 otherwise, the airbag will not fit back into the module frame properly. Confirm both retaining claws come through the corresponding insulator holes like the example shown in photo 2.

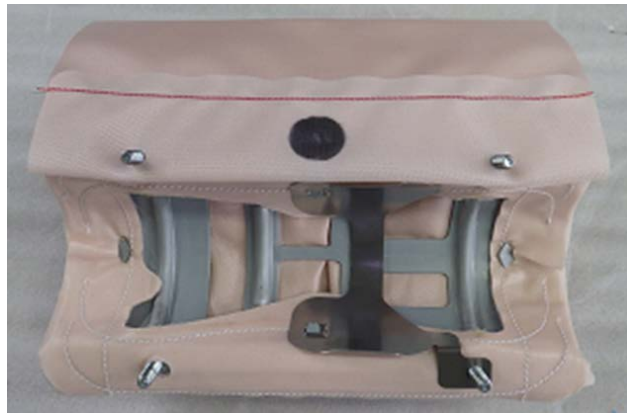
**STEP 12-** Install the protective sheet onto the studs of the airbag with the black mark in the position specified in the photo below. Due to the different spacing of the studs, the protective sheet will only fit properly when installed in this manner.

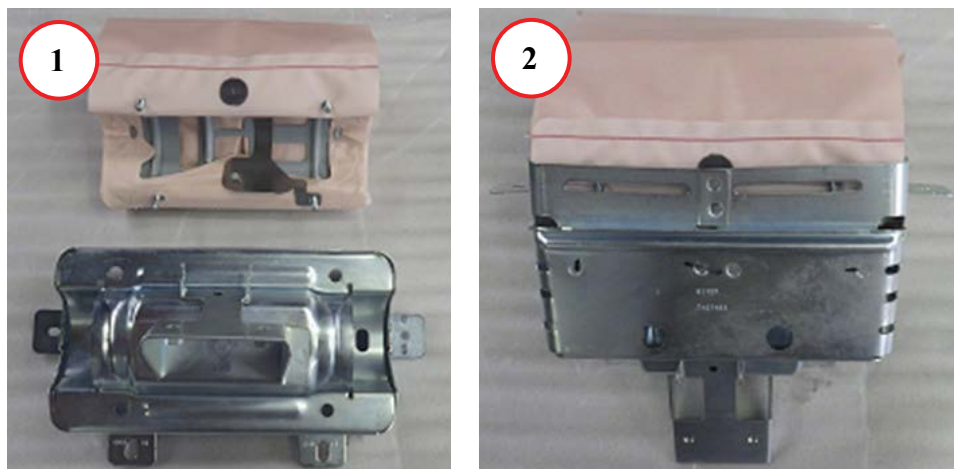
**STEP 14- CAREFULLY** refit the airbag back into the mounting bracket as shown in the sequence below.
