**PRODUCT CAMPAIGN BULLETIN**

<p><b>APPLICABILITY:</b> 2003-2006 model year Baja          2003-2004 model year Legacy          2003-2004 model year Outback          2009-2011 model year Legacy          2009-2011 model year Outback          2009-2011 model year Forester          2006-2011 model year Tribeca          2006-2011 model year Impreza (including WRX and STI)</p>	<p><b>NUMBERS:</b> TKA-16R          TKB-16R          TKC-16R</p> <p><b>DATE:</b> 07/13/16</p> <p style="background-color: #ffc107;"><b>REVISED:</b> 04/21/17</p> <p><b>NHTSA ID:</b> 16V-358          16V-359          16V-361</p>
---	--

**SUBJECT:** Takata Front Passenger Airbag Inflator Replacement

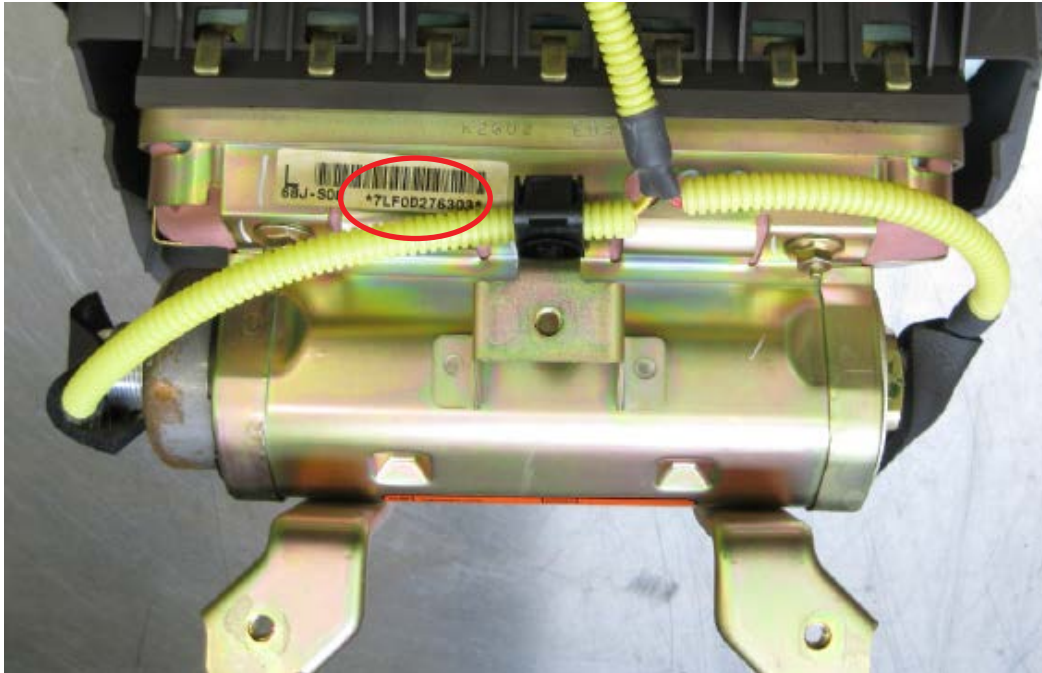
**Inflator WITHOUT Ammonium Nitrate- Serial Number Label Location (2003 Legacy, Outback and Baja models only): Record this **11-digit** number for claims purposes.**

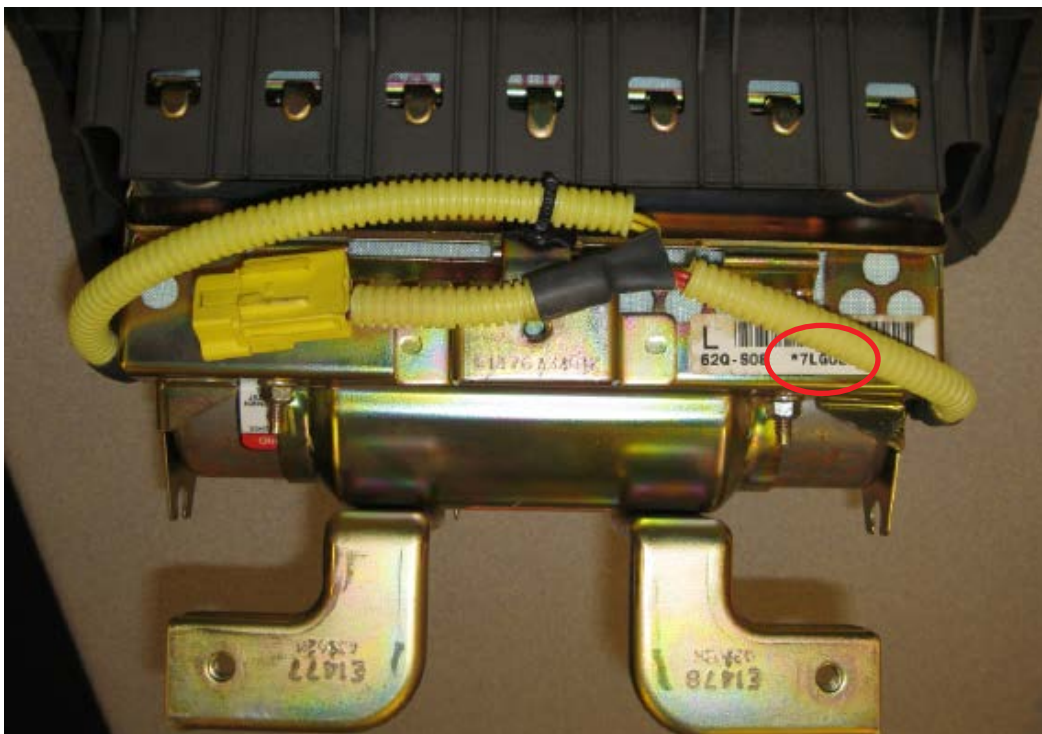
**Inflator WITH Ammonium Nitrate- Serial Number Label Location**

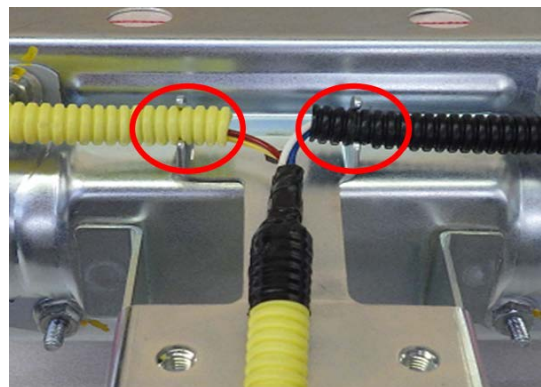
**STEP 21-** After connecting both sides of the harness, refit the harness cover tube back into the retaining bracket.

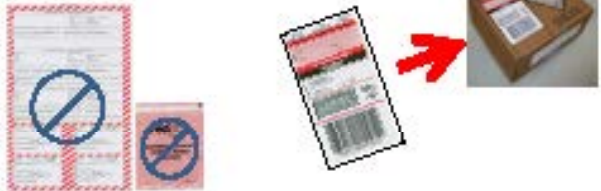
1. Peel off the backing of the FedEx Ground PEP Shipping label and stick to top of box to left of the Class II label.
- Use the scribe line on the box as a guide
- The FedEx-Ground PEP Shipping label must not touch any portion of the printing to the right of the scribe line.
2. Discard the remaining Documentation
3. Do Not contact FedEx.

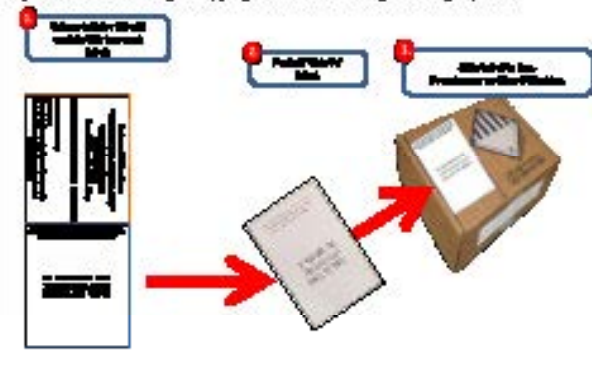
#### 4a. Shipping Instructions – Label each Box

a) New Labels will begin shipping in each IR starting with August, 2025
