# Service Bulletin No. 433B

<i>MODEL</i>	<b>J4500 Series</b>	<i>TYPE</i>	<b>Field Change Program</b>	<i>SECTION/GROUP</i>	<b>3-Body</b>	<i>DATE</i>	
<i>SUBJECT</i>	<b>WINDOW MOUNTING HARDWARE</b>						
<i>CONDITIONS</i>

Ref. MCI NHTSA Recall No.:16V-XXX

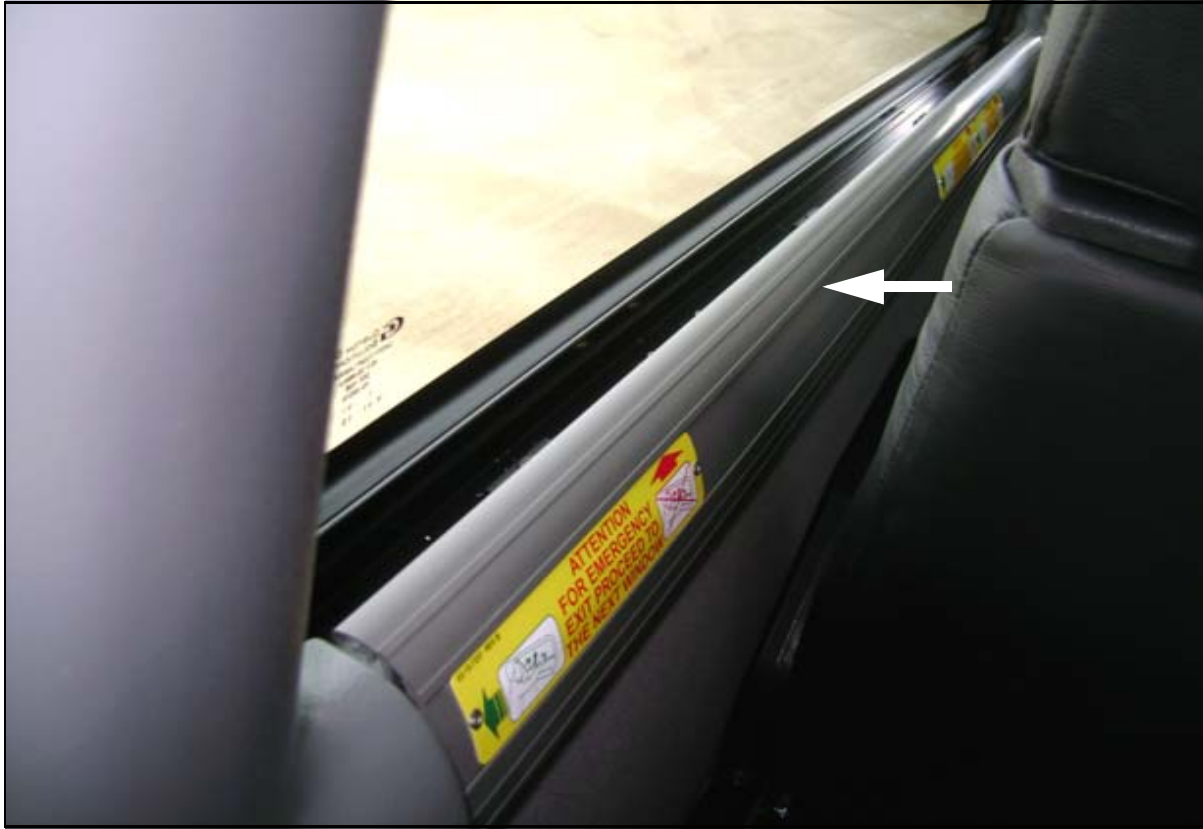
Figure 2.

1. Turn the main battery disconnect to the OFF position.
2. Chock both sides of the tires.
3. Enter the coach cabin.
4. Locate the gray handle cover on window number #2 ( refer to window layout in Figure 1 )
