Technical Service Bulletin

16-01-037

**2015
GENESIS SEDAN (DH)****SUBJECT:****GENESIS SEDAN (DH) SUPER VISION CLUSTER LOGIC UPDATE
(RECALL 147)****★ IMPORTANT******* Dealer Stock and Retail Vehicles *****

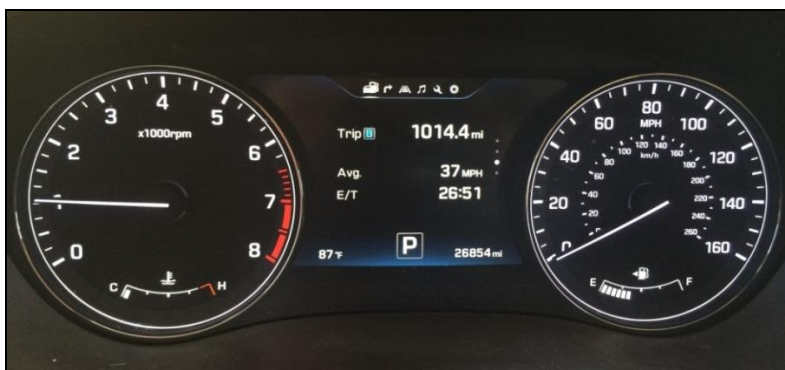
Description: Certain Model Year 2015 Hyundai Genesis sedans are equipped with a 7 inch TFT-LCD (Thin Film Transistor LCD) type cluster and AVN (8" Navigation). Some affected clusters may exhibit one or more of the following symptoms:

- All warning lights illuminating
- Speedometer reading inaccurate
- No cluster illumination
- Turn signal indicators not illuminating when turn signals are activated
- Momentarily inoperative instrument cluster
- Malfunctions of the tachometer and odometer

Any one or combination of the above conditions present can increase the risk of a crash. This bulletin describes the service procedure to update the instrument cluster logic to correct the above conditions.
