HYUNDAI NEW THINKING. NEW POSSIBILITIES. Technical Service Bulletin	GROUP RECALL	NUMBER 16-01-040-1
	DATE OCTOBER 2016	MODEL(S) SONATA (LF)
SUBJECT: DRIVER AIRBAG (DAB) REPLACEMENT (RECALL CAMPAIGN 148)

This TSB supersedes TSB 16-01-040 to revise the DAB manufacturing date in the Parts Information Table.

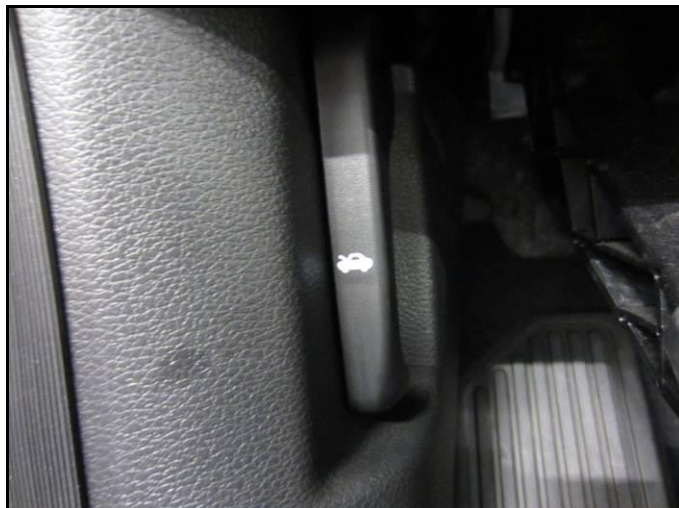
1. If applicable, record the customer's radio preset stations for AM/FM/XM.
2. Pull hood release to open the hood to access the battery.

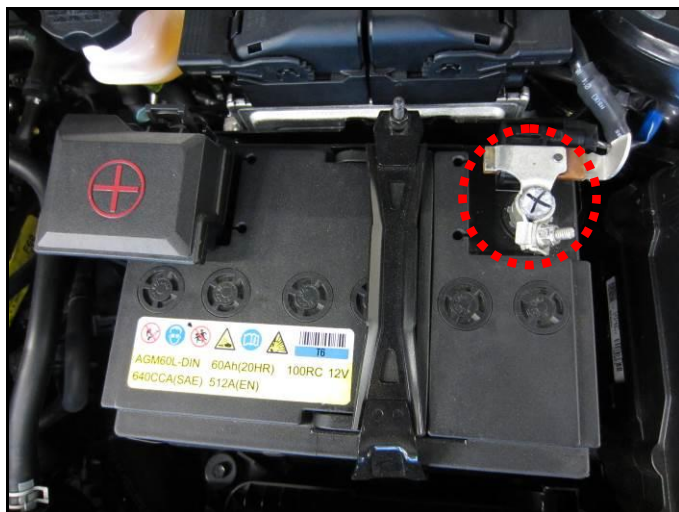
3. Disconnect the negative battery terminal and wait at least **3 minutes** prior to performing the Driver Airbag (DAB) replacement procedure.

4.0 ~ 6.0 N.m (0.4 ~ 0.6 kgf.m, 3.0 ~ 4.4 lb-ft)

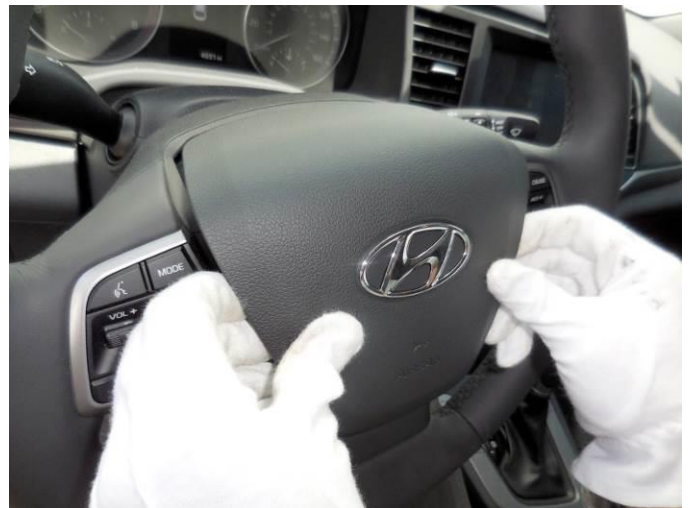
7. Disconnect the squib and horn connectors and remove the Driver Airbag (DAB) from the steering wheel.

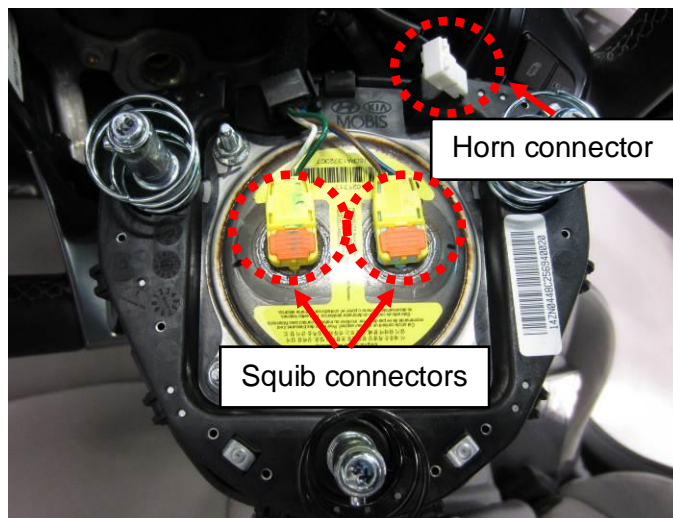
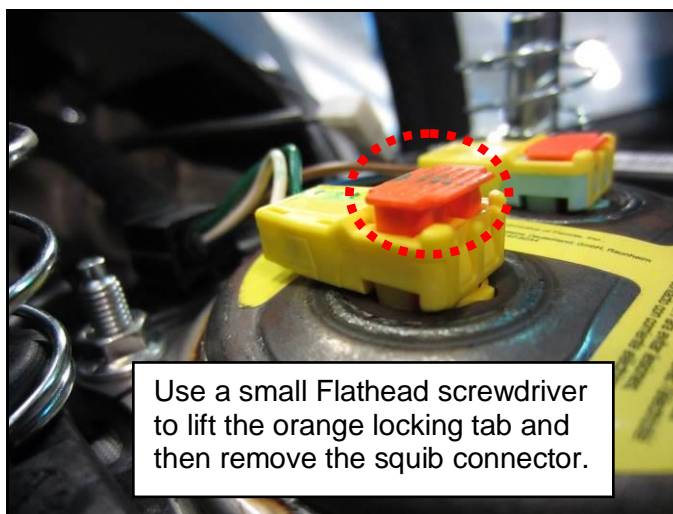
The removed airbag module should be stored in a clean, dry place with the pad cover facing up.

8. Install the new driver airbag module in the reverse order of removal, ensuring that the module is fully seated to the steering wheel (all 3 snap fit pins will click into position and airbag module will be flush with the steering wheel).
