Safety Recall

Code: 20Y6

Subject	Suction Pump
Release Date	December 21, 2016
Revision Summary	Certain work instruction steps have been modified to help technicians avoid consequential damage during this repair.
Affected Vehicles	U.S.A. & CANADA: 2015-2016 MY Volkswagen Golf, GTI & Golf SportWagen <i>Check Campaigns/Actions screen in Elsa on the day of repair to verify that a VIN qualifies for repair under this action. Elsa is the <u>only</u> valid campaign inquiry & verification source.</i> <ul style="list-style-type: none">✓ Campaign status must show "open."✓ If Elsa shows other open action(s), inform your customer so that the work can also be completed at the same time the vehicle is in the workshop for this campaign.
Problem Description	The suction pump inside the fuel tank designed to purge fuel from the evaporative emissions (EVAP) system may have been damaged during assembly. This could cause fuel to flow directly into the EVAP system which could, over time, accumulate and cause a leak through the charcoal canister filter element. Leaking fuel, in the presence of an ignition source, may result in a fire.

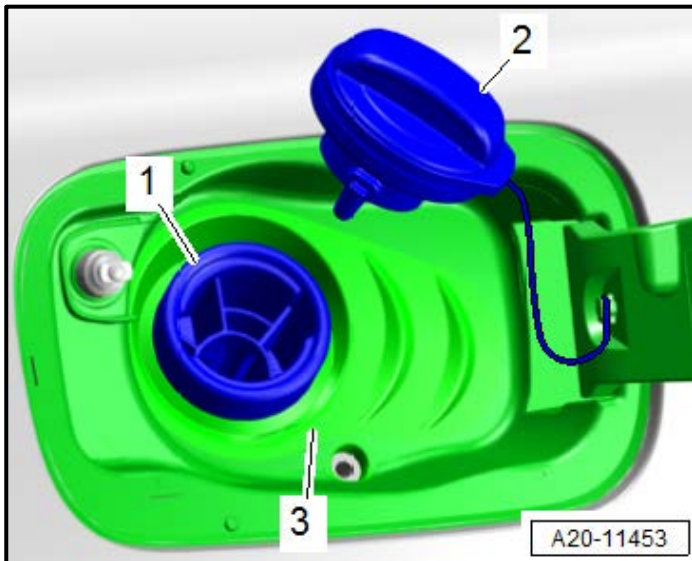
NOTE
Risk for repeat repair!
Failing to fill the fuel tank with the same amount of fuel that was extracted can result in fuel level sending unit faults, or fuel gauge inaccuracies. Additional diagnostic time required to perform a capacitive discharge or remove fused power to the instrument cluster to clear these faults or inaccuracies are NOT covered under this campaign.

- Open the fuel door and remove the fuel cap <2>.
- Refill the fuel tank with the same amount of fuel removed prior with the -VAS 5190- Fuel Extraction Unit.
- Verify using the sightglass on the side of the -VAS 5190- Fuel Extraction Unit that the fuel tank was filled with the same amount of fuel that was extracted before reconnecting the battery.
