SAFETY RECALL BULLETIN

HID HEADLAMP HORIZONTAL ADJUSTMENT LOCKING CLIPS NOT SECURED – SAFETY RECALL CAMPAIGN

No: **SR-16-008**

MODEL: 2017 Mirage

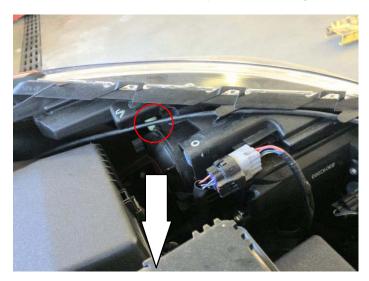
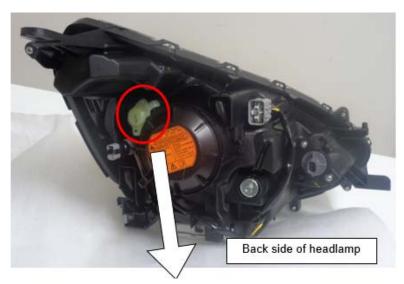
- a. If HID headlamp horizontal adjustment locking clip is secured, proceed to step 5.
- b. If NG condition is found (HID headlamp horizontal adjustment locking clip not secured), take a photo of NG condition for posting to Photos Required Condition (PRC) system, then fold the tab over against the lamp housing using a Phillips screwdriver until you hear a "click" as it locks into place.
