## Technical Service Bulletin

GROUP <b>RECALL</b>	NUMBER <b>16-01-042</b>
DATE <b>OCTOBER 2016</b>	MODEL(S) <b>GENESIS COUPE (BK)</b>

**SUBJECT:** PASSENGER OCCUPANT DETECTING SENSOR (PODS) UNIT  
CONNECTOR REWORK (RECALL 151)

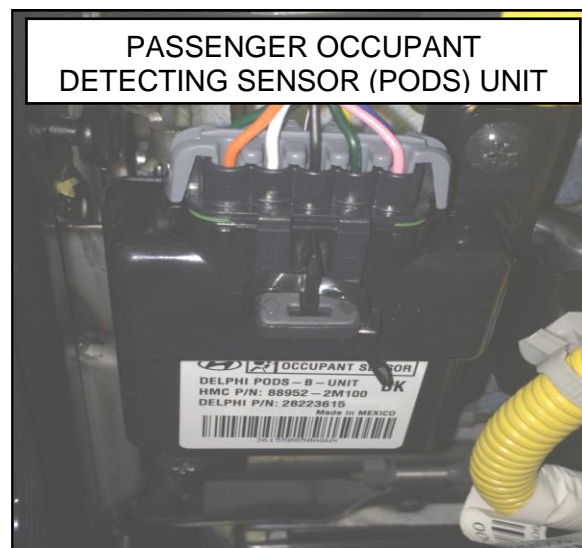
**Description:** The Hyundai Genesis Coupe is equipped with an Occupant Classification System (OCS) to determine if the front passenger seat is occupied, and if so, detect the presence of a Child Restraint System or small statured occupant. In certain cases, the front passenger airbag is deactivated to help prevent airbag-related injuries to the front passenger. If objects are placed under the front passenger seat that contact the OCS connector, the connector can become disconnected, illuminating the Air Bag warning lamp in the instrument cluster. If this occurs, the front passenger airbag will deploy in a frontal collision regardless of the front passenger seat occupant. Additionally, the system's second stage airbag will not deploy in more severe collisions.

This bulletin provides the procedure to inspect and secure the connector to the Passenger Occupant Detection Sensor (PODS) module underneath the front passenger seat.
